Appendix XI

SBEACH 15 and 25 yr. Storm Erosion Profiles

Brevard County

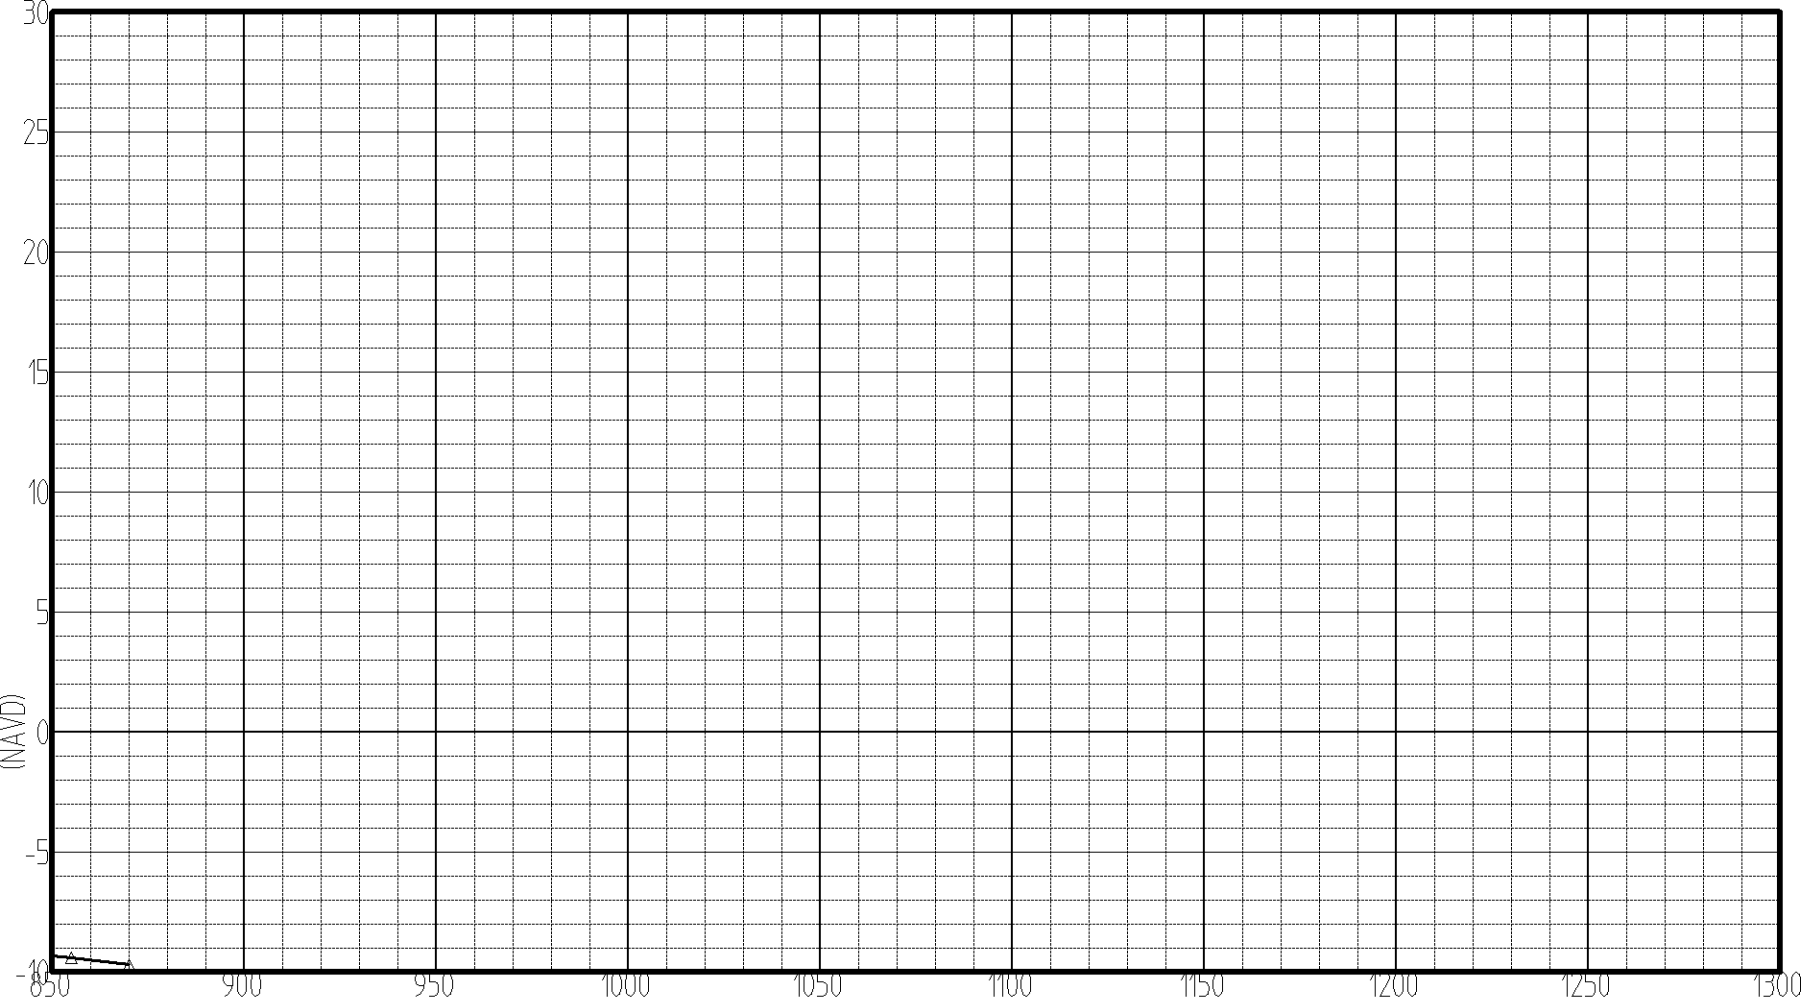
Range: R-139 3/3

BEACH PROFILE

- △—△— 2005-2008 INPUT PRF
- - - * - - - 15-YR SBEACH ERODED PRF
- - - o - - - 25-YR SBEACH ERODED PRF

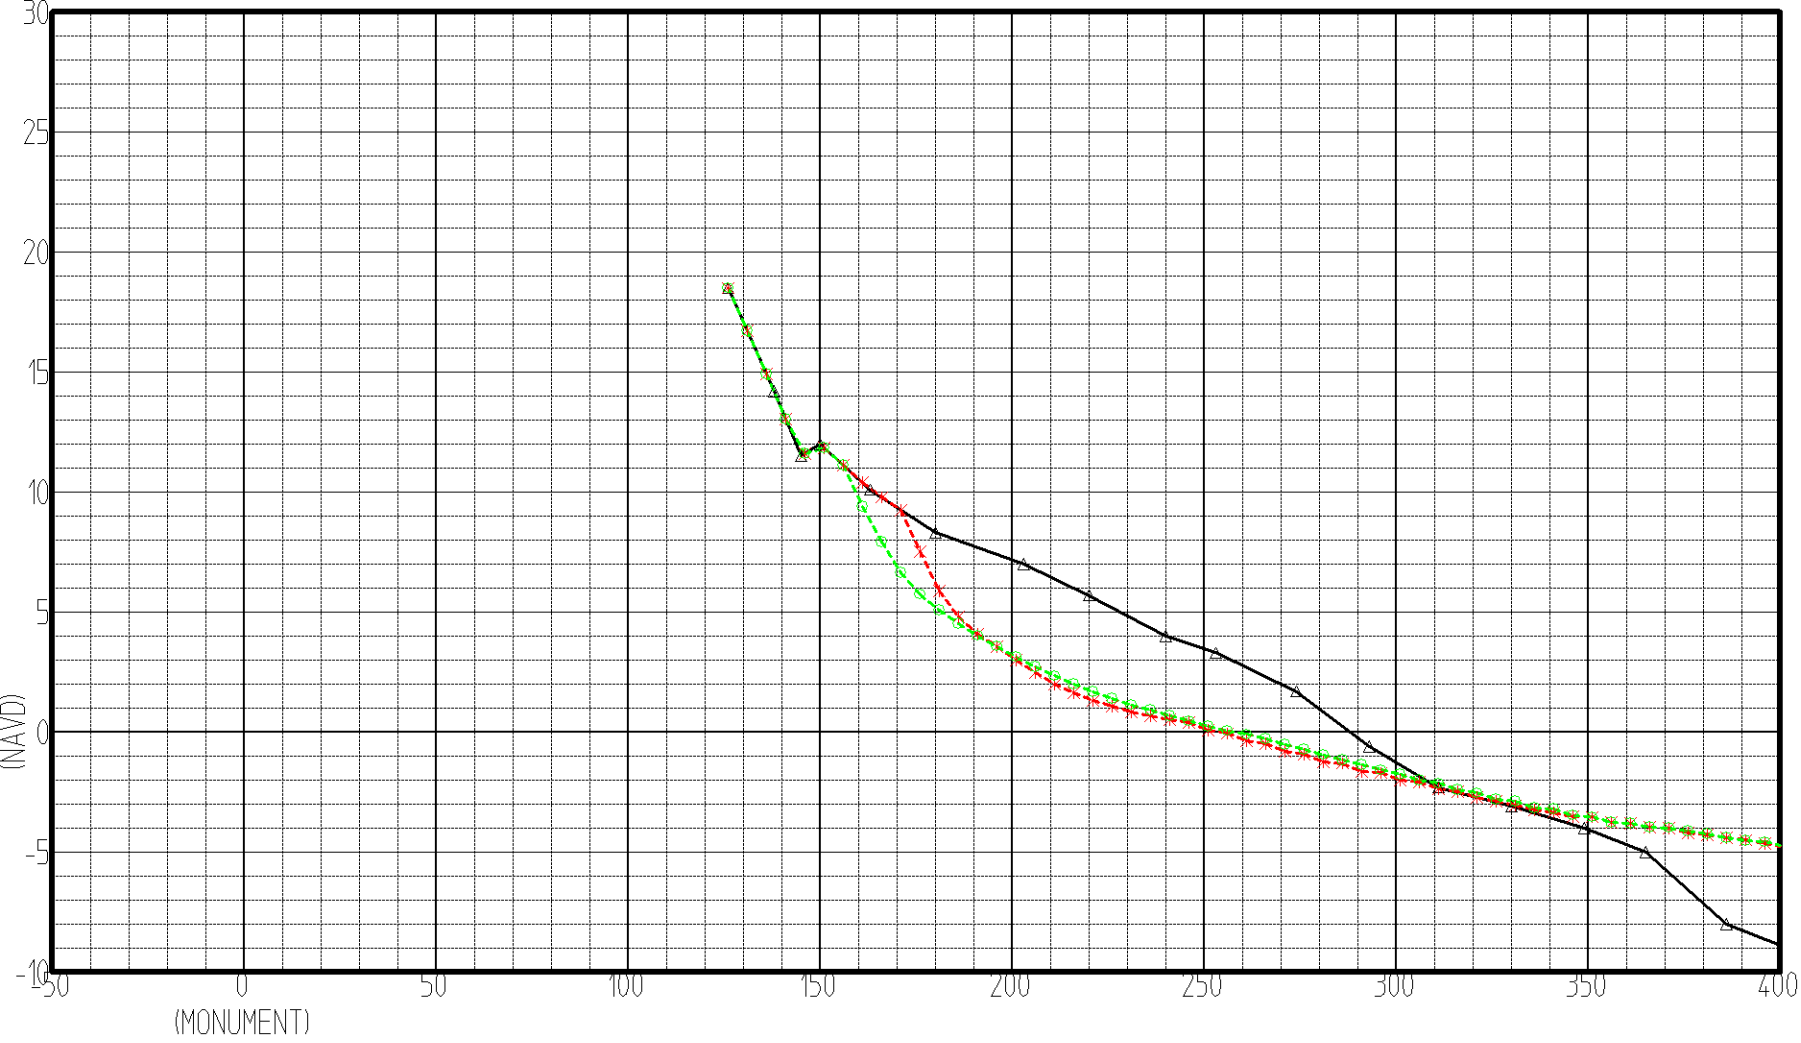
Range: R-140

BEACH PROFILE

—△—△— 2005-2008 INPUT PRF

- - - * - - - 15-YR SBEACH ERODED PRF

- - - o - - - 25-YR SBEACH ERODED PRF

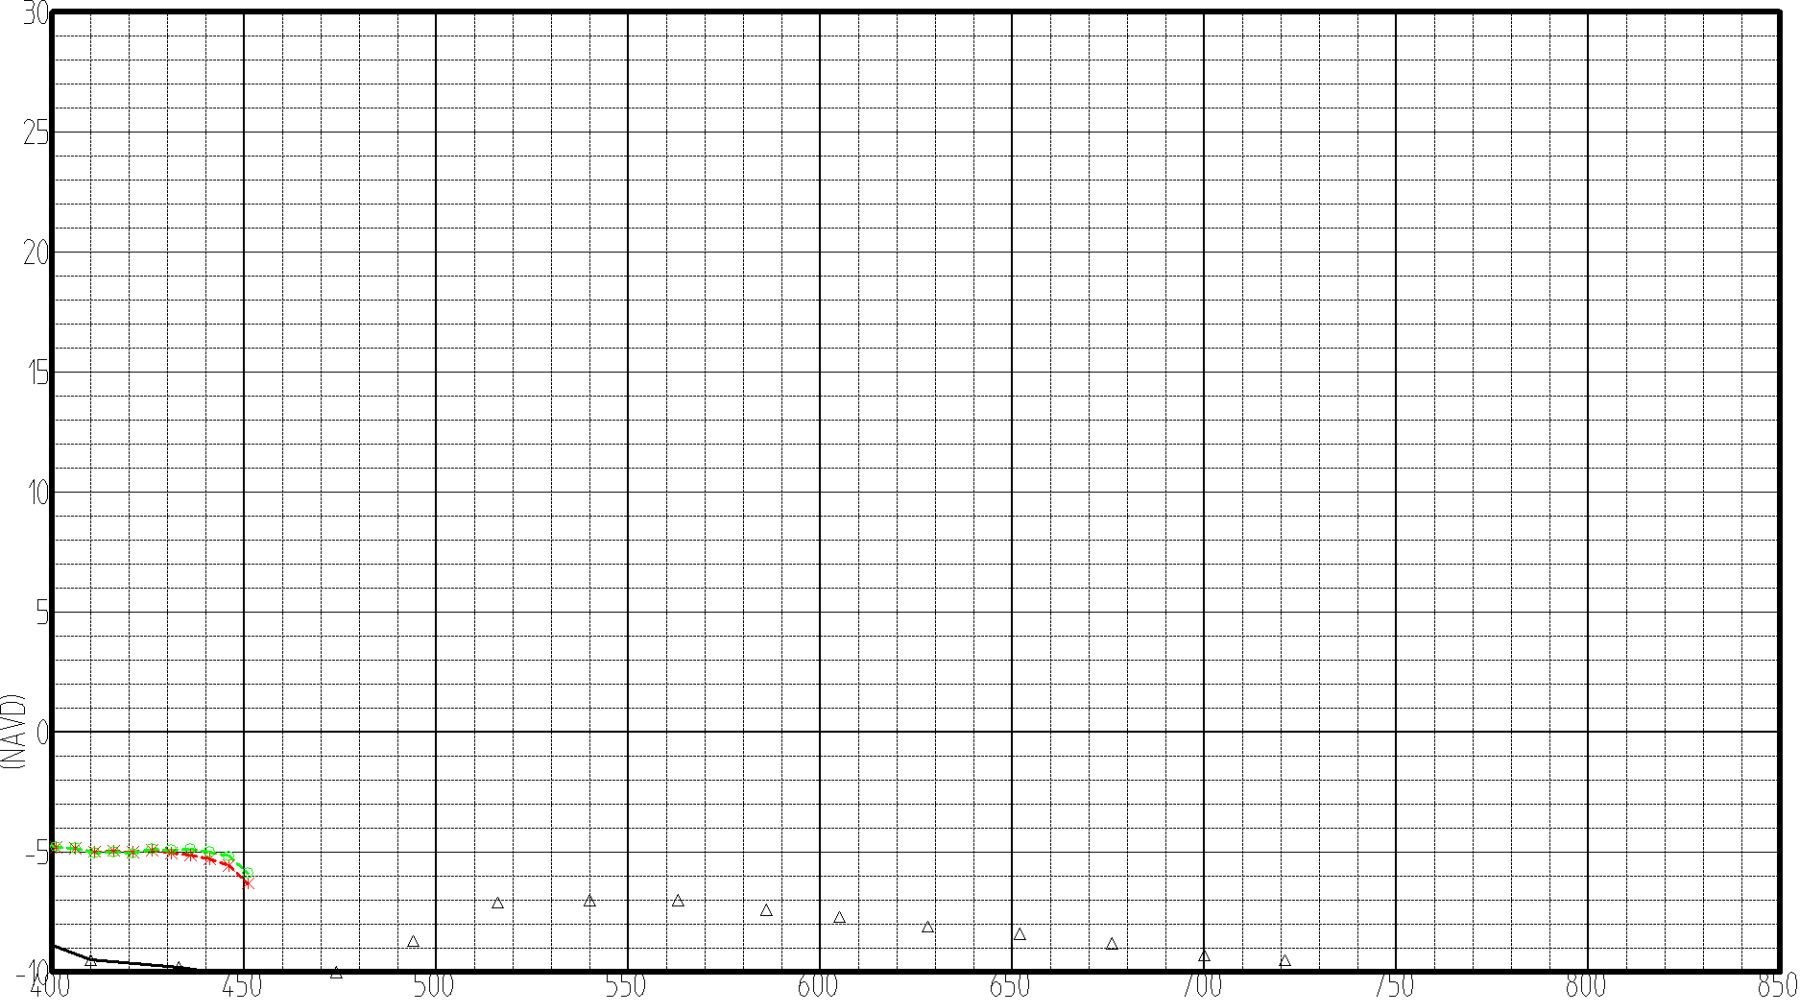
Range: R-140
 BEARING: 70.00
 2/2

BEACH PROFILE
 —△—△— 2005-2008 INPUT PRF
 - - * - - * - - 15-YR SBEACH ERODED PRF
 - - o - - o - - 25-YR SBEACH ERODED PRF

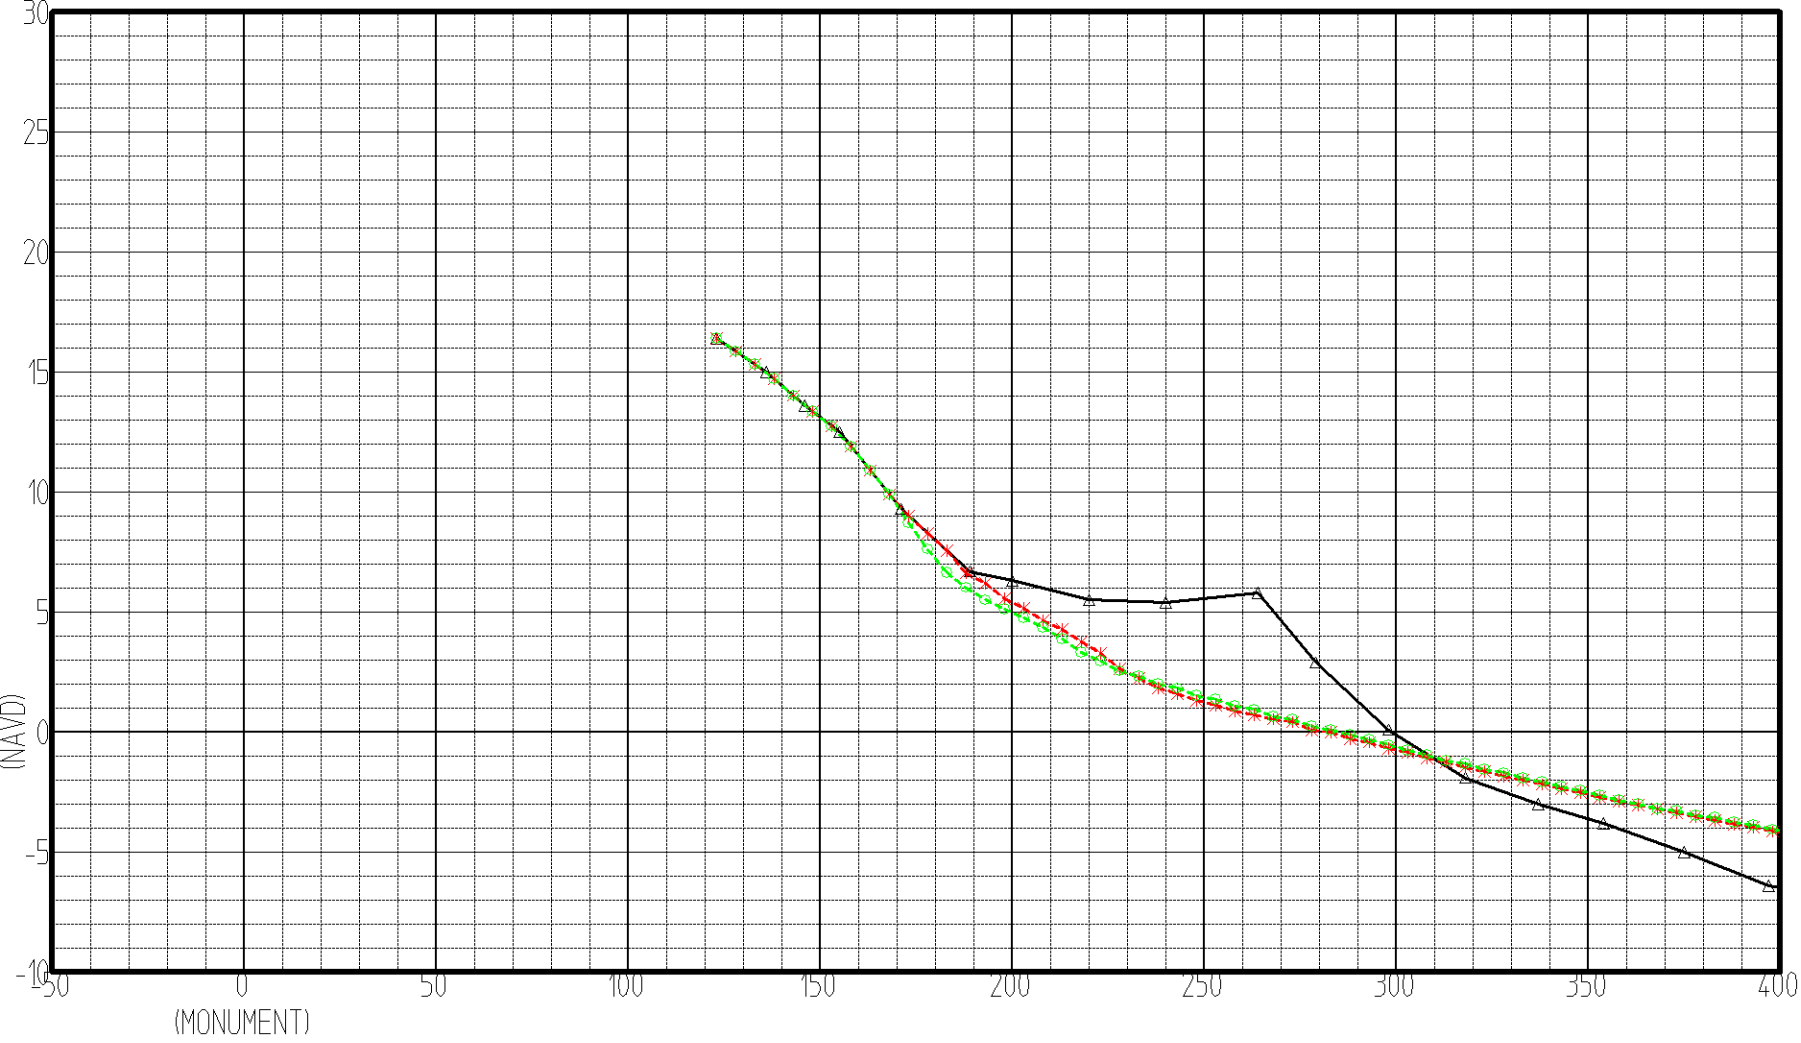
Range: R-141

BEACH PROFILE

—△—△— 2005-2008 INPUT PRF

- - * - - * - - 15-YR SBEACH ERODED PRF

- - o - - o - - 25-YR SBEACH ERODED PRF

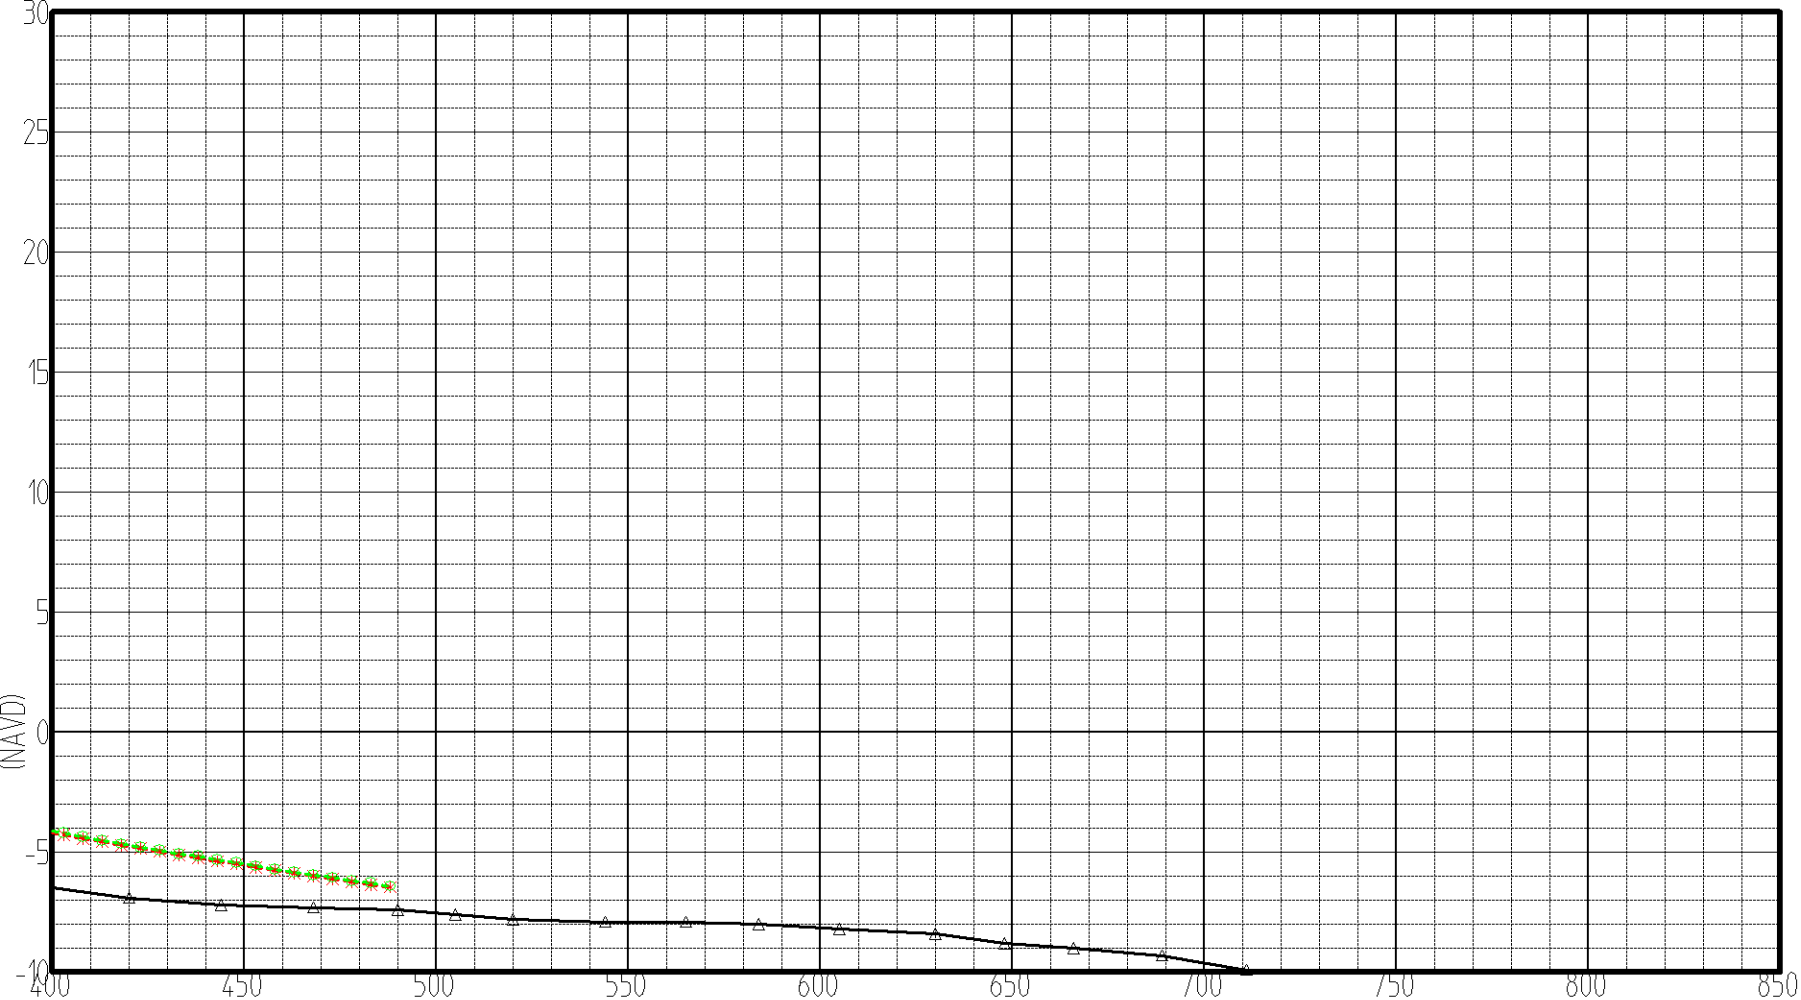
Range: R-141

BEACH PROFILE

—△—△— 2005-2008 INPUT PRF

- - - * - - - 15-YR SBEACH ERODED PRF

- - - o - - - 25-YR SBEACH ERODED PRF

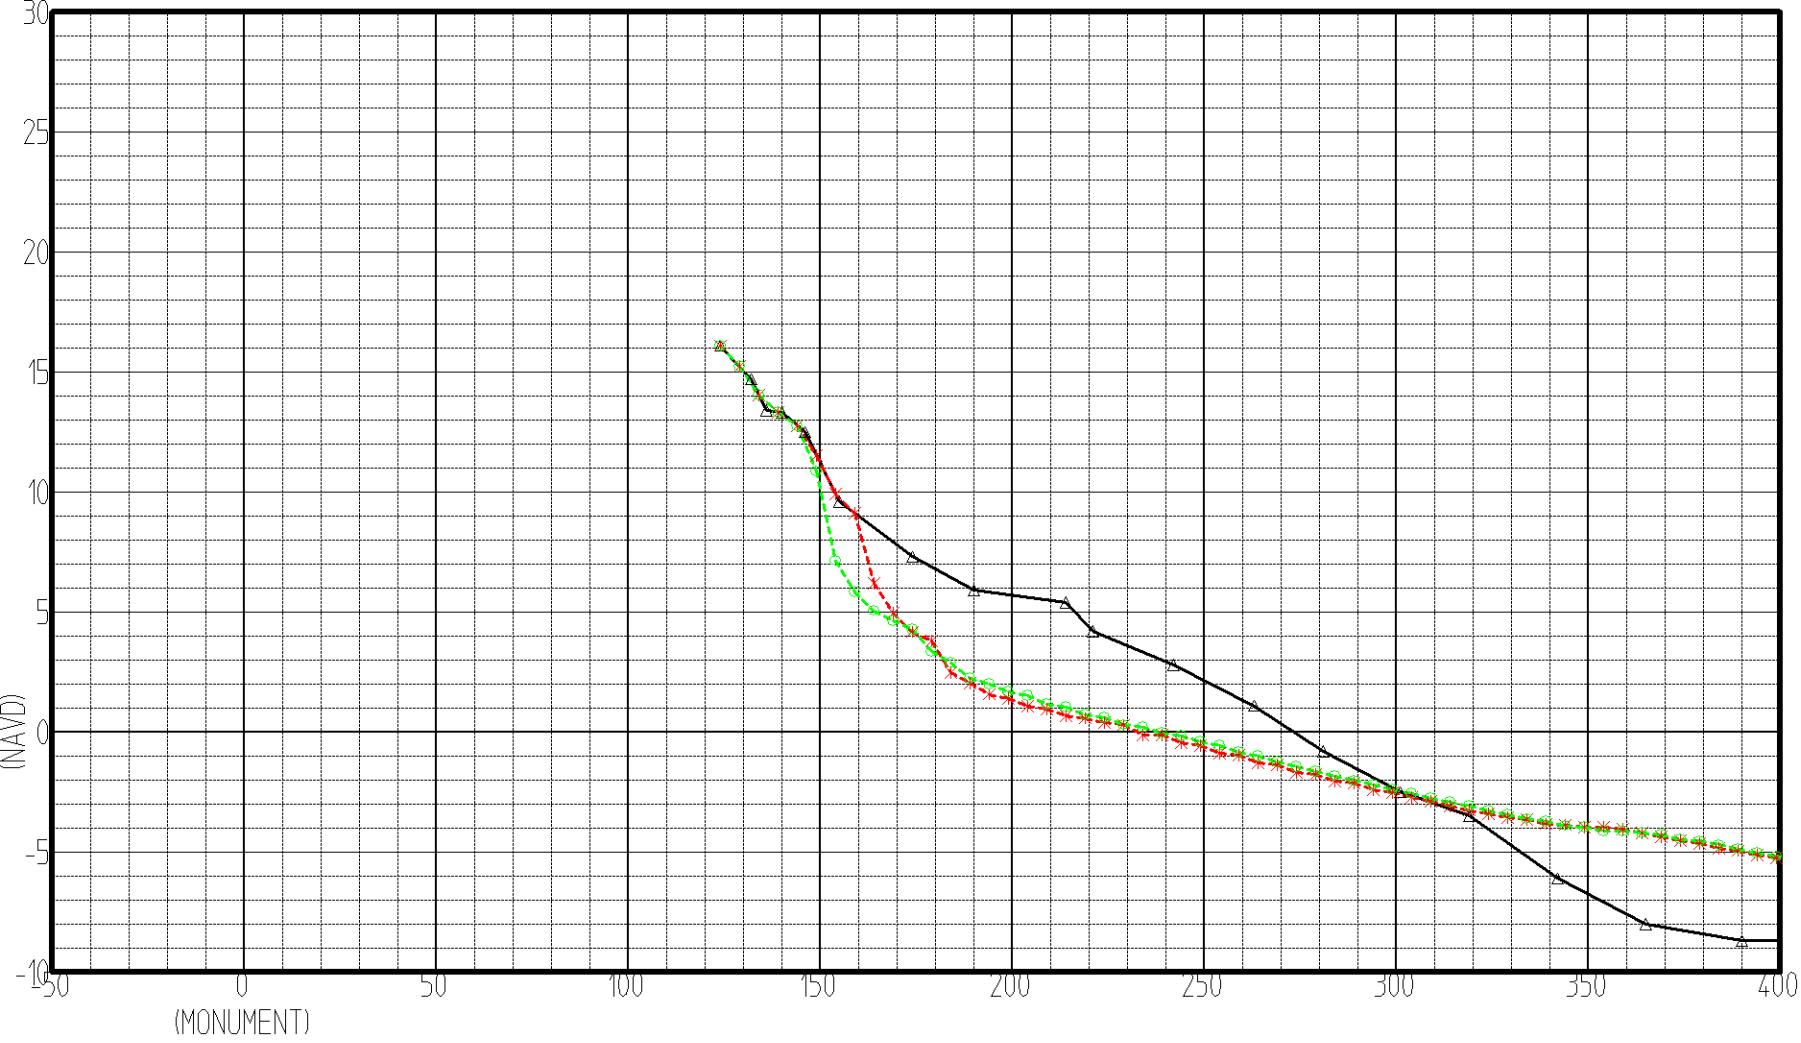
Range: R-142

BEACH PROFILE

—△—△— 2005-2008 INPUT PRF

- - - * - - - 15-YR SBEACH ERODED PRF

- - - o - - - 25-YR SBEACH ERODED PRF

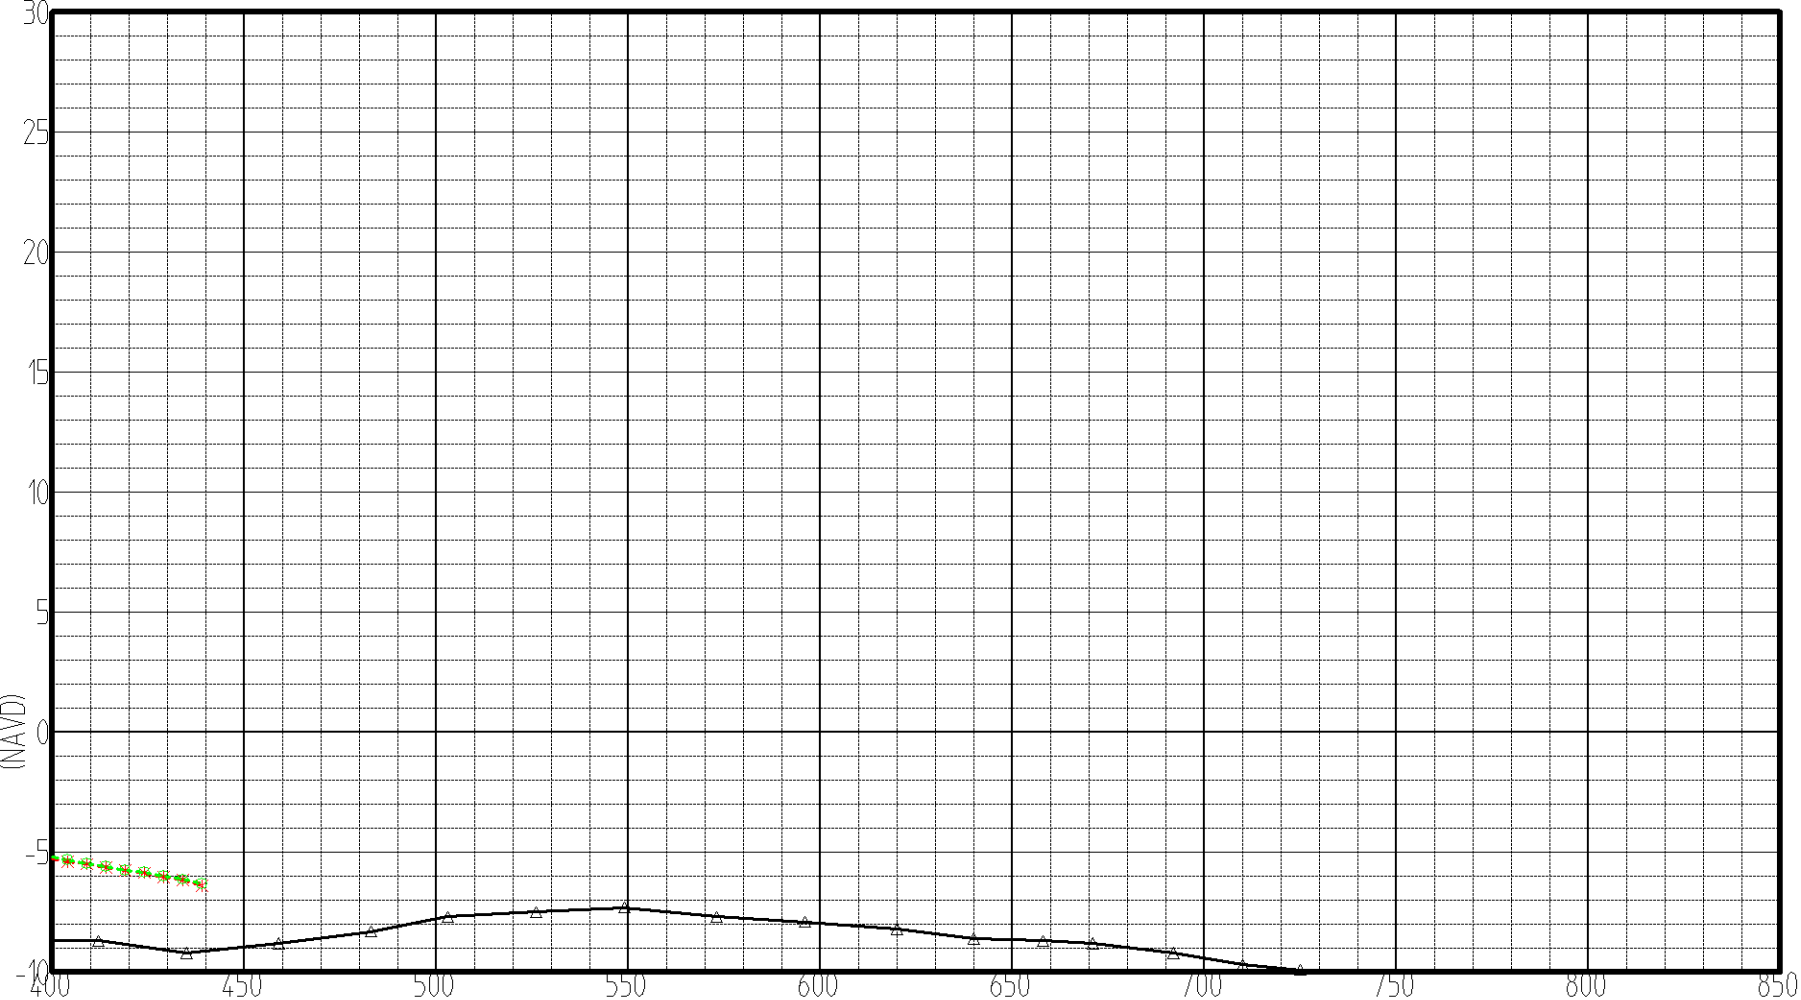
Range: R-142

BEACH PROFILE

—△—△— 2005-2008 INPUT PRF

- - - * - - - 15-YR SBEACH ERODED PRF

- - - o - - - 25-YR SBEACH ERODED PRF

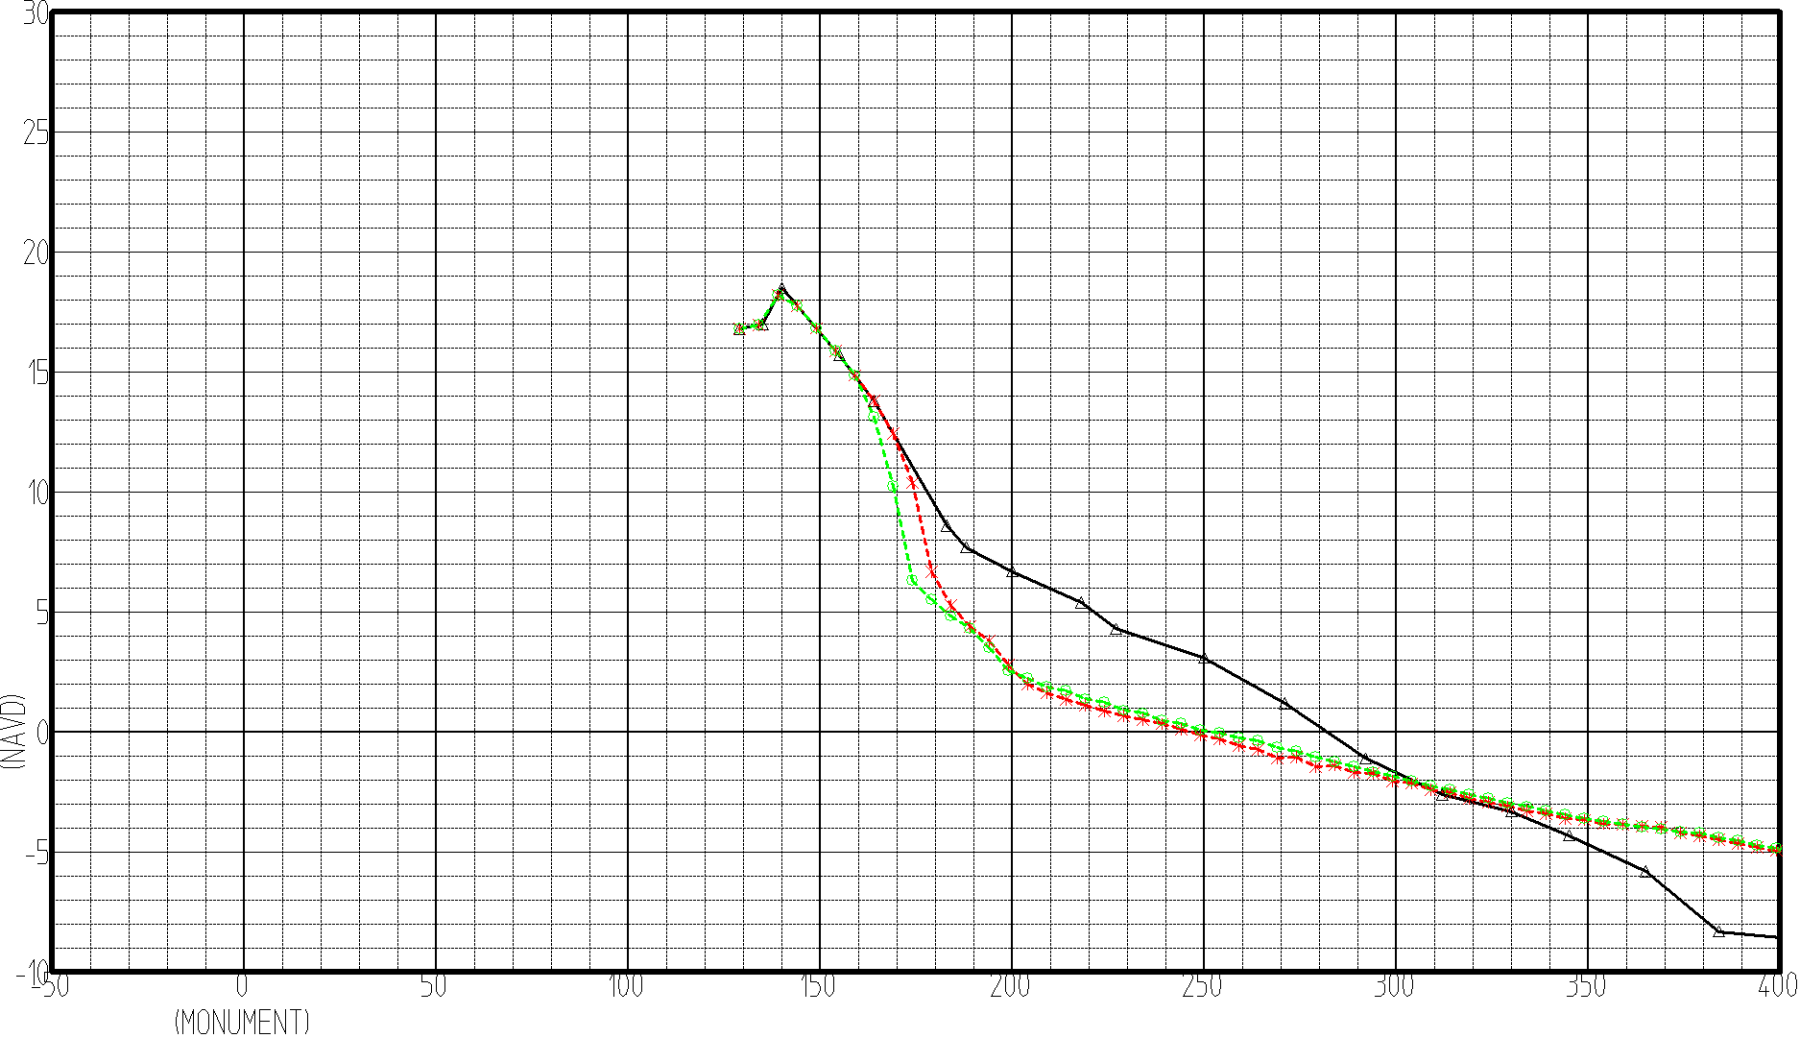
Range: R-143

BEACH PROFILE

- △—△— 2005-2008 INPUT PRF
- - * - - * - - 15-YR SBEACH ERODED PRF
- - o - - o - - 25-YR SBEACH ERODED PRF

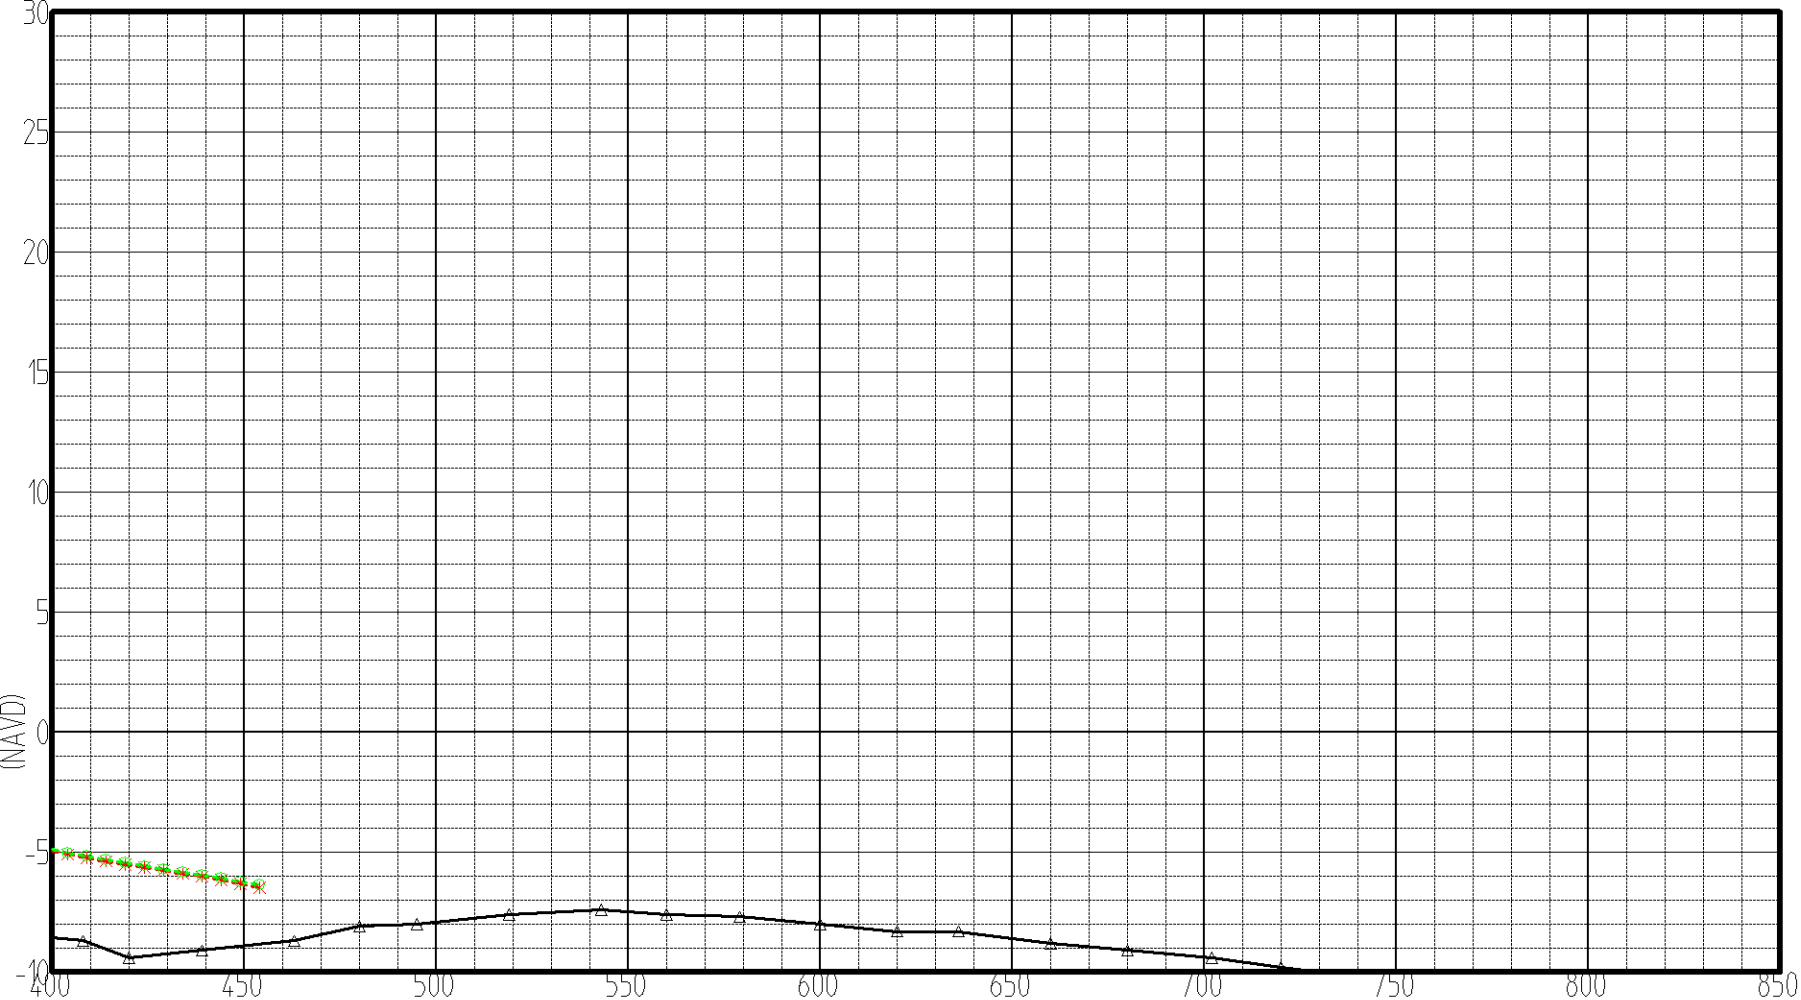
Range: R-143

BEACH PROFILE

—△—△— 2005-2008 INPUT PRF

- - - * - - - 15-YR SBEACH ERODED PRF

- - - o - - - 25-YR SBEACH ERODED PRF

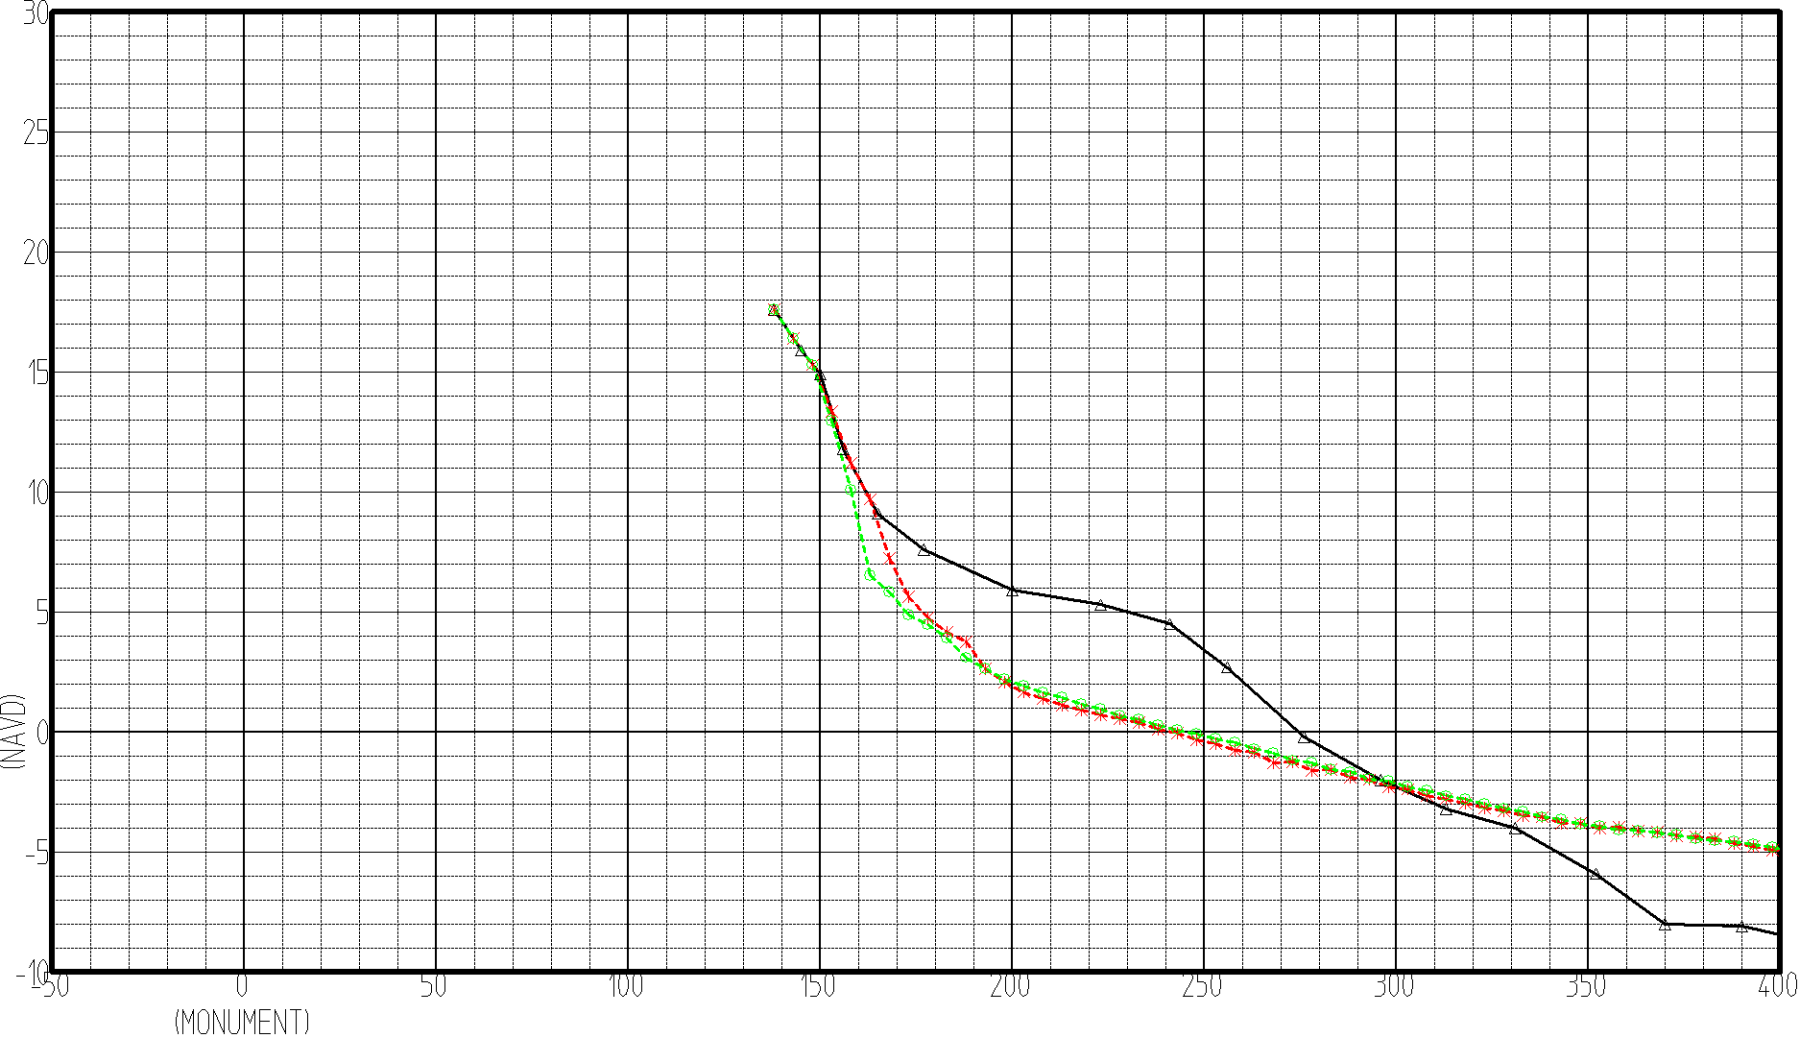
Range: R-144

BEACH PROFILE

—△—△— 2005-2008 INPUT PRF

- - - * - - - 15-YR SBEACH ERODED PRF

- - - o - - - 25-YR SBEACH ERODED PRF

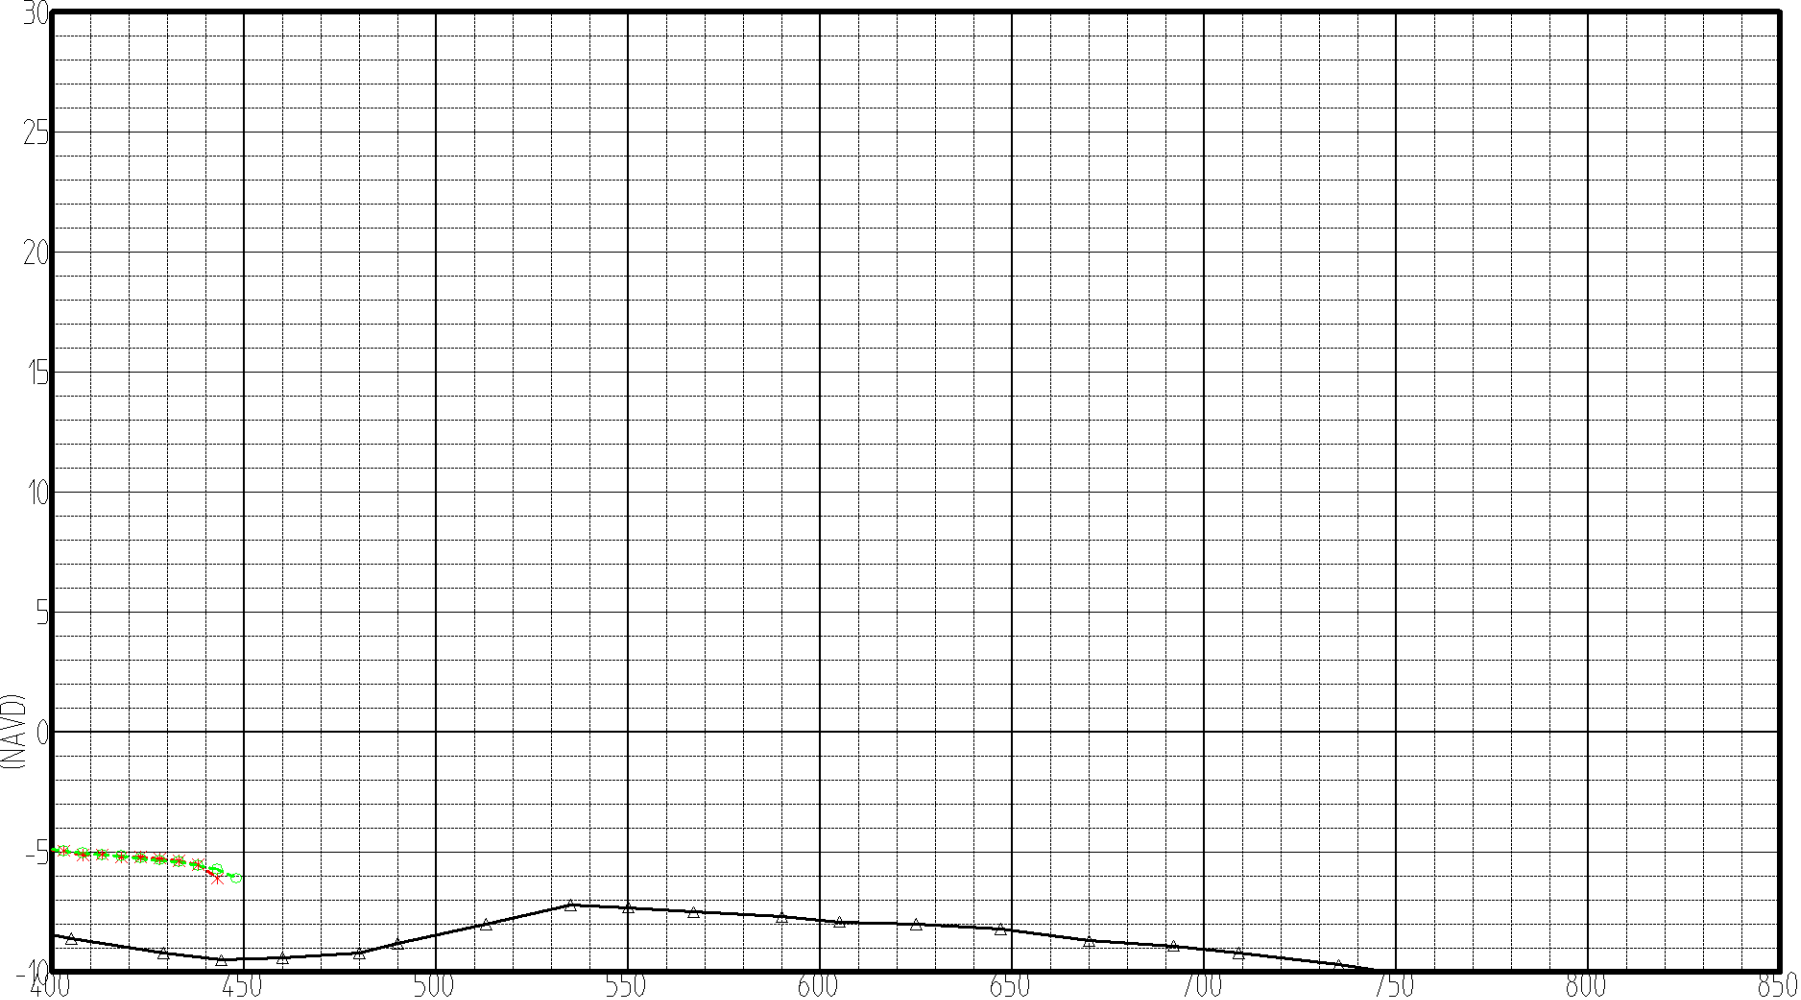
Range: R-144
 BEARING: 70.00
 2/3

BEACH PROFILE
 —△—△— 2005-2008 INPUT PRF
 - - - * - - - 15-YR SBEACH ERODED PRF
 - - - o - - - 25-YR SBEACH ERODED PRF

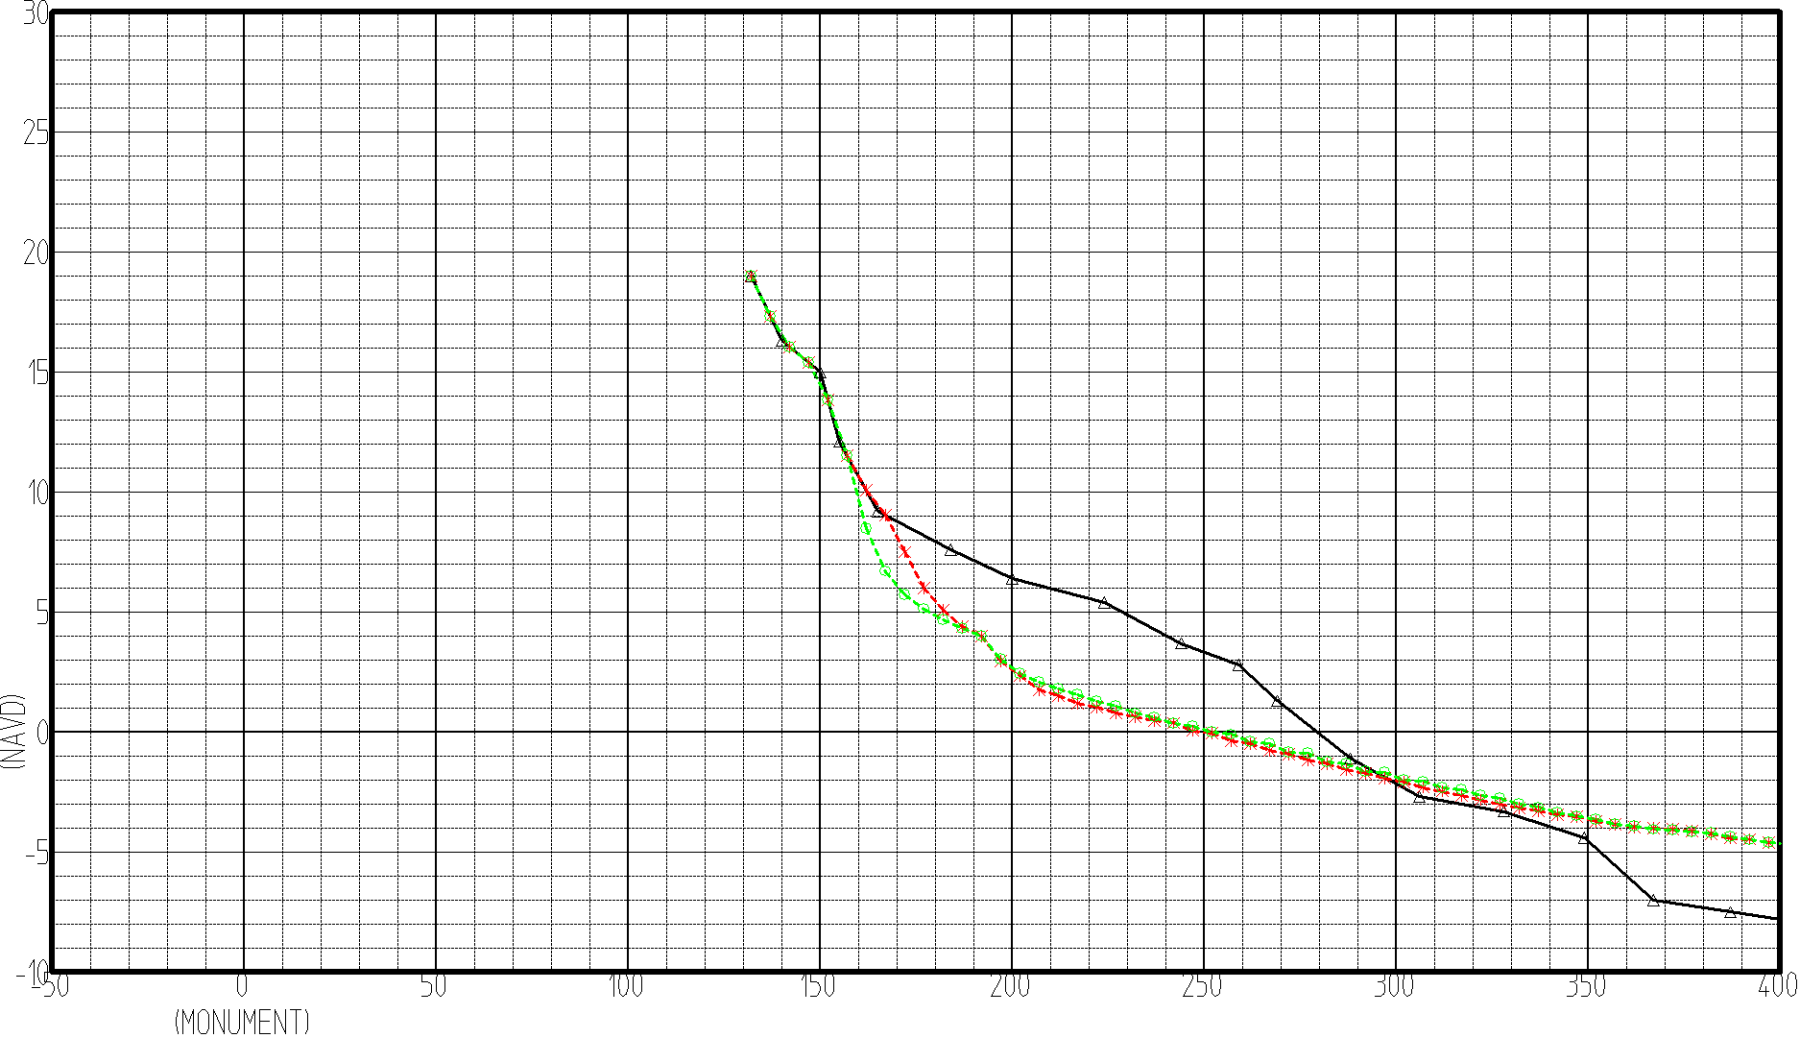
Range: R-145

BEACH PROFILE

—△—△— 2005-2008 INPUT PRF

- - - * - - - 15-YR SBEACH ERODED PRF

- - - o - - - 25-YR SBEACH ERODED PRF
