Appendix XI

SBEACH 15 and 25 yr. Storm Erosion Profiles

Brevard County

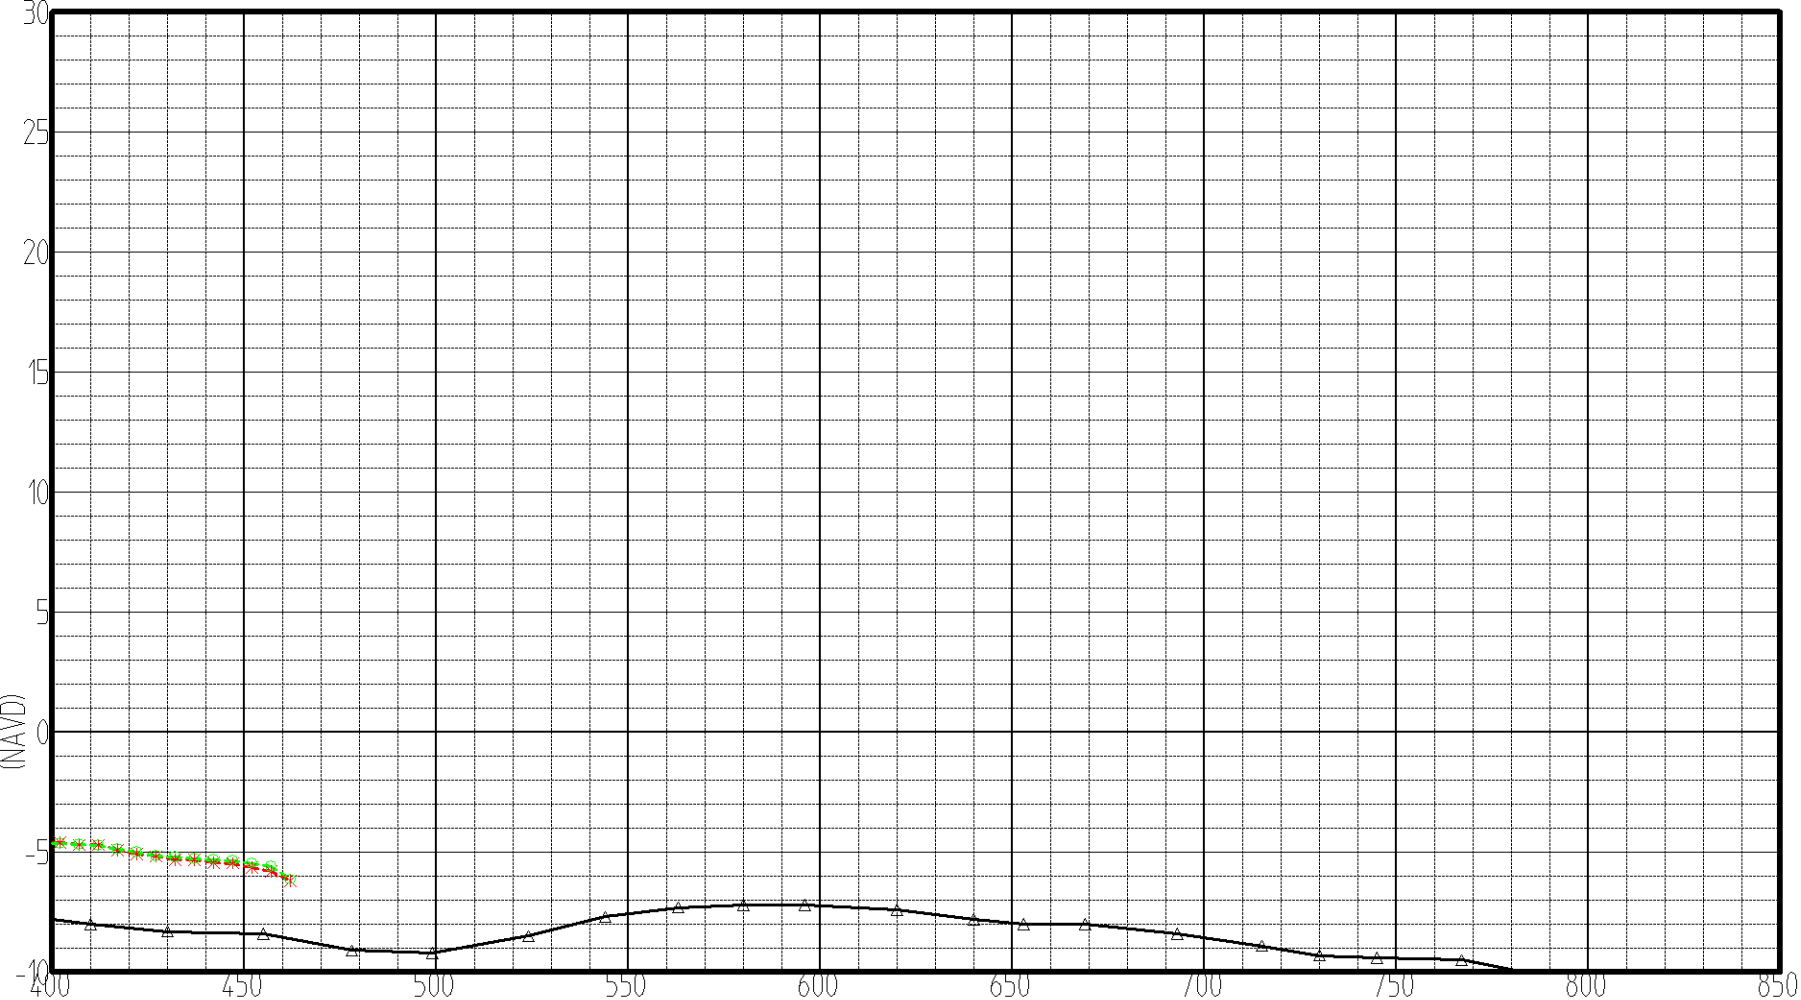
Range: R-145
 BEARING: 70.00
 2/2

BEACH PROFILE
 —△—△— 2005-2008 INPUT PRF
 - - * - - * - - 15-YR SBEACH ERODED PRF
 - - o - - o - - 25-YR SBEACH ERODED PRF

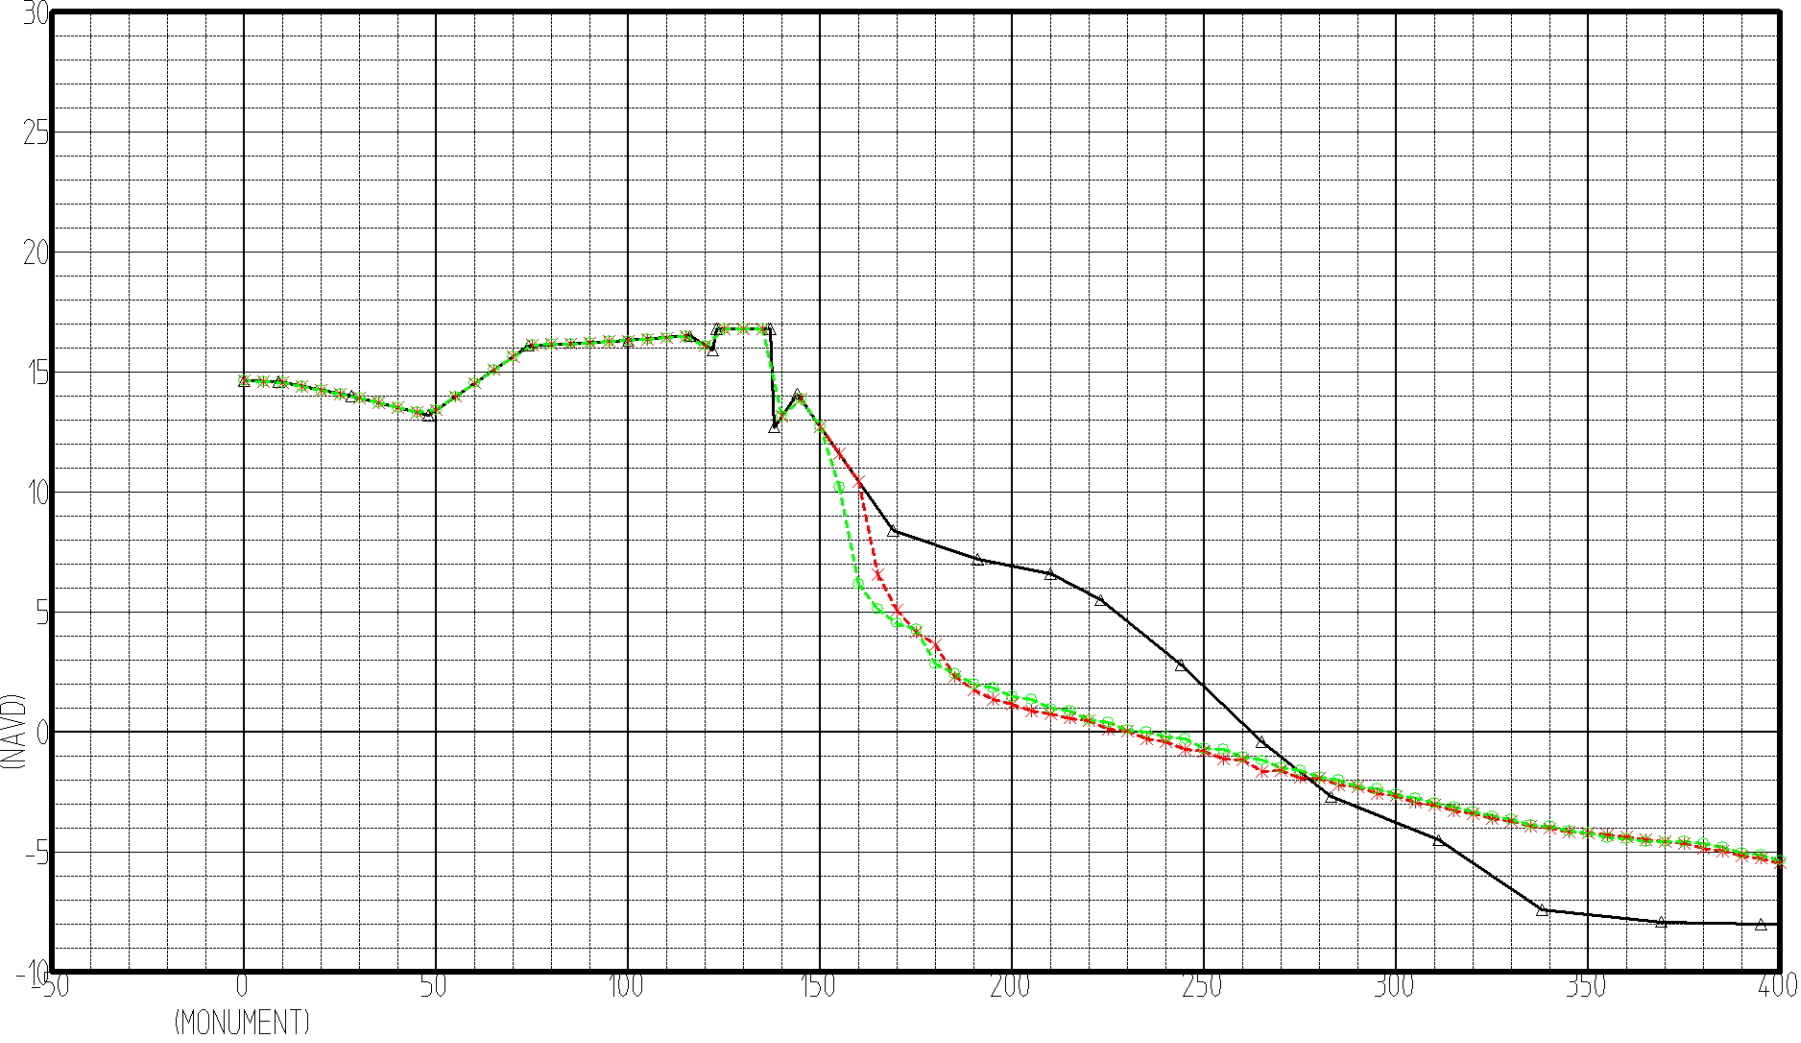
Range: R-146

BEACH PROFILE

—△—△— 2005-2008 INPUT PRF

- - - * - - - 15-YR SBEACH ERODED PRF

- - - o - - - 25-YR SBEACH ERODED PRF

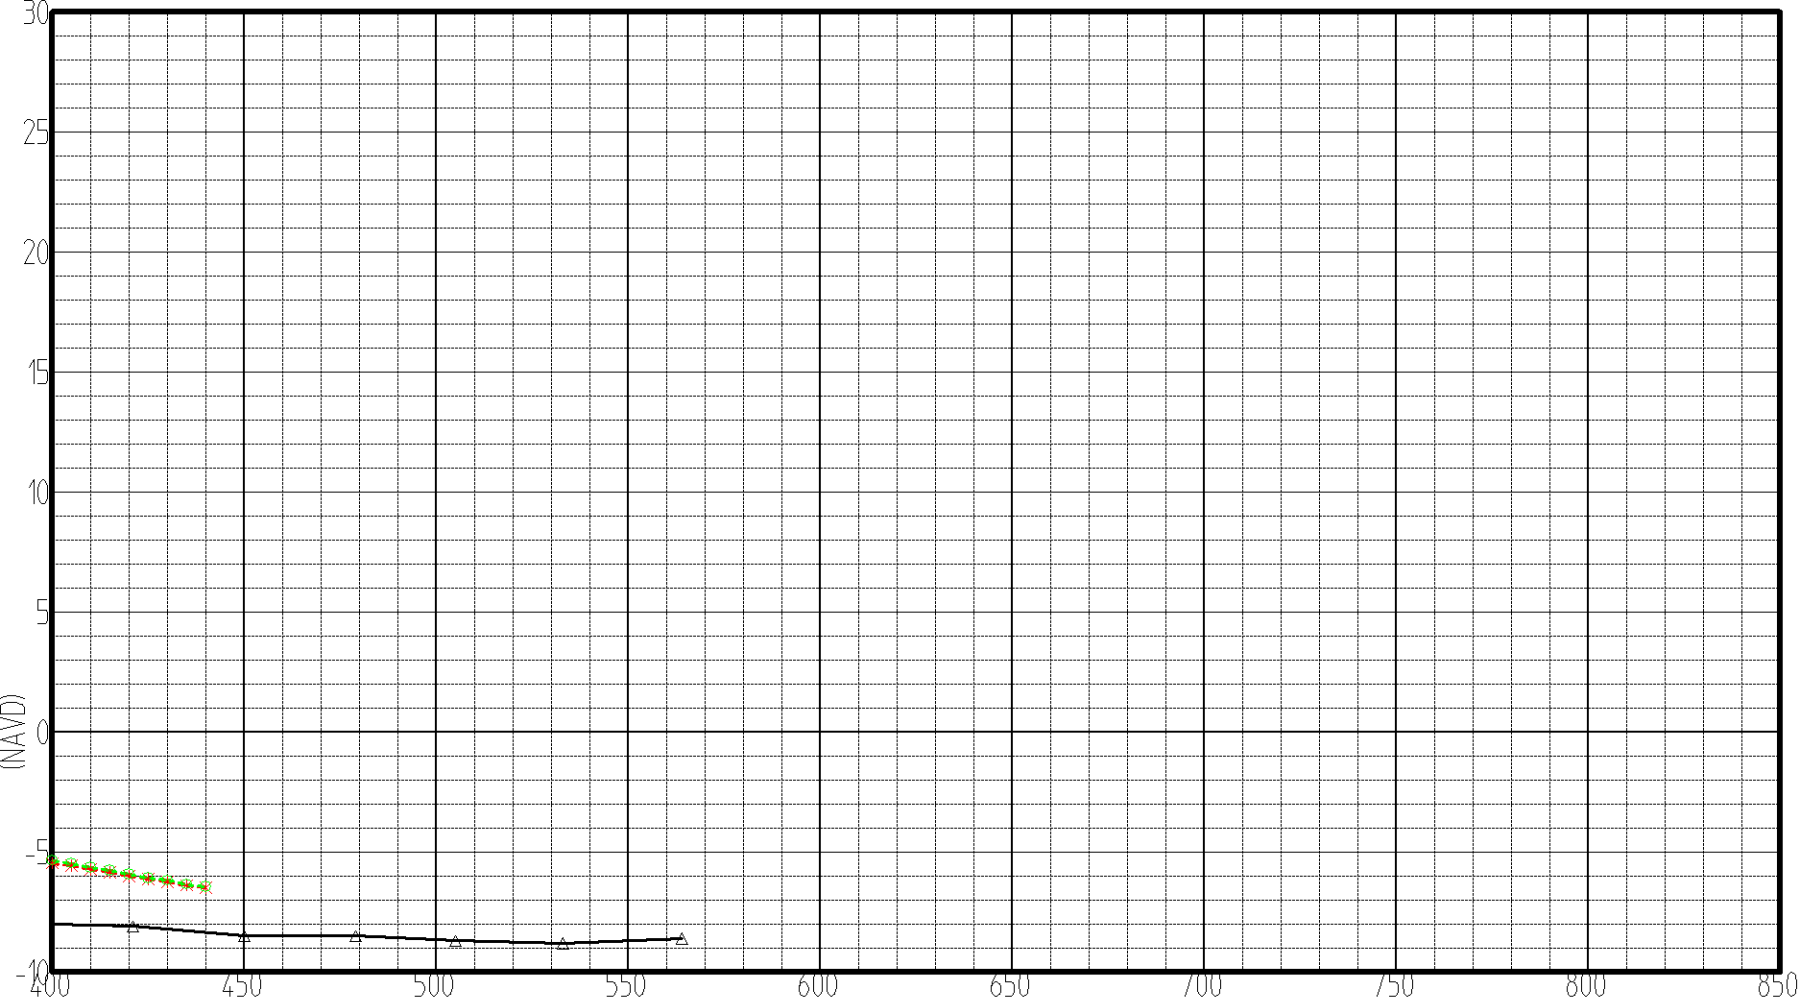
Range: R-146

BEACH PROFILE

—△—△— 2005-2008 INPUT PRF

- - - * - - - 15-YR SBEACH ERODED PRF

- - - o - - - 25-YR SBEACH ERODED PRF

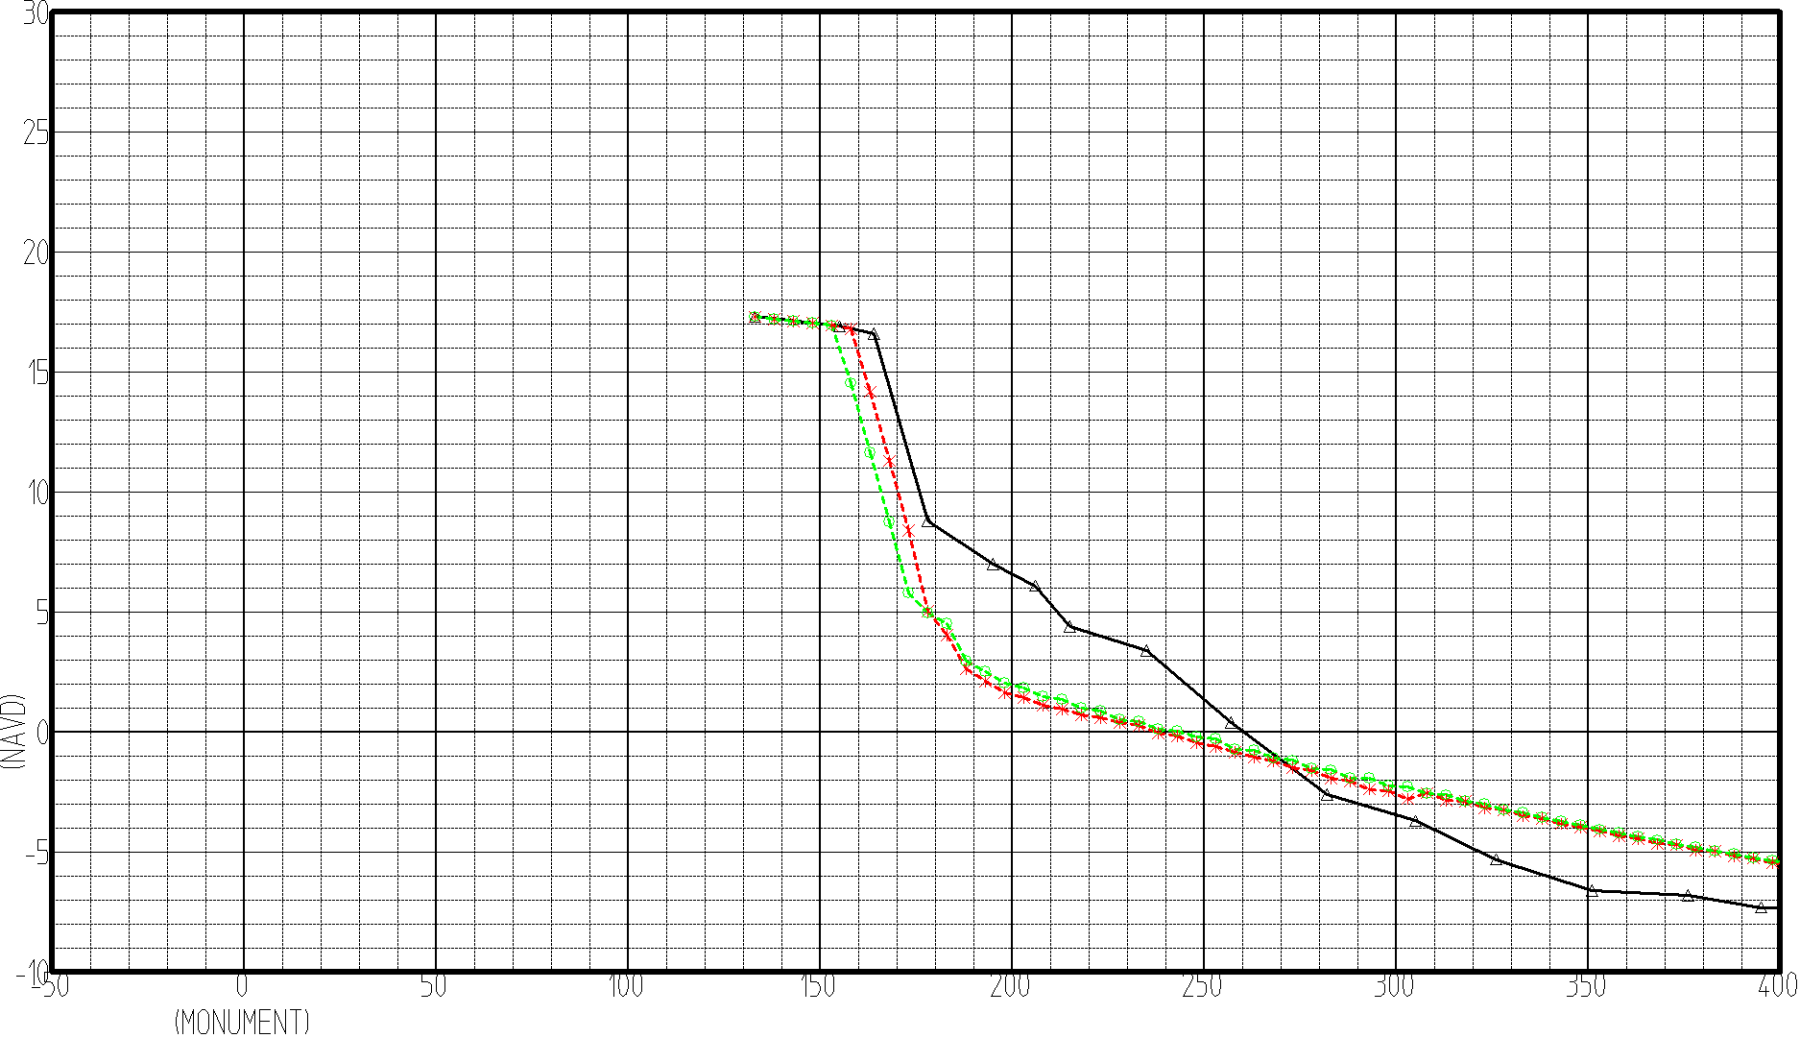
Range: R-147

BEACH PROFILE

—△—△— 2005-2008 INPUT PRF

- - - * - - - 15-YR SBEACH ERODED PRF

- - - o - - - 25-YR SBEACH ERODED PRF

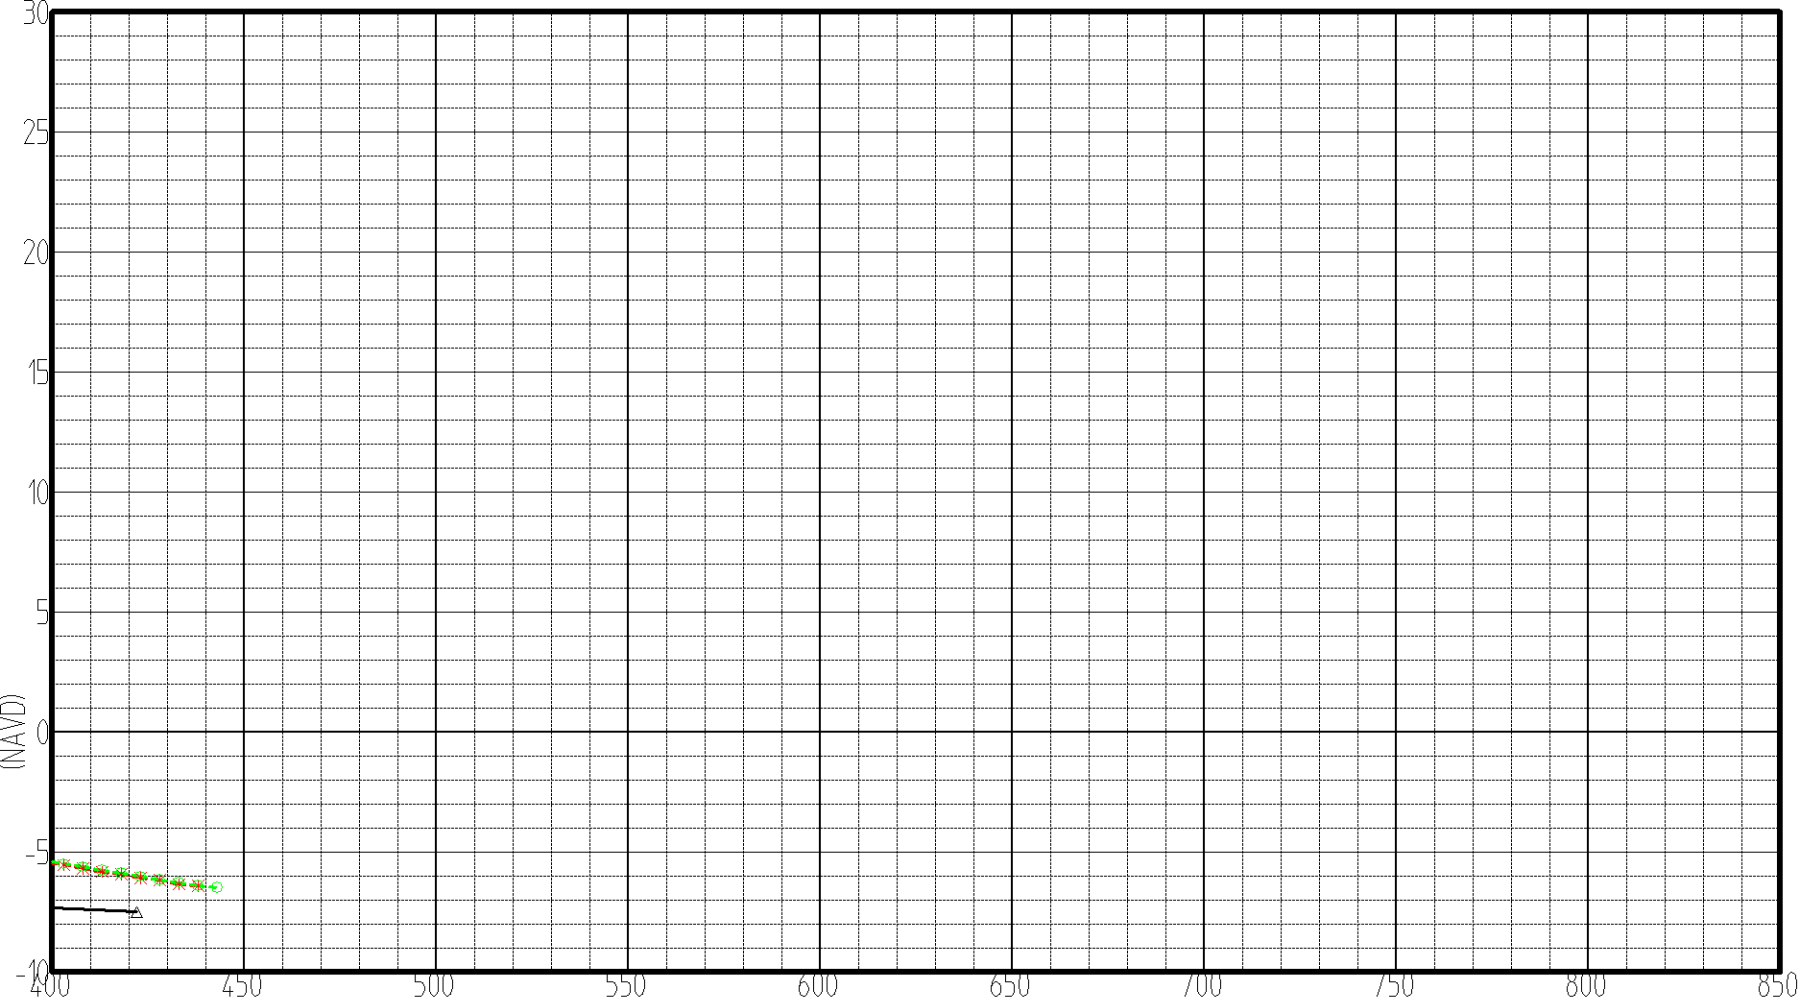
Range: R-147 2/2

BEACH PROFILE

- △—△— 2005-2008 INPUT PRF
- - - * - - - 15-YR SBEACH ERODED PRF
- - - o - - - 25-YR SBEACH ERODED PRF

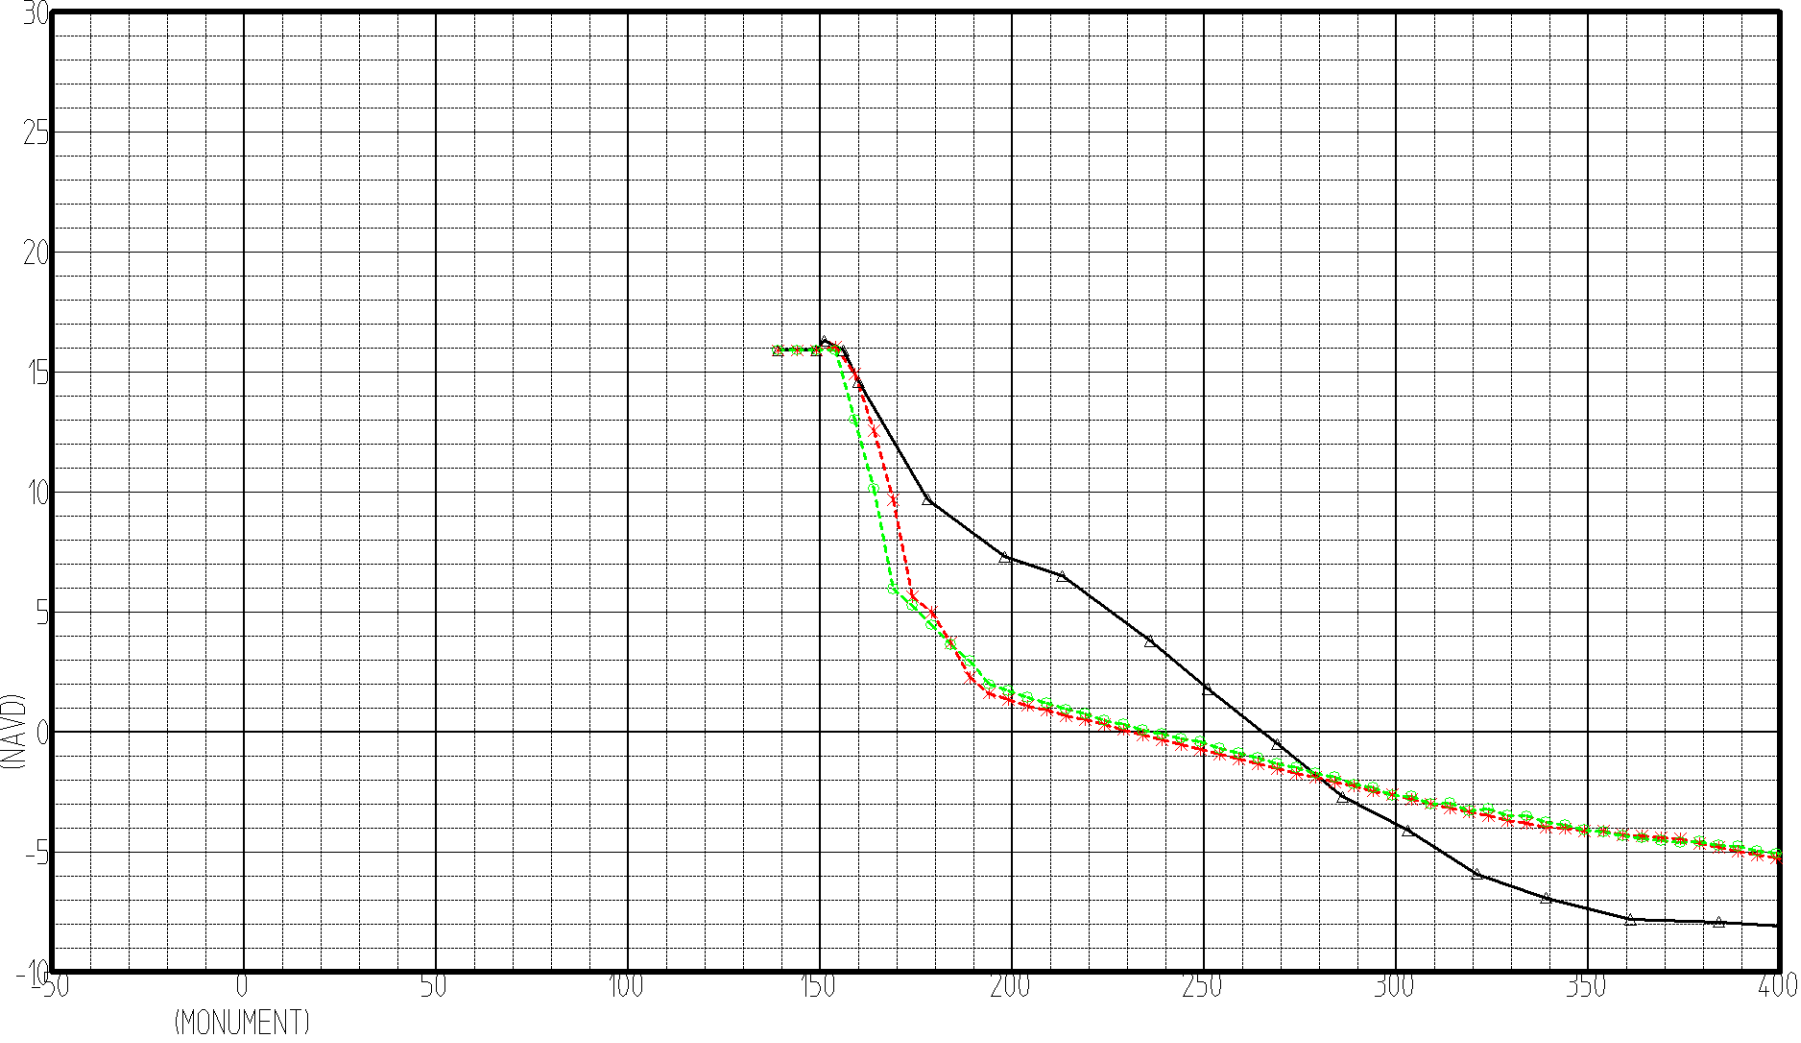
Range: R-148

BEACH PROFILE

- △—△— 2005-2008 INPUT PRF
- - - * - - - 15-YR SBEACH ERODED PRF
- - - o - - - 25-YR SBEACH ERODED PRF

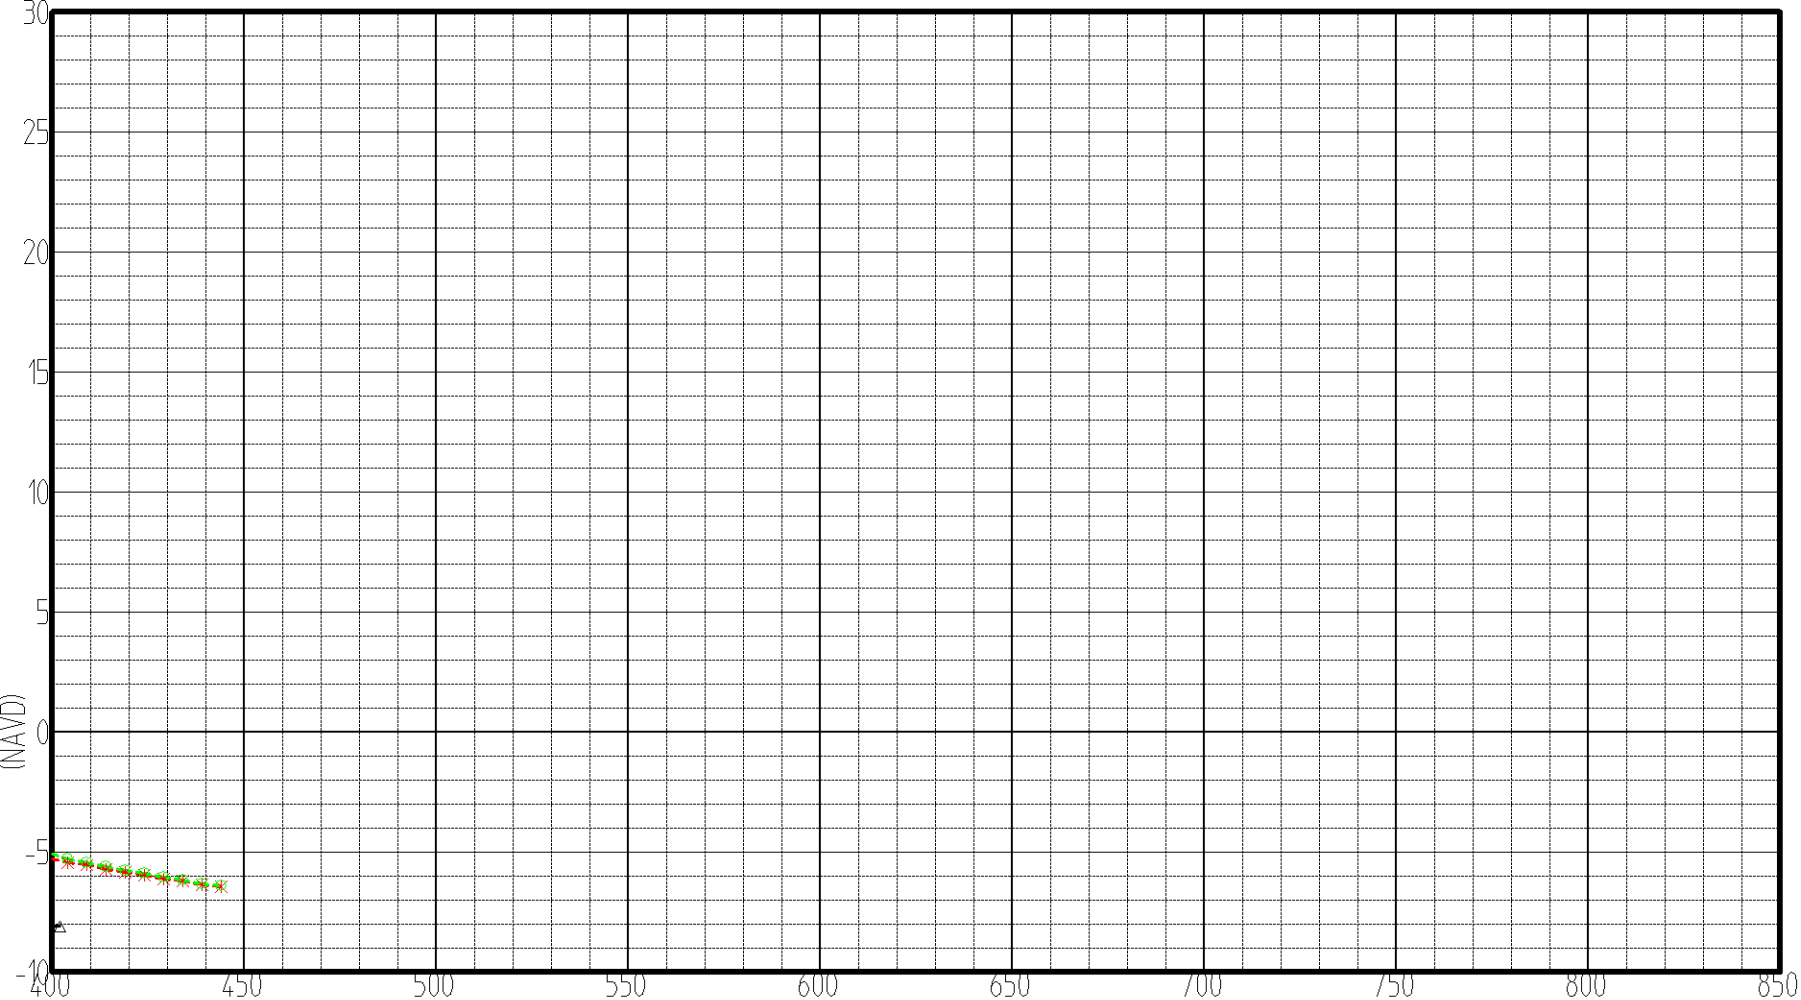
Range: R-148 2/2

BEACH PROFILE

- △—△— 2005-2008 INPUT PRF
- - - * - - - 15-YR SBEACH ERODED PRF
- - - o - - - 25-YR SBEACH ERODED PRF

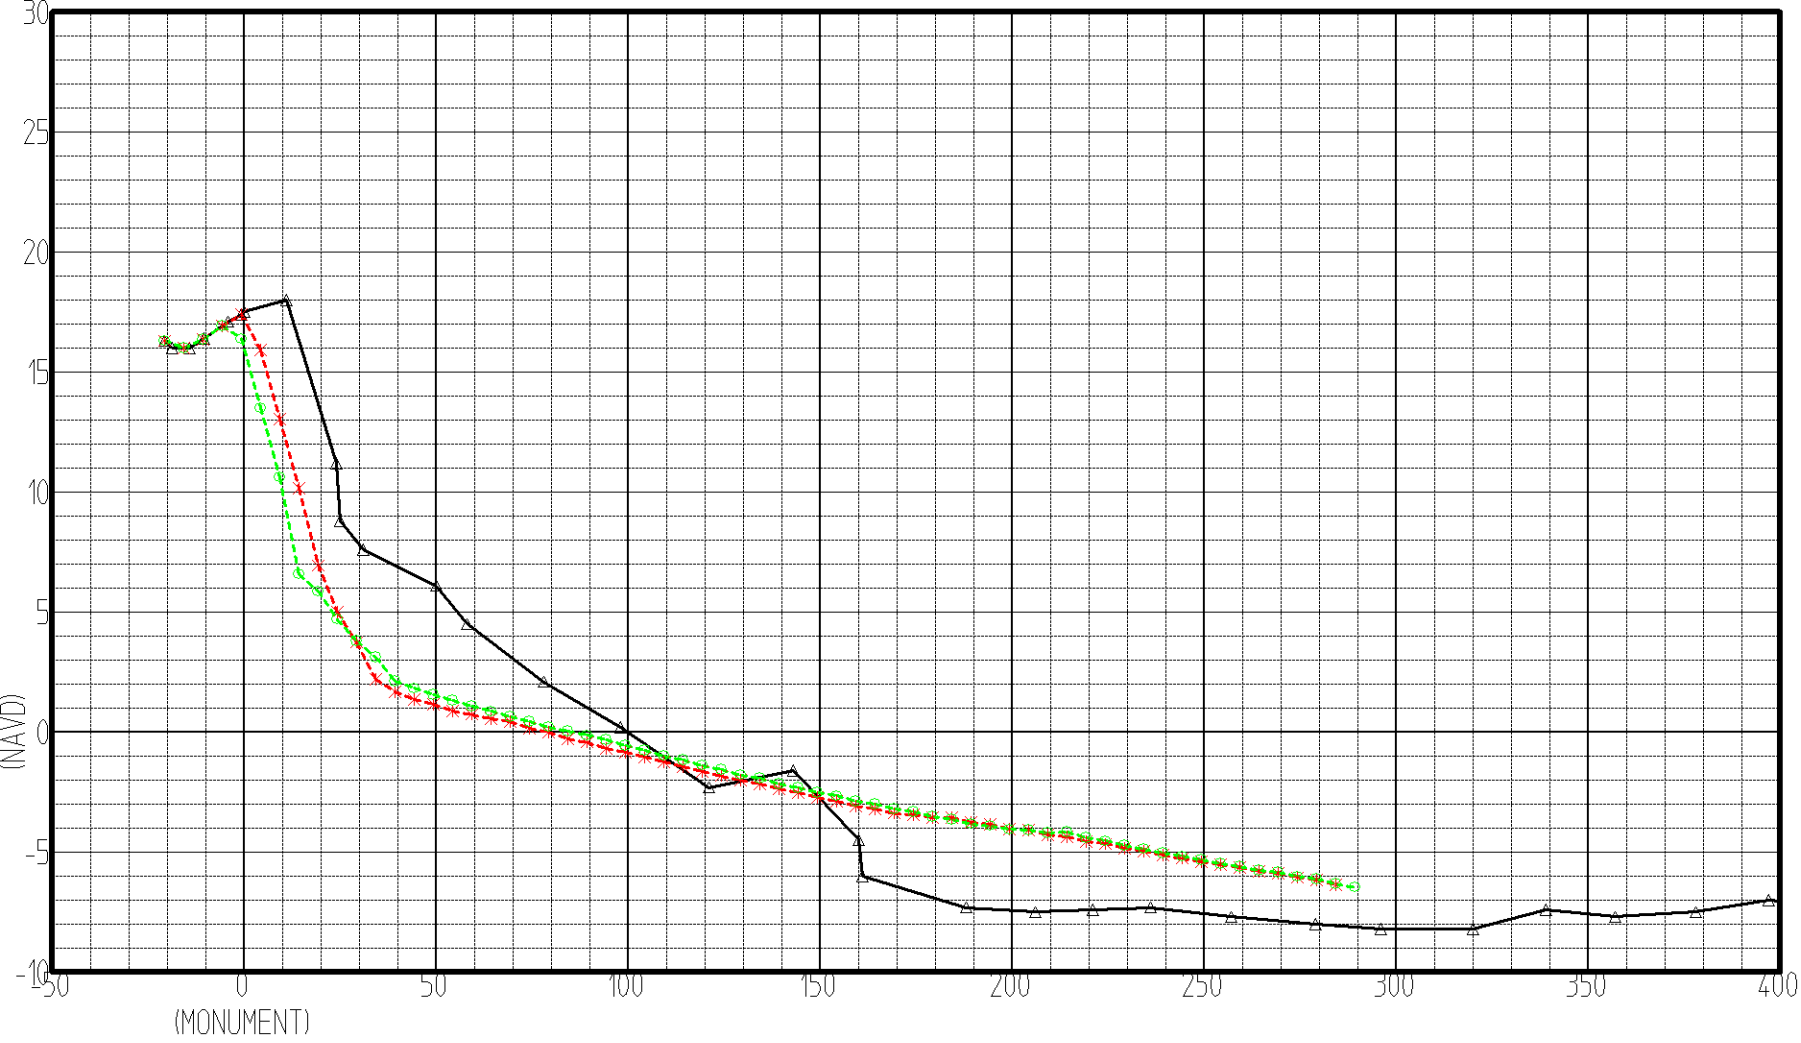
Range: R-149

BEACH PROFILE

—△—△— 2005-2008 INPUT PRF

- - - * - - - 15-YR SBEACH ERODED PRF

- - - o - - - 25-YR SBEACH ERODED PRF

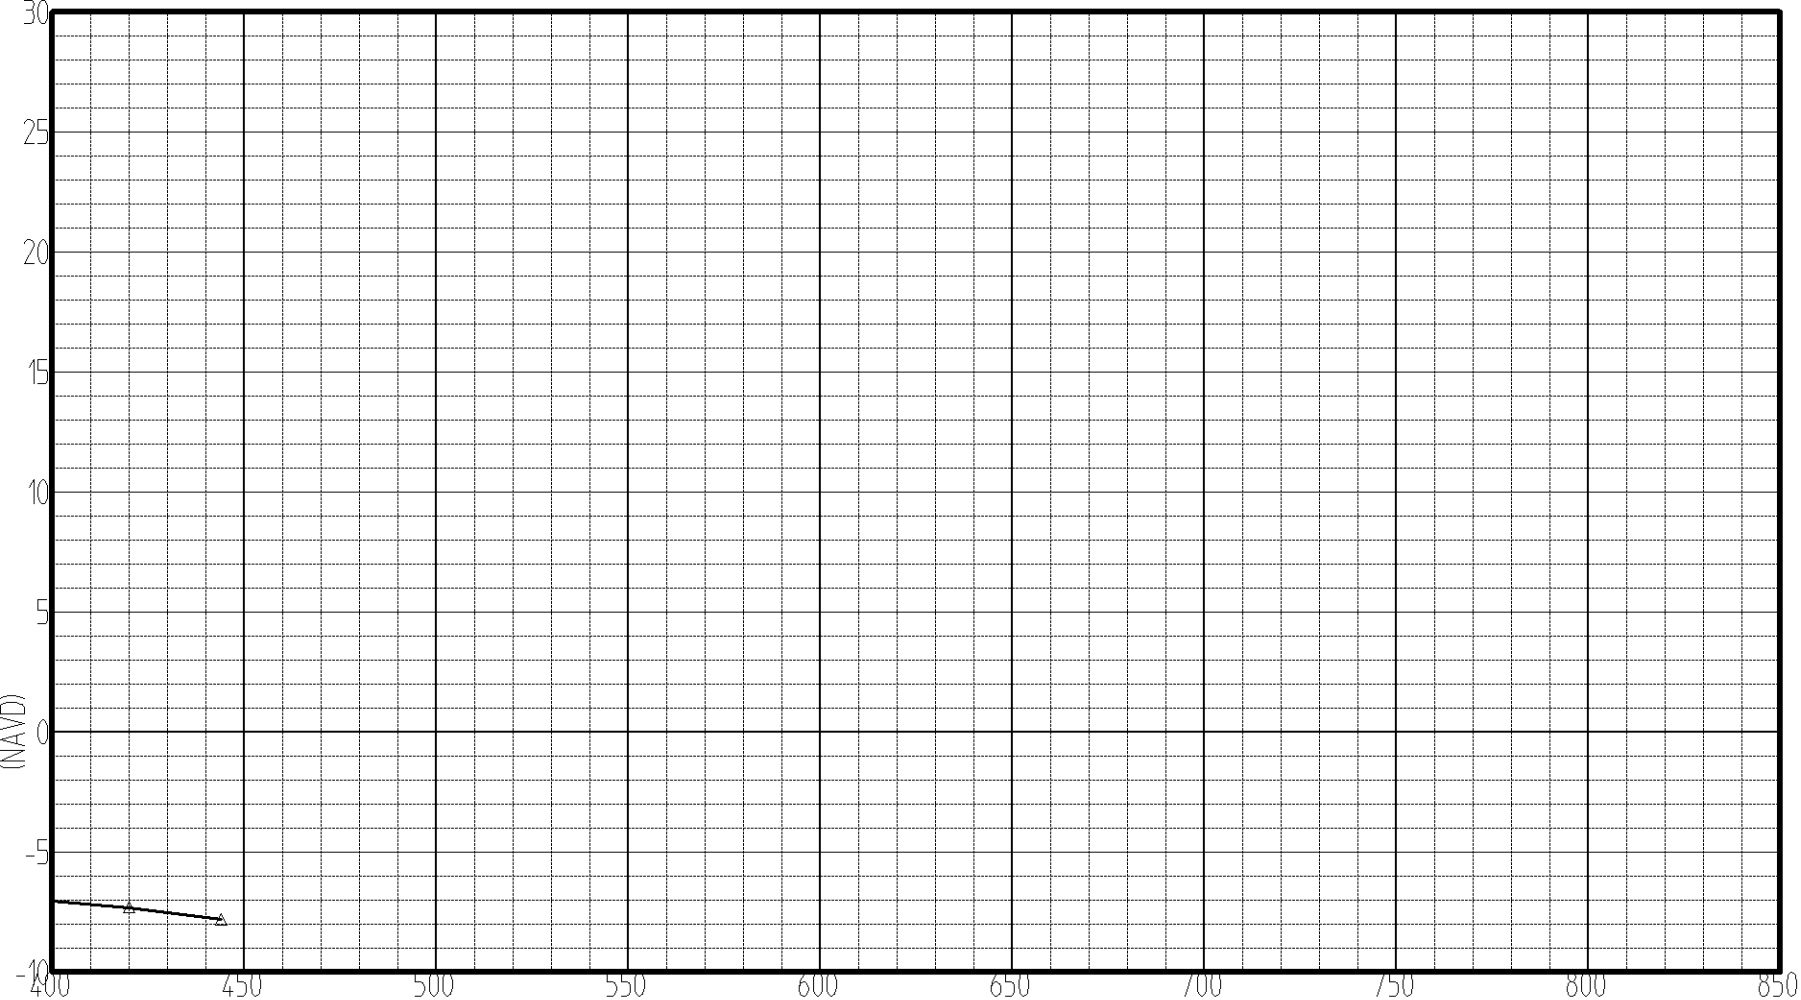
Range: R-149 2/2

BEACH PROFILE

- △—△— 2005-2008 INPUT PRF
- - - * - - - 15-YR SBEACH ERODED PRF
- - - ○ - - - 25-YR SBEACH ERODED PRF

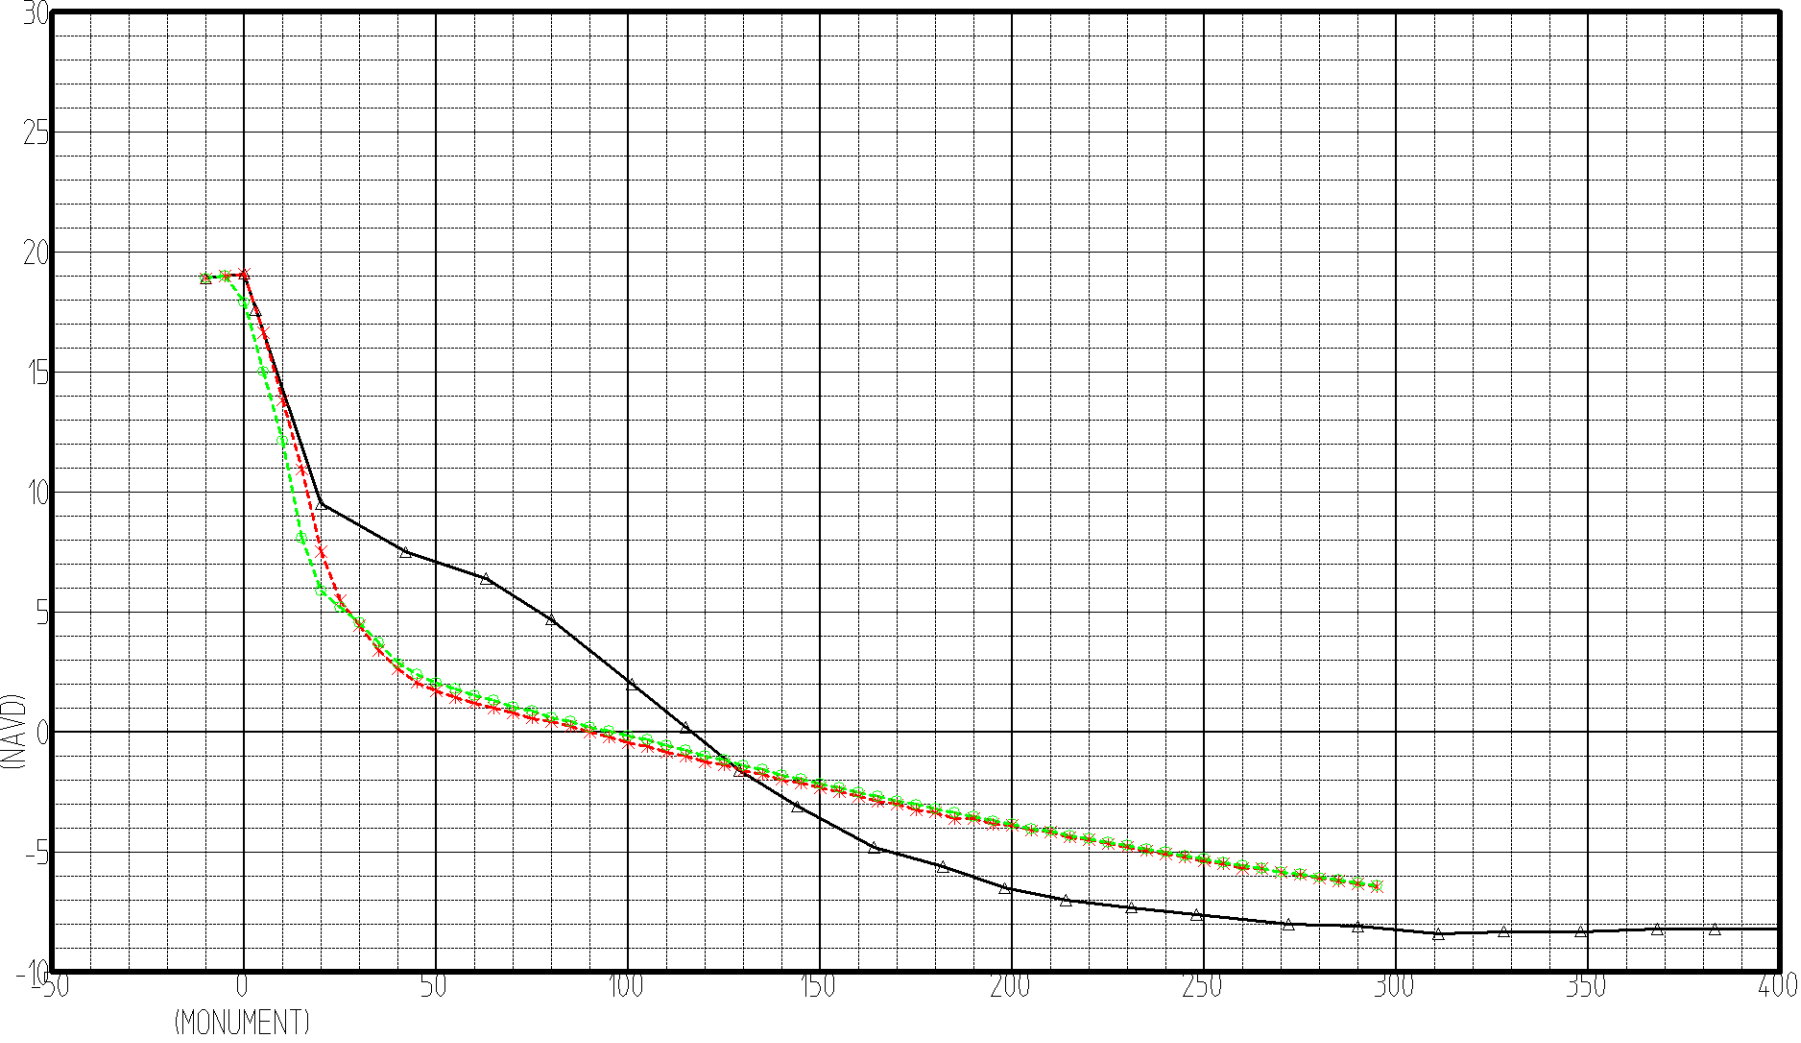
BEACH PROFILE

—△—△— 2005-2008 INPUT PRF

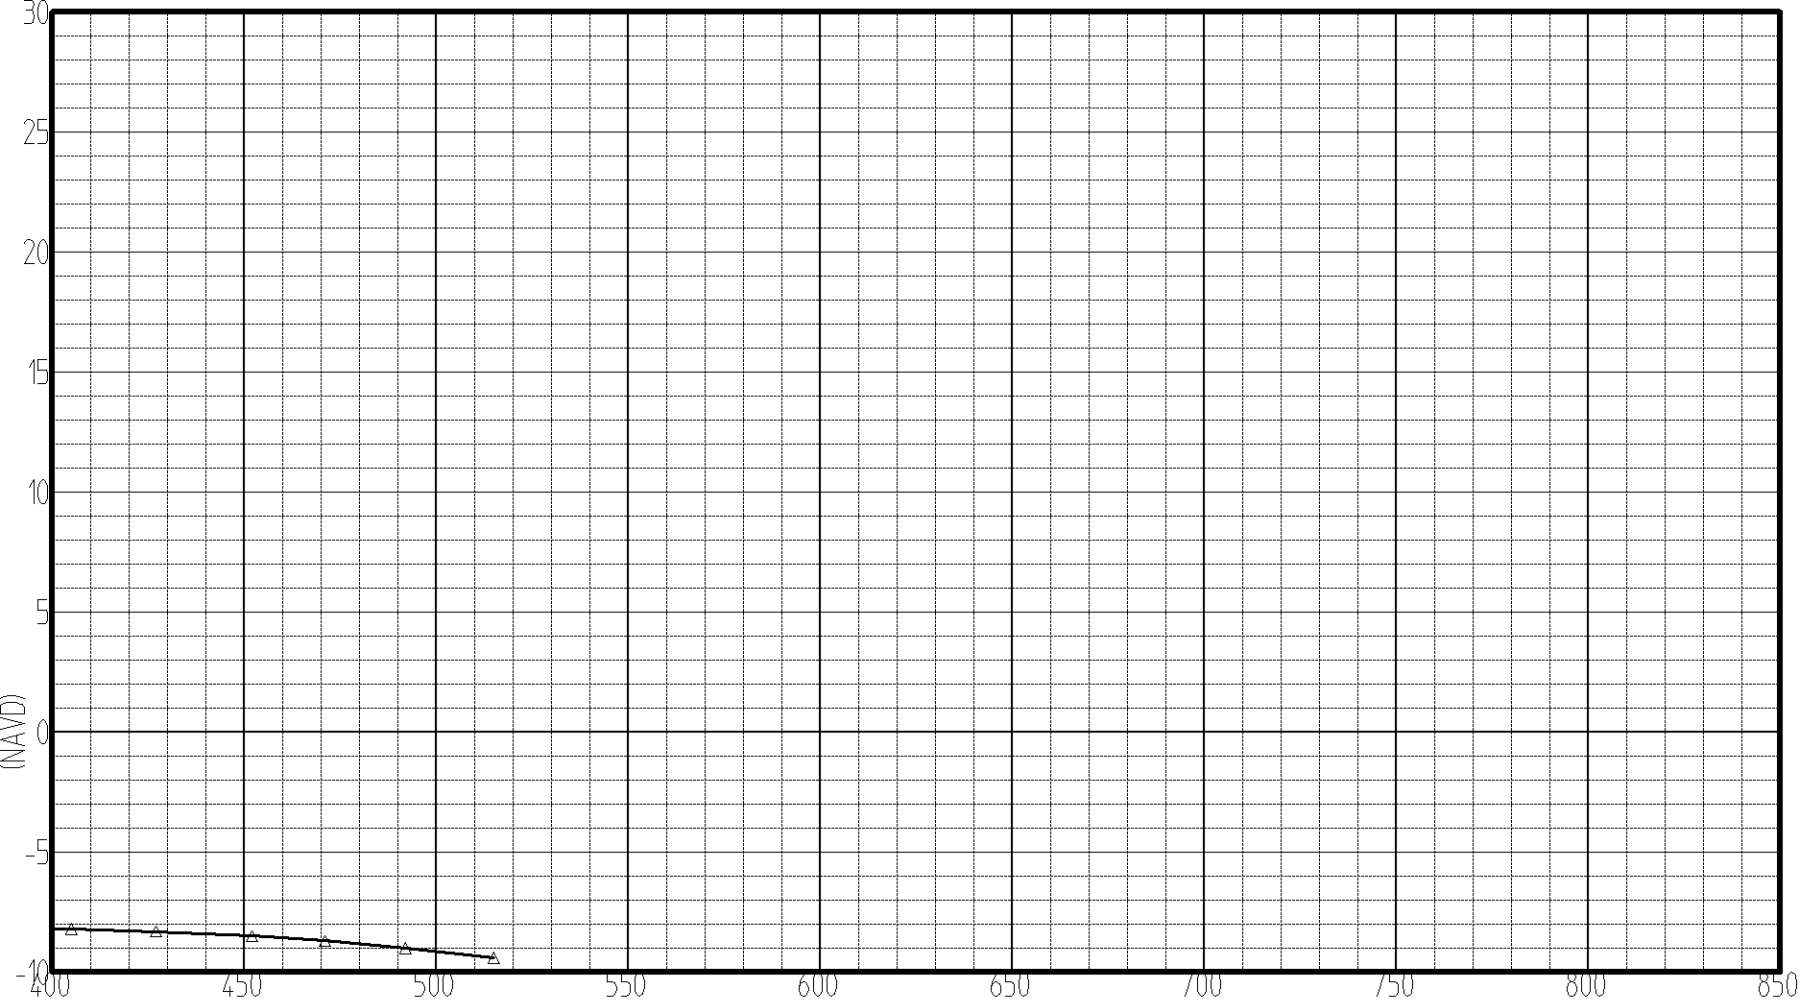
Range: R-150

- △—△— 2005-2008 INPUT PRF
- - - * - - - 15-YR SBEACH ERODED PRF
- - - o - - - 25-YR SBEACH ERODED PRF

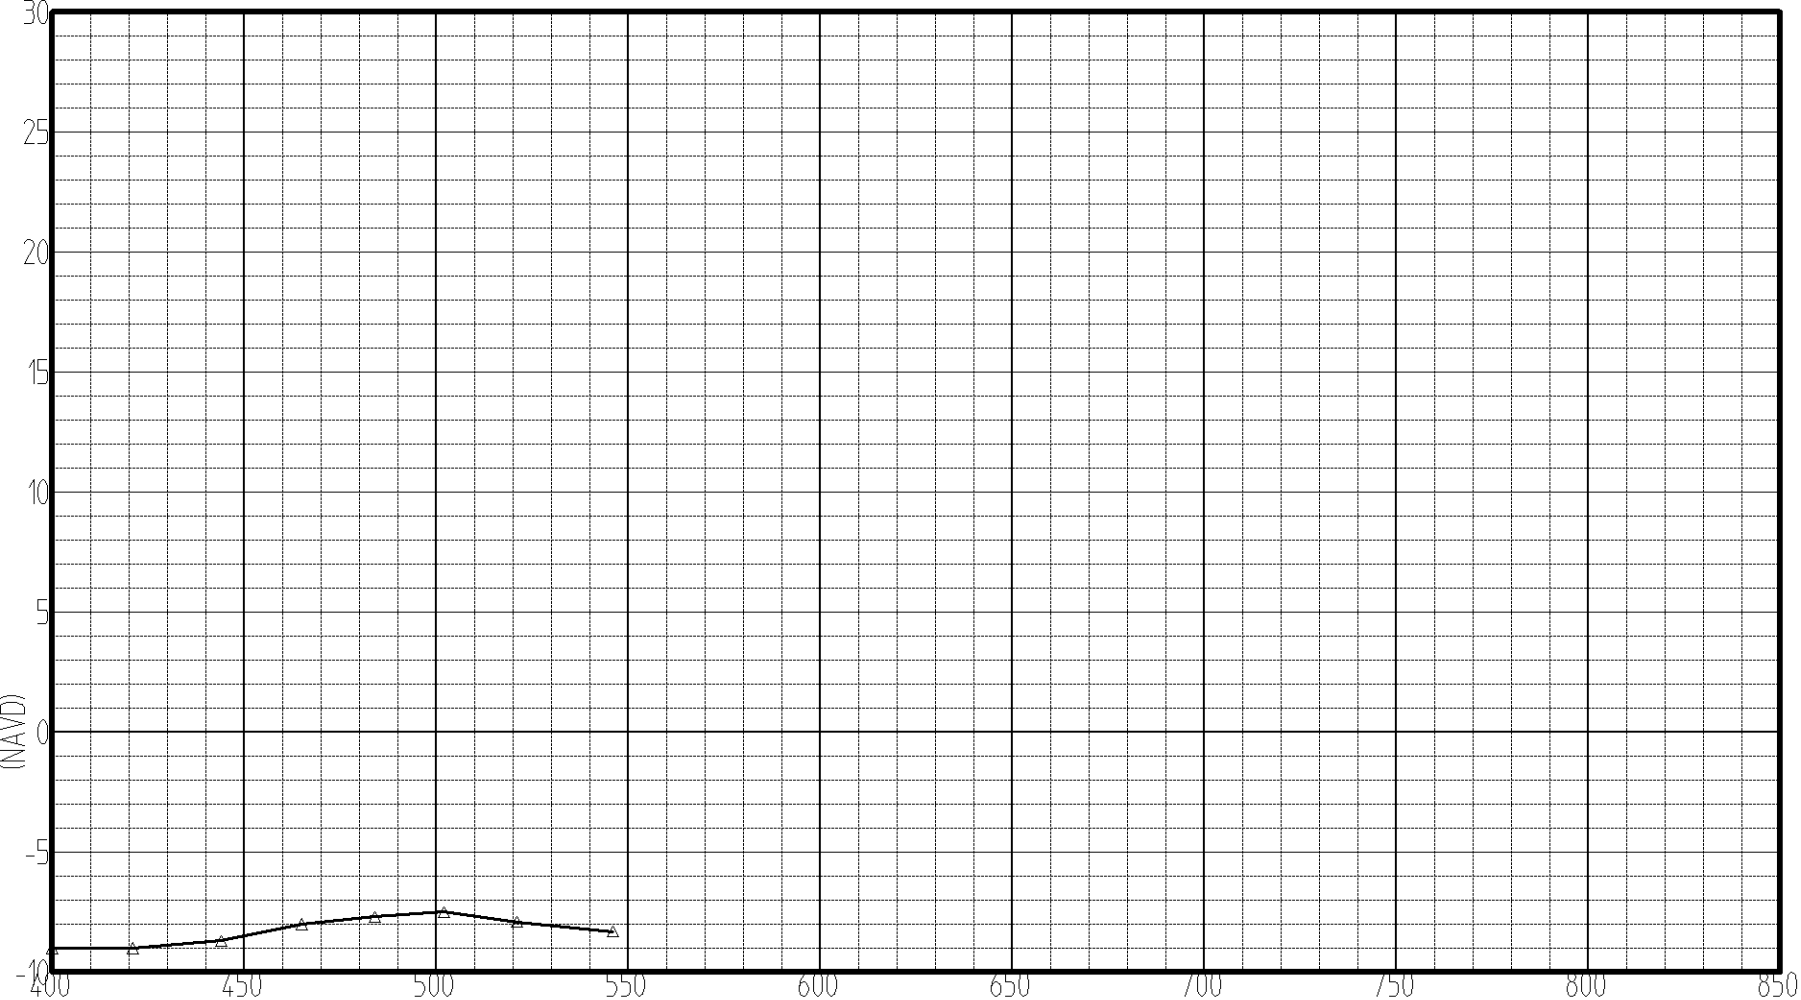
Range: R-151
 BEARING: 70.00
 2/2

BEACH PROFILE
 —△—△— 2005-2008 INPUT PRF
 - - * - - * - - 15-YR SBEACH ERODED PRF
 - - o - - o - - 25-YR SBEACH ERODED PRF
