Appendix XI

SBEACH 15 and 25 yr. Storm Erosion Profiles

Brevard County

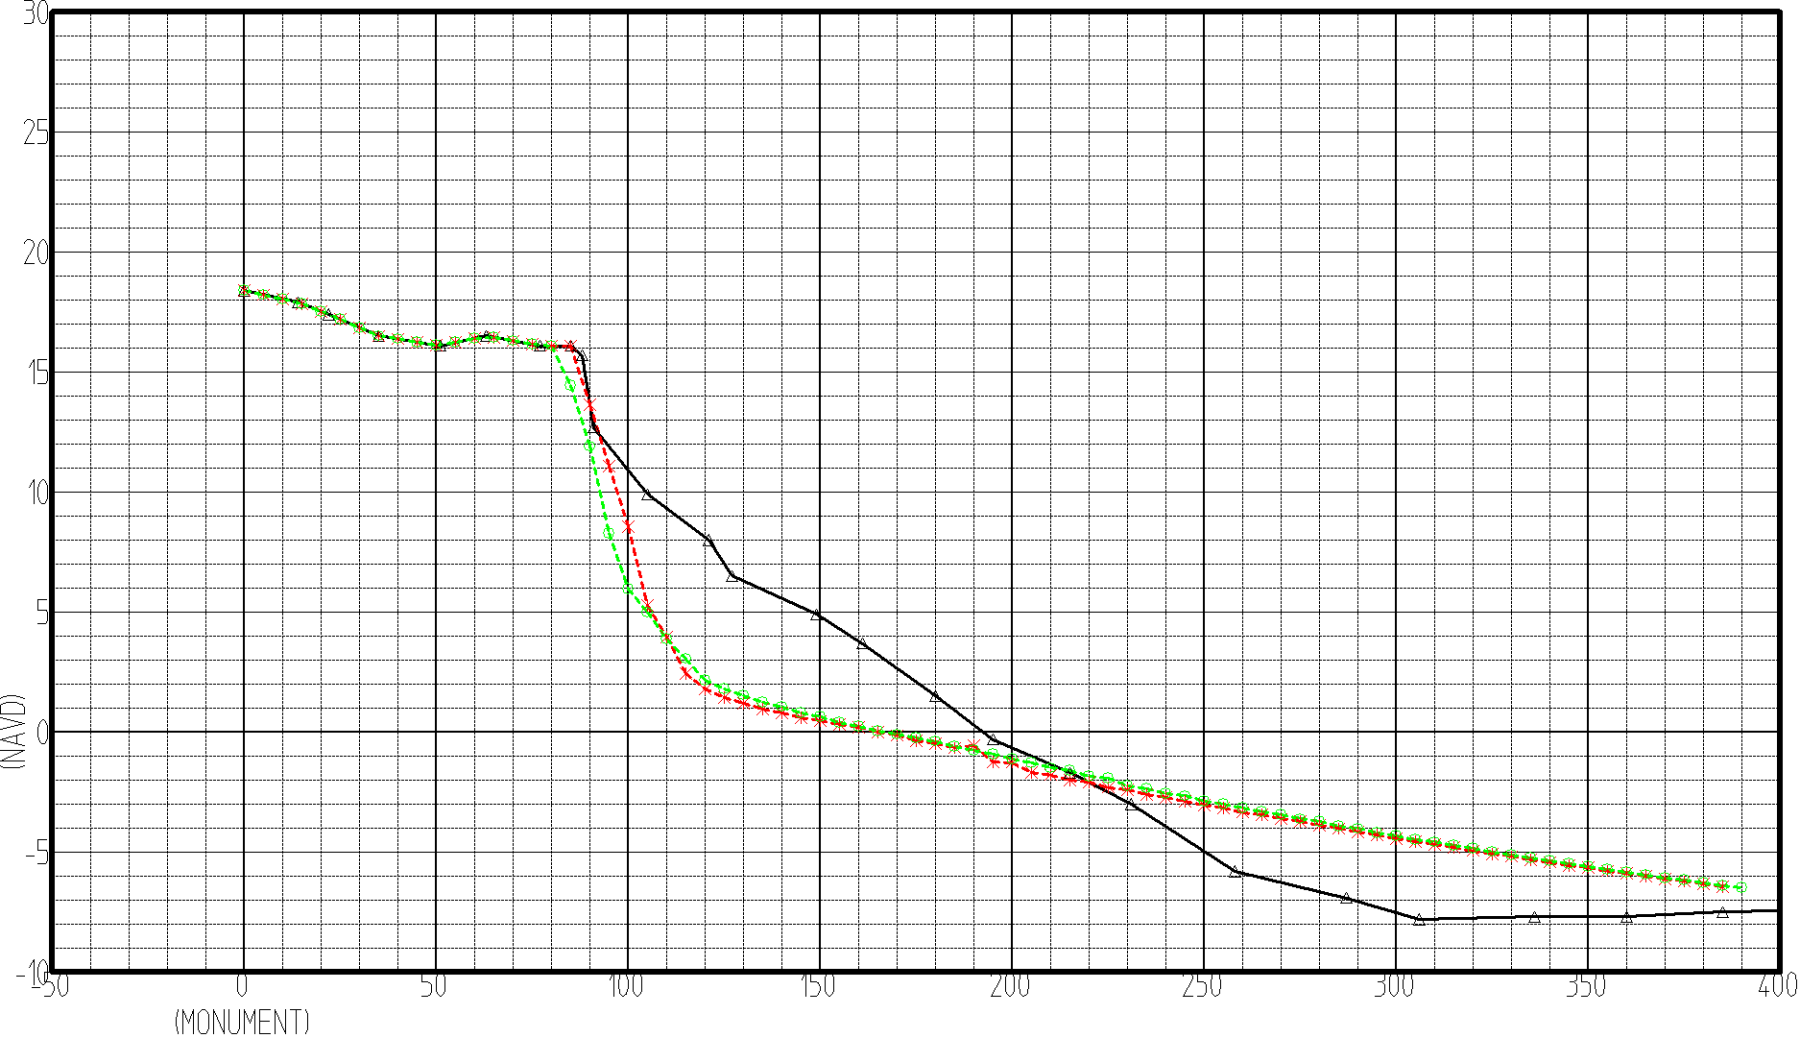
Range: R-152

—△—△— 2005-2008 INPUT PRF

- - - * - - - 15-YR SBEACH ERODED PRF

- - - o - - - 25-YR SBEACH ERODED PRF

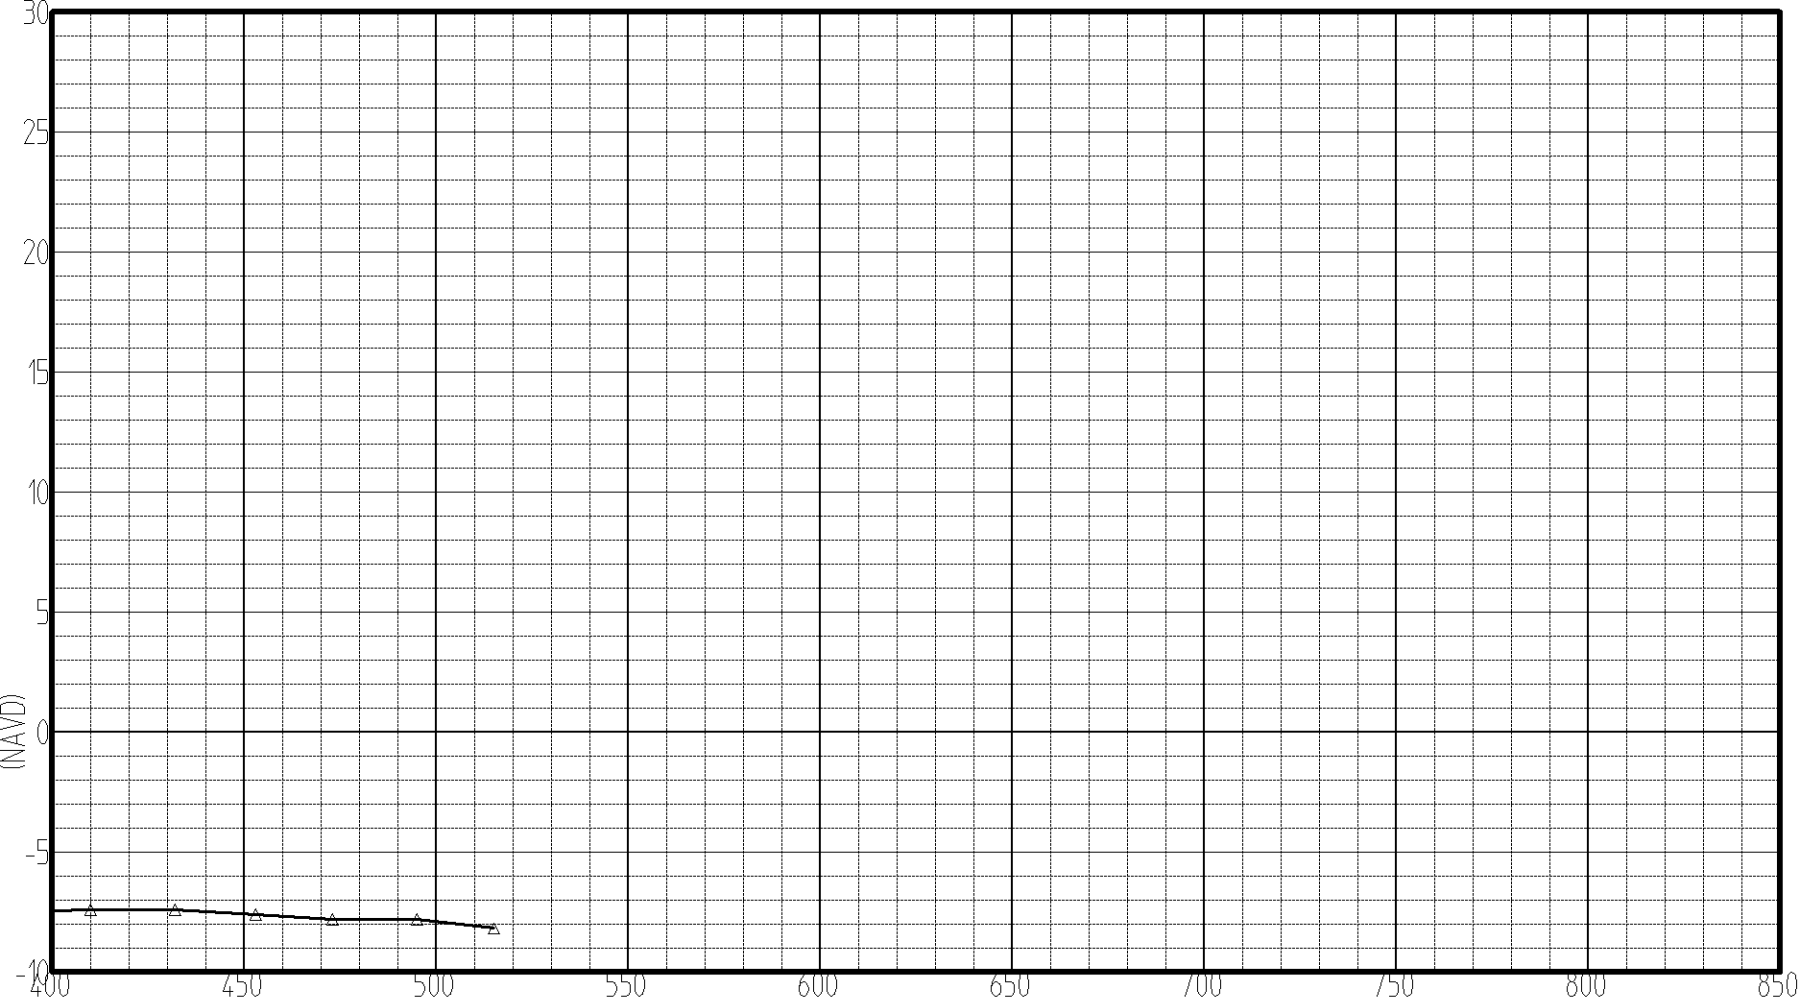
Range: R-152

—△—△— 2005-2008 INPUT PRF

- - - * - - - 15-YR SBEACH ERODED PRF

- - - o - - - 25-YR SBEACH ERODED PRF

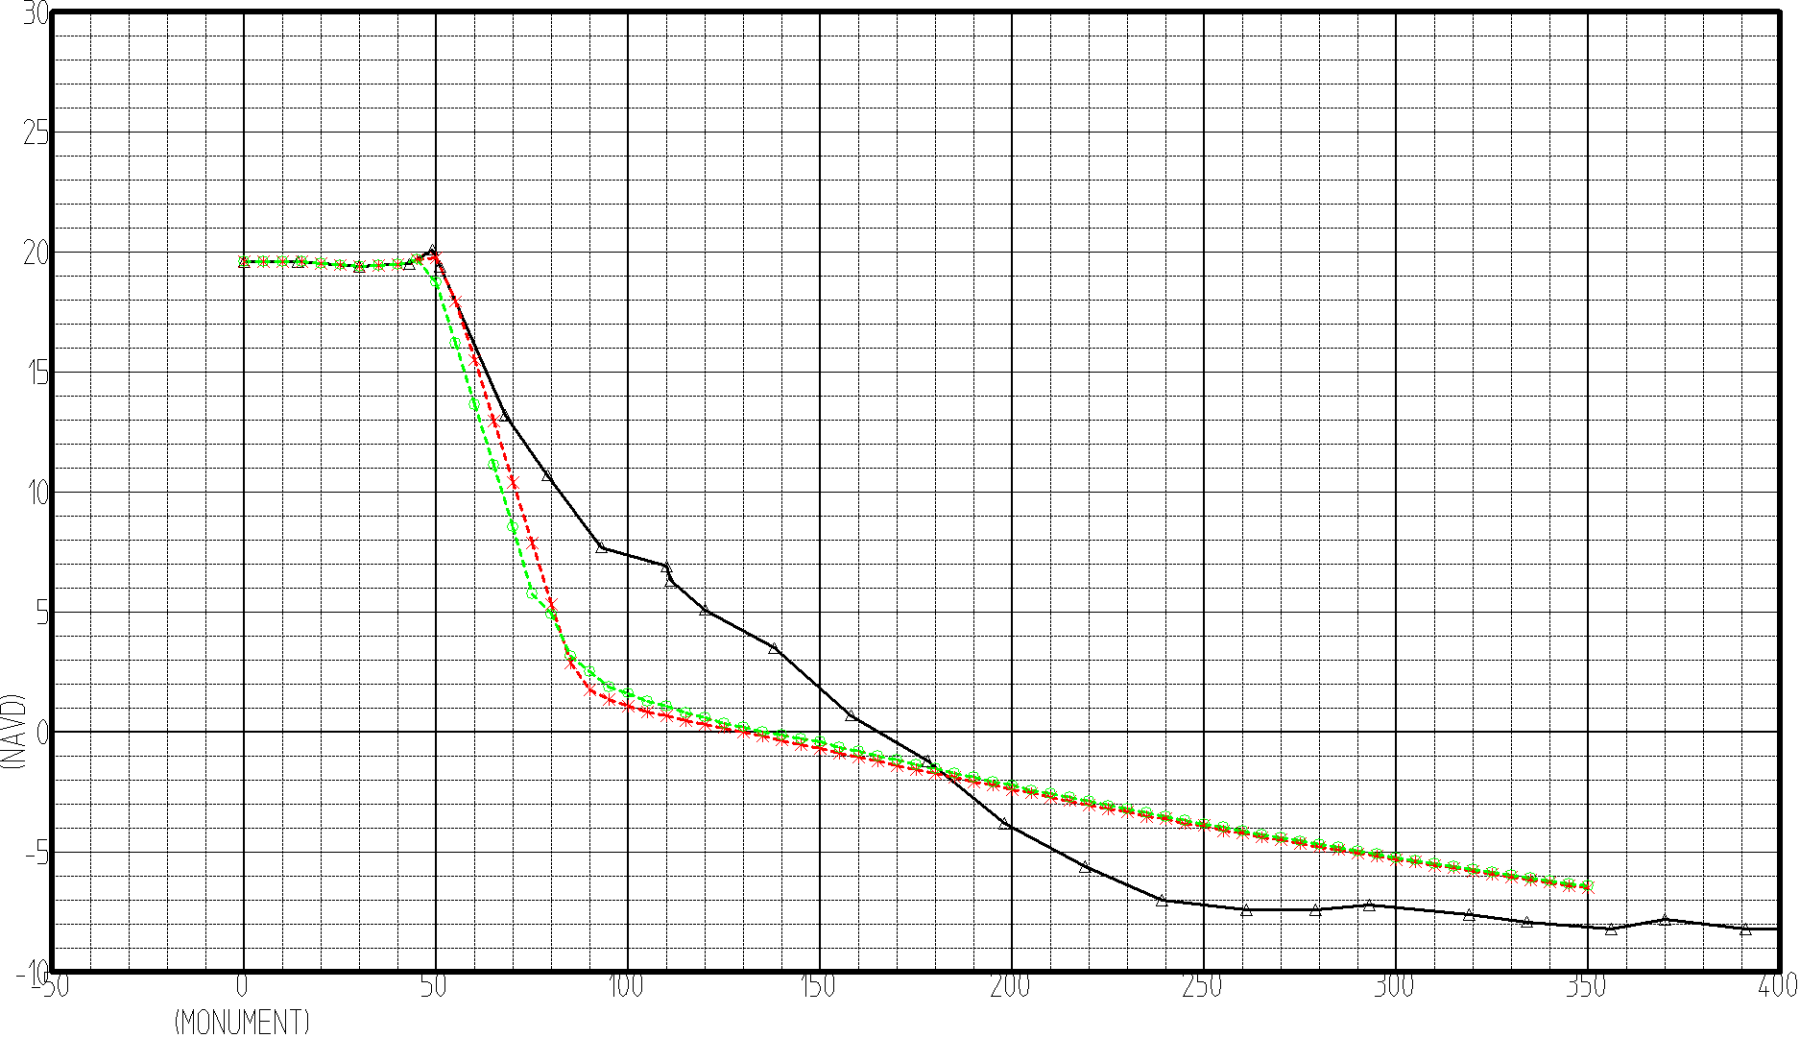
Range: R-153

—△—△— 2005-2008 INPUT PRF

- - - * - - - 15-YR SBEACH ERODED PRF

- - - o - - - 25-YR SBEACH ERODED PRF

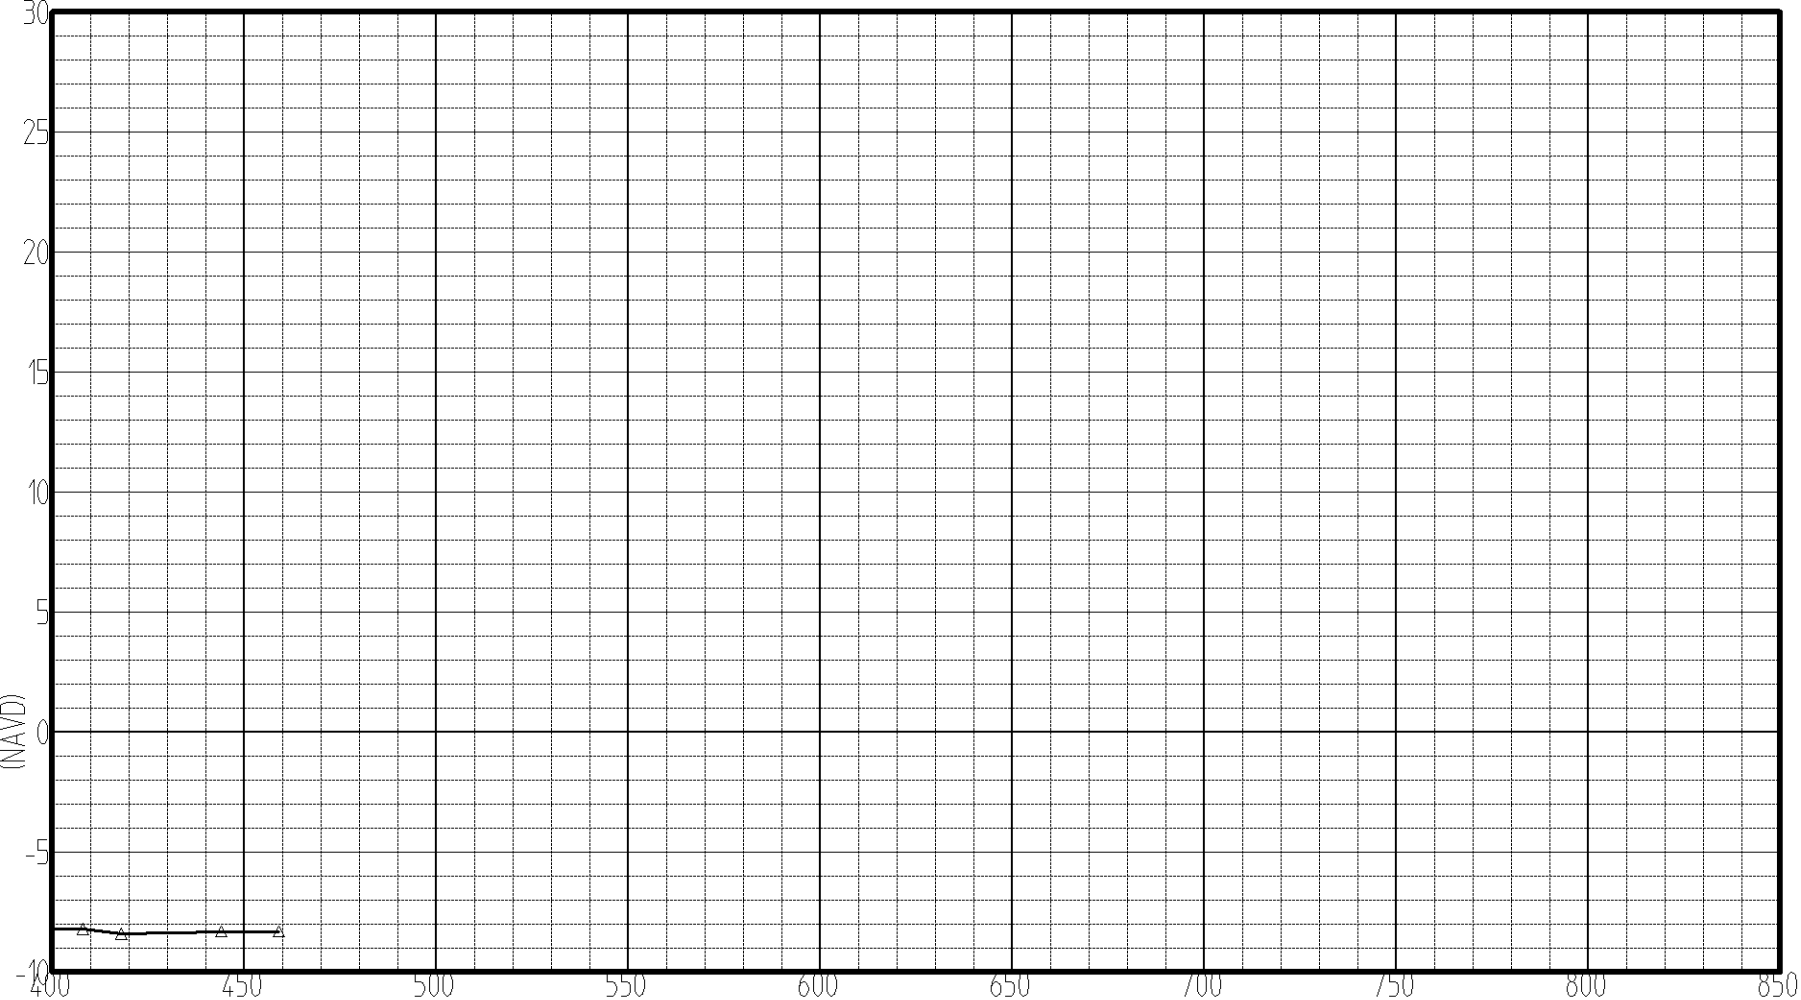
Range: R-153 2/2

- △—△— 2005-2008 INPUT PRF
- - - * - - - 15-YR SBEACH ERODED PRF
- - - o - - - 25-YR SBEACH ERODED PRF

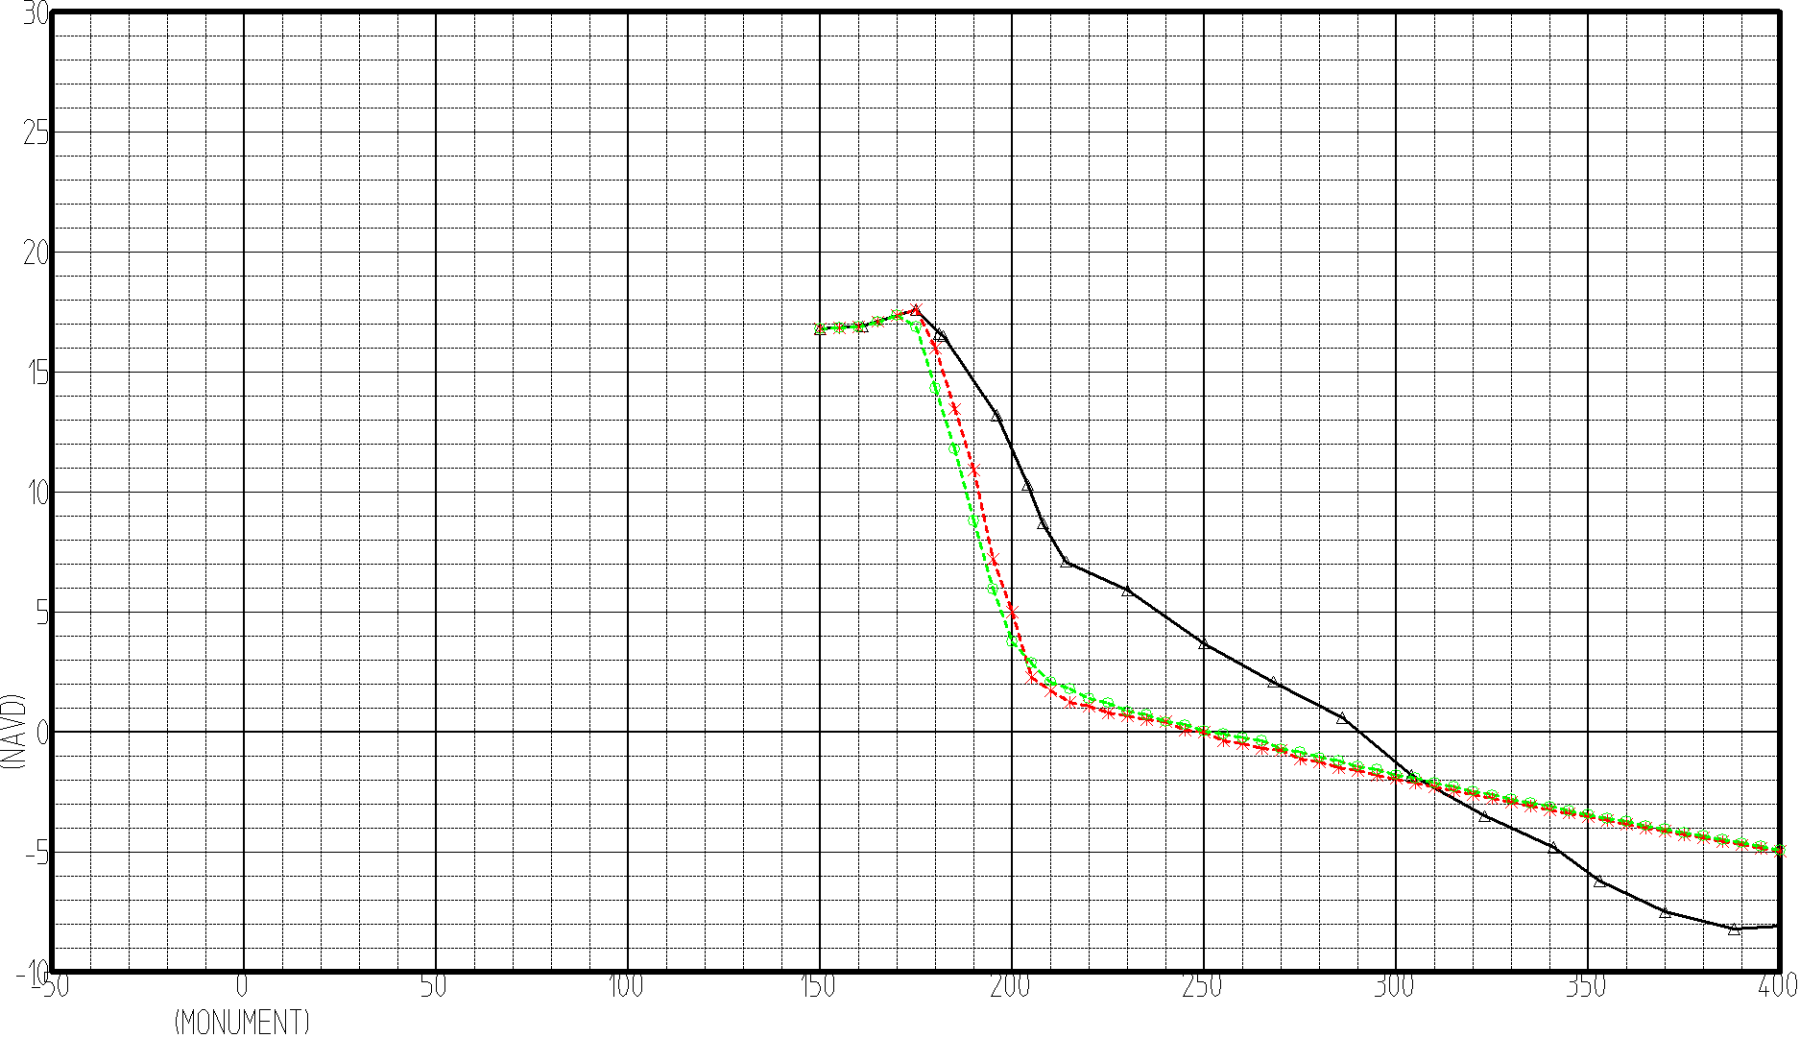
Range: R-154

—△—△— 2005-2008 INPUT PRF

- - - * - - - 15-YR SBEACH ERODED PRF

- - - o - - - 25-YR SBEACH ERODED PRF

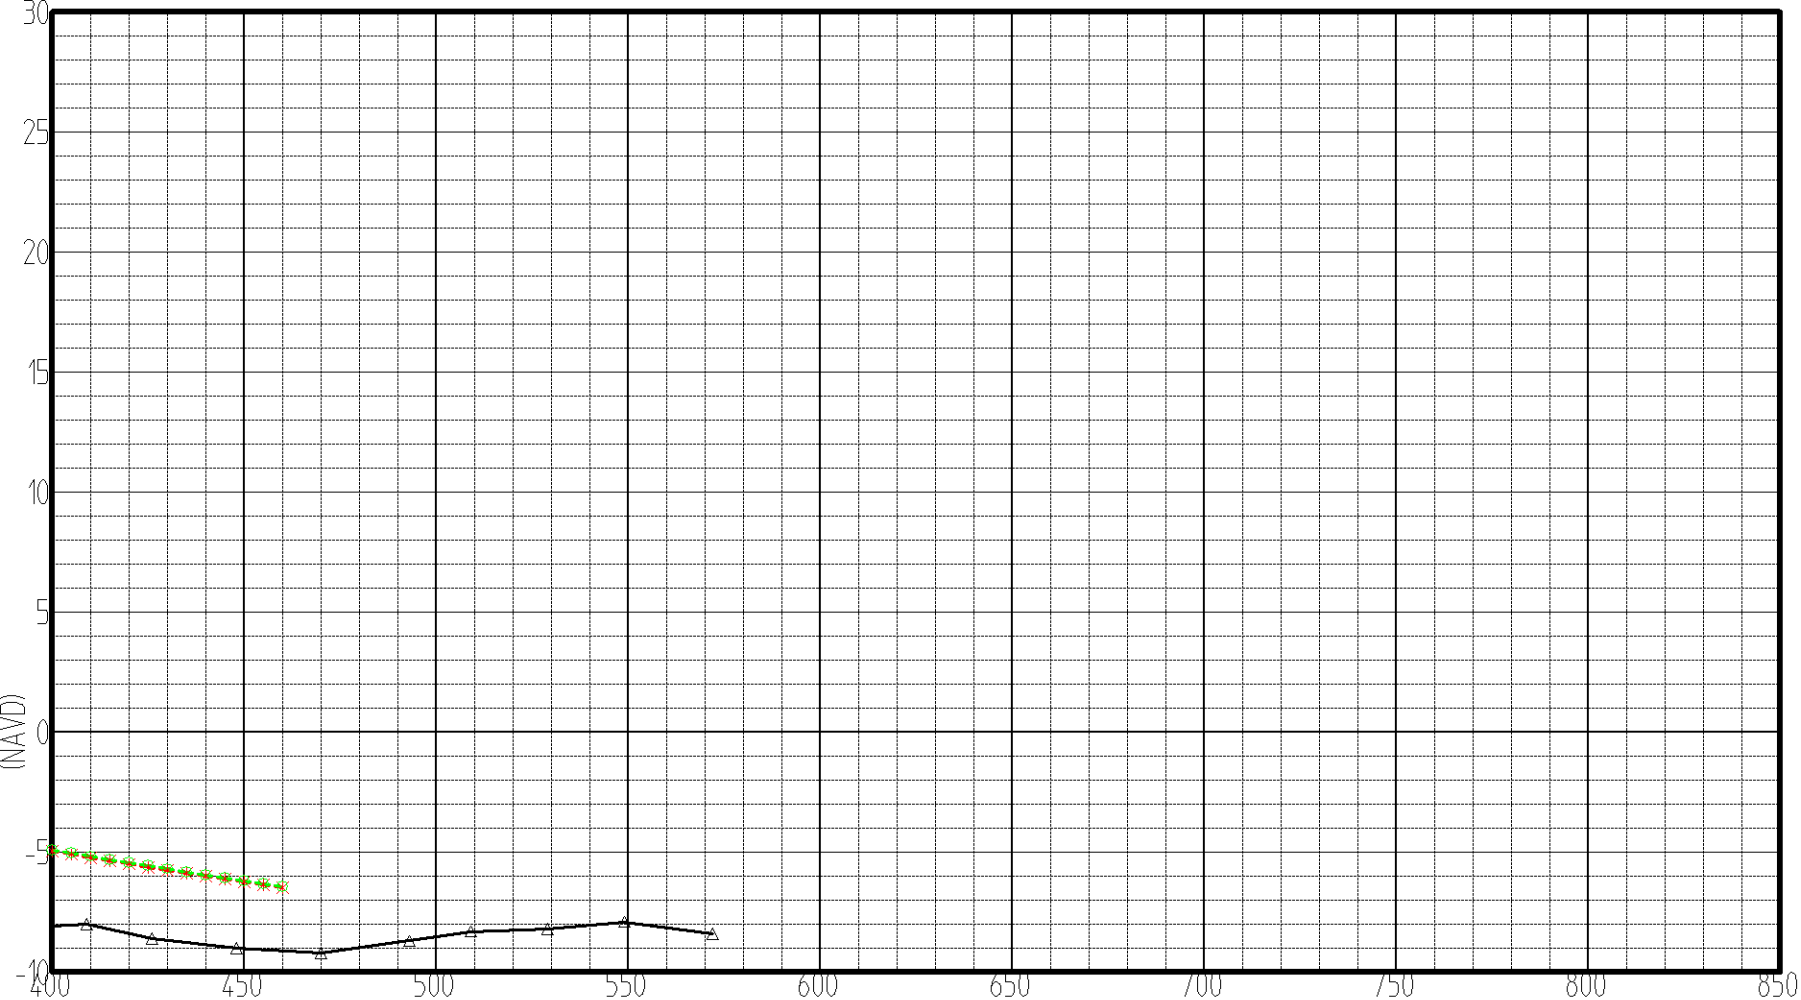
Range: R-154

—△—△— 2005-2008 INPUT PRF

- - - * - - - 15-YR SBEACH ERODED PRF

- - - o - - - 25-YR SBEACH ERODED PRF

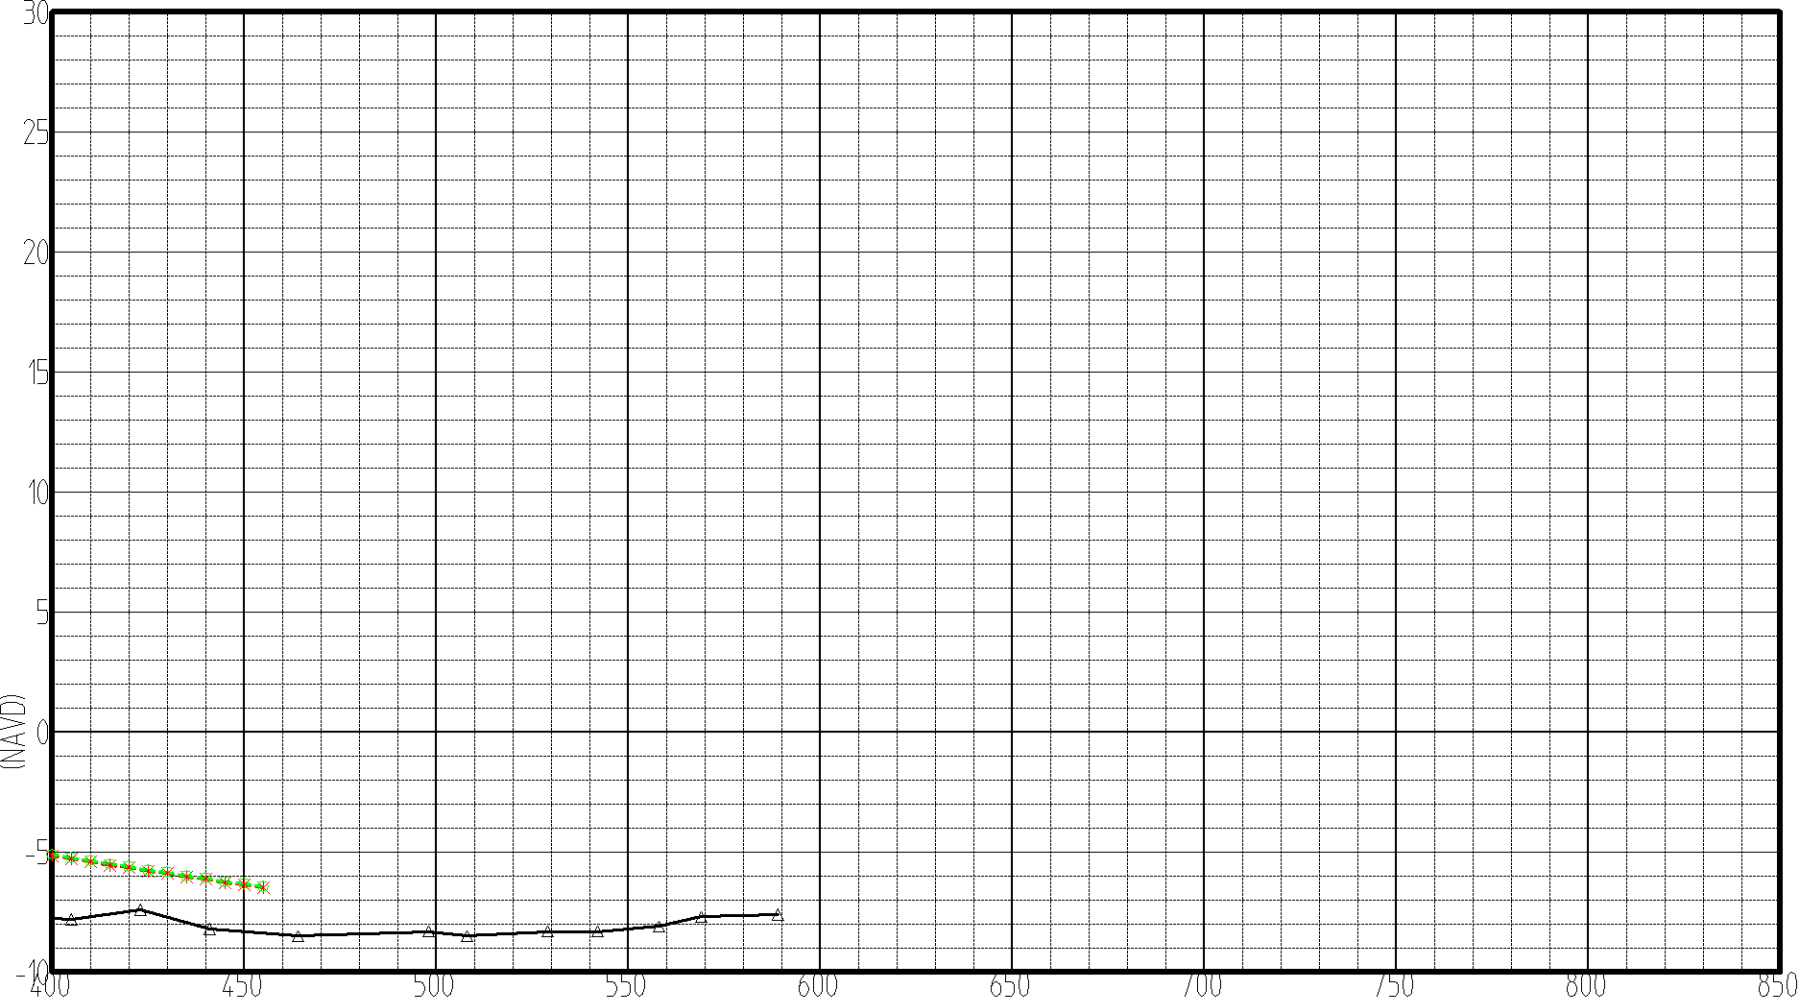
Range: R-155
 BEARING: 70.00
 2/2

BEACH PROFILE
 —△—△— 2005-2008 INPUT PRF
 - - * - - * - - 15-YR SBEACH ERODED PRF
 - - o - - o - - 25-YR SBEACH ERODED PRF

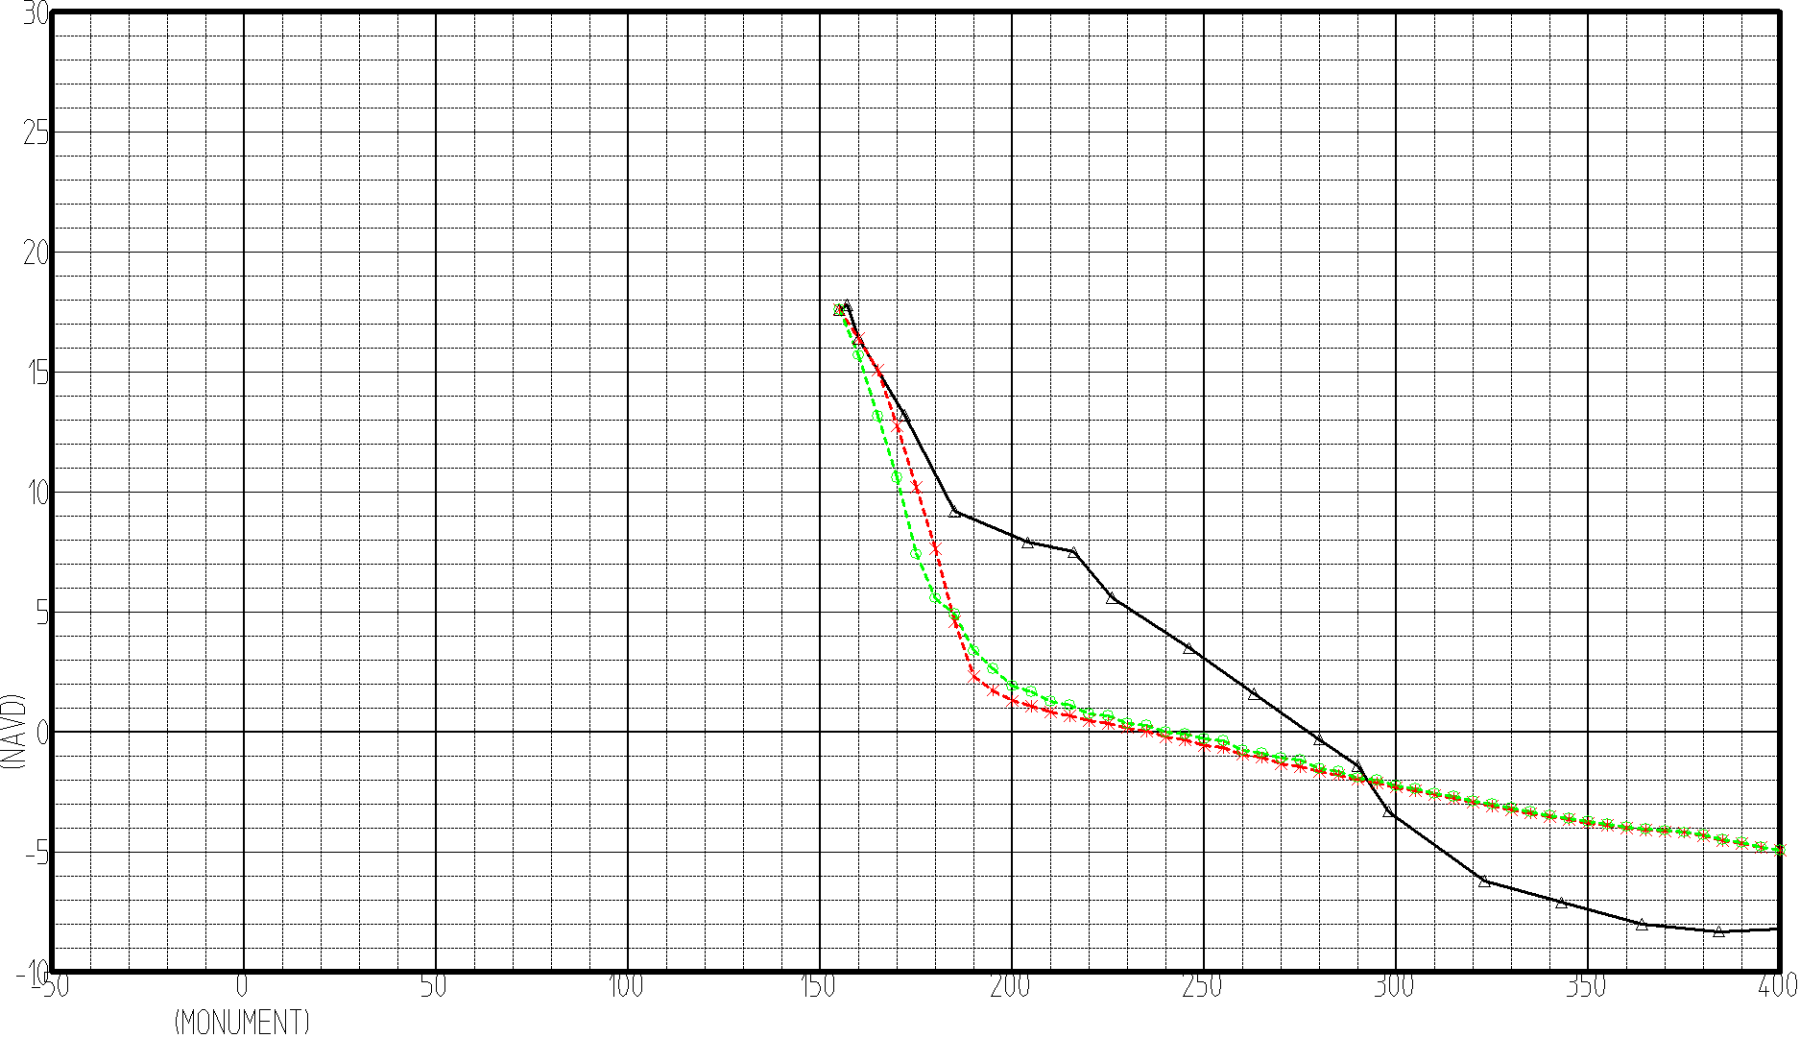
Range: R-156

—△—△— 2005-2008 INPUT PRF

- - - * - - - 15-YR SBEACH ERODED PRF

- - - o - - - 25-YR SBEACH ERODED PRF

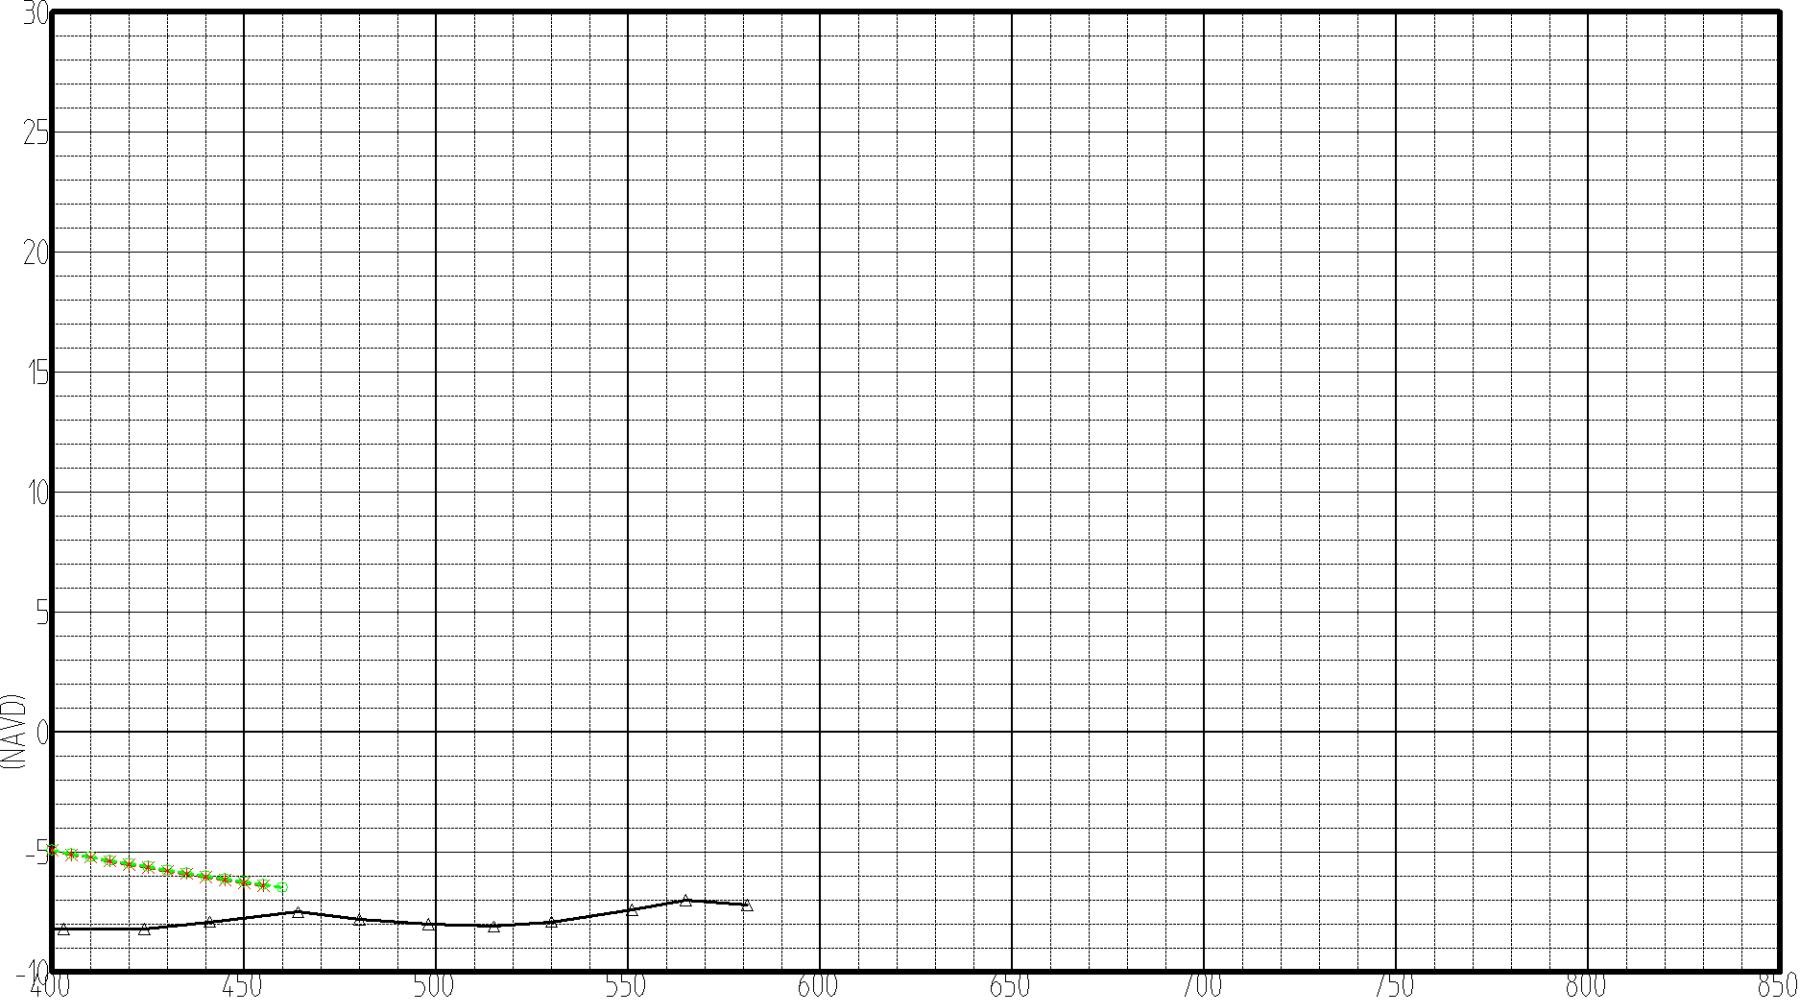
Range: R-156

—△—△— 2005-2008 INPUT PRF

- - - * - - - 15-YR SBEACH ERODED PRF

- - - o - - - 25-YR SBEACH ERODED PRF

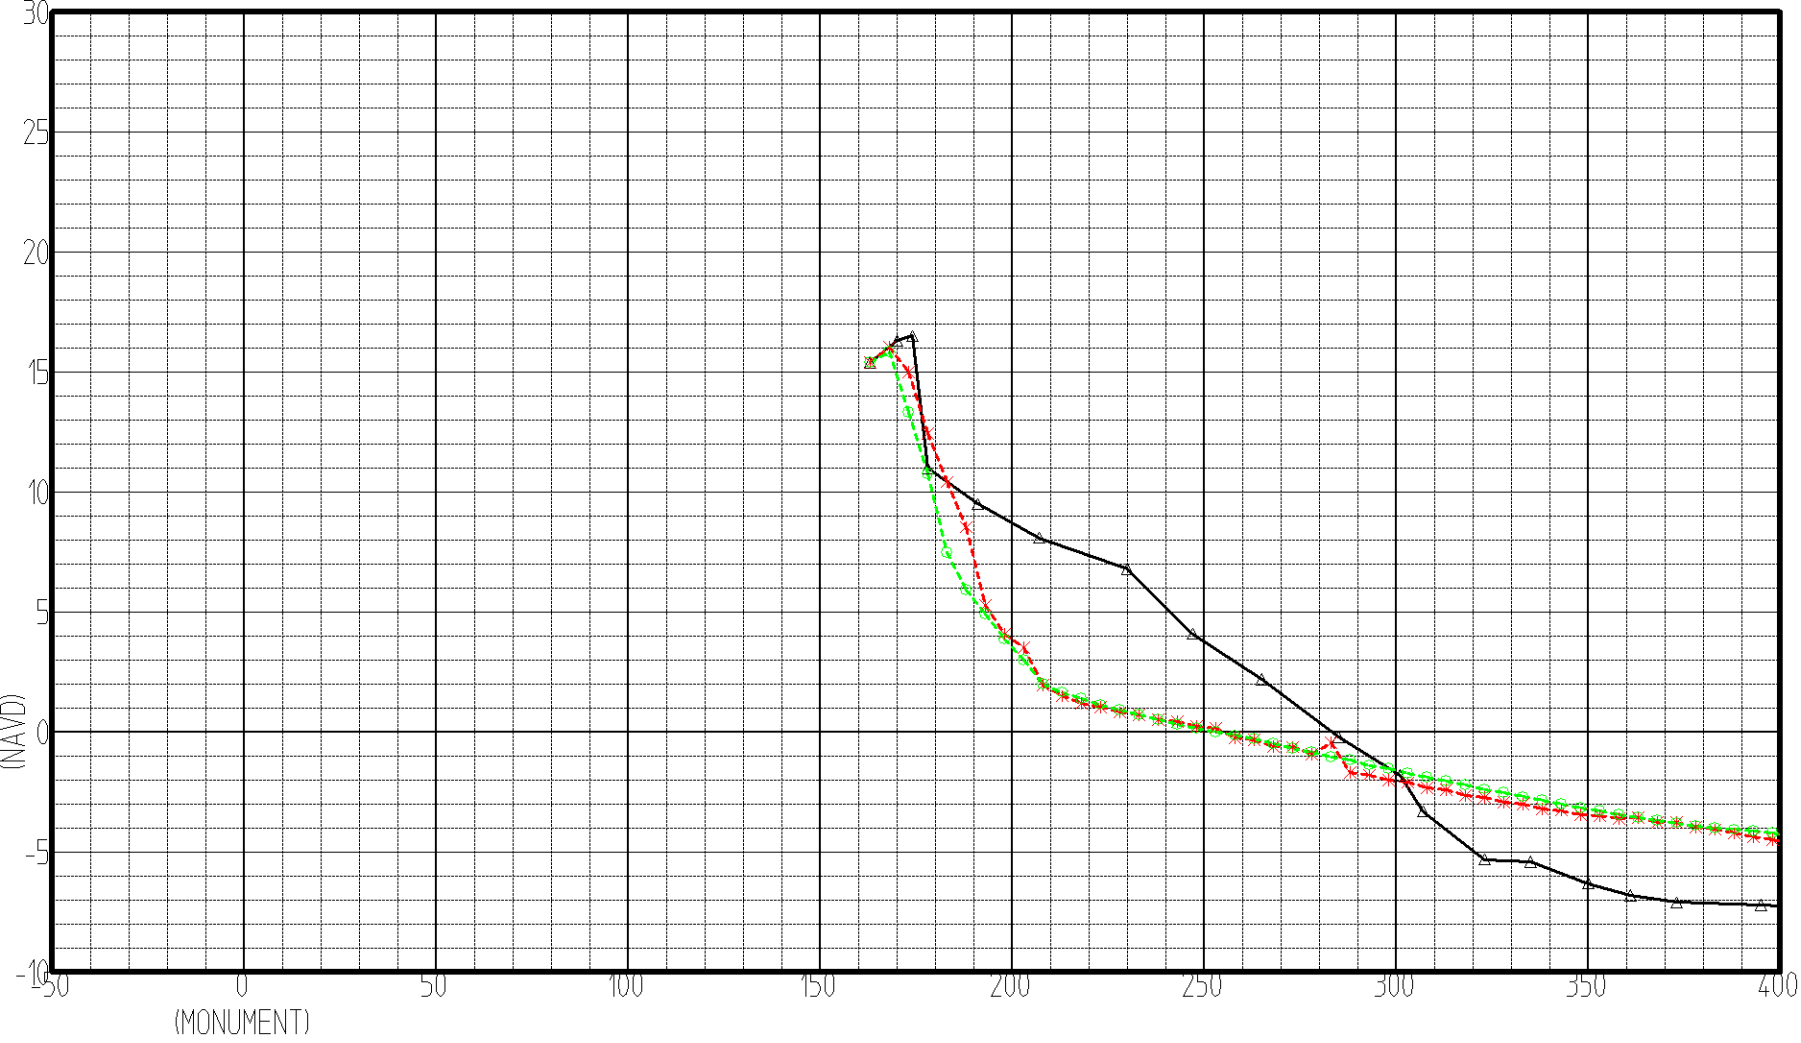
Range: R-157-T

—△—△— 2005-2008 INPUT PRF

- - - * - - - 15-YR SBEACH ERODED PRF

- - - o - - - 25-YR SBEACH ERODED PRF

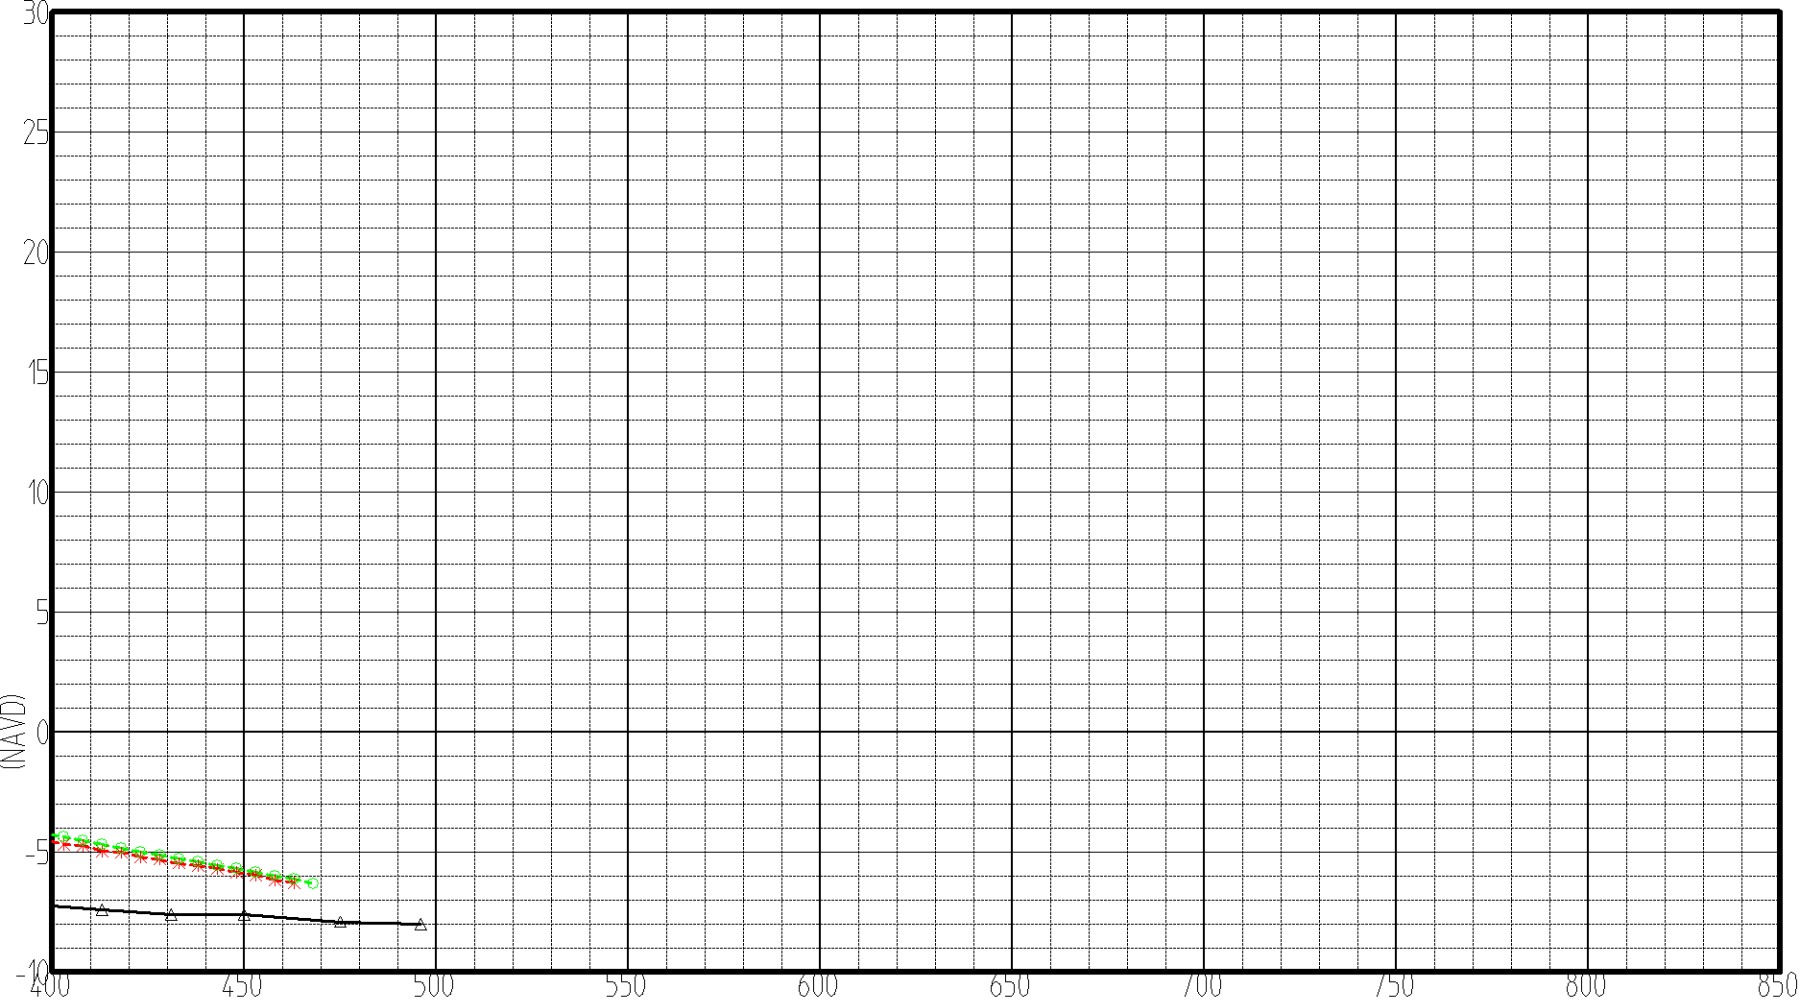
Range: R-157-T 2/2
 BEARING: 70.00

BEACH PROFILE
 —△—△— 2005-2008 INPUT PRF
 - - * - - * - - 15-YR SBEACH ERODED PRF
 - - o - - o - - 25-YR SBEACH ERODED PRF

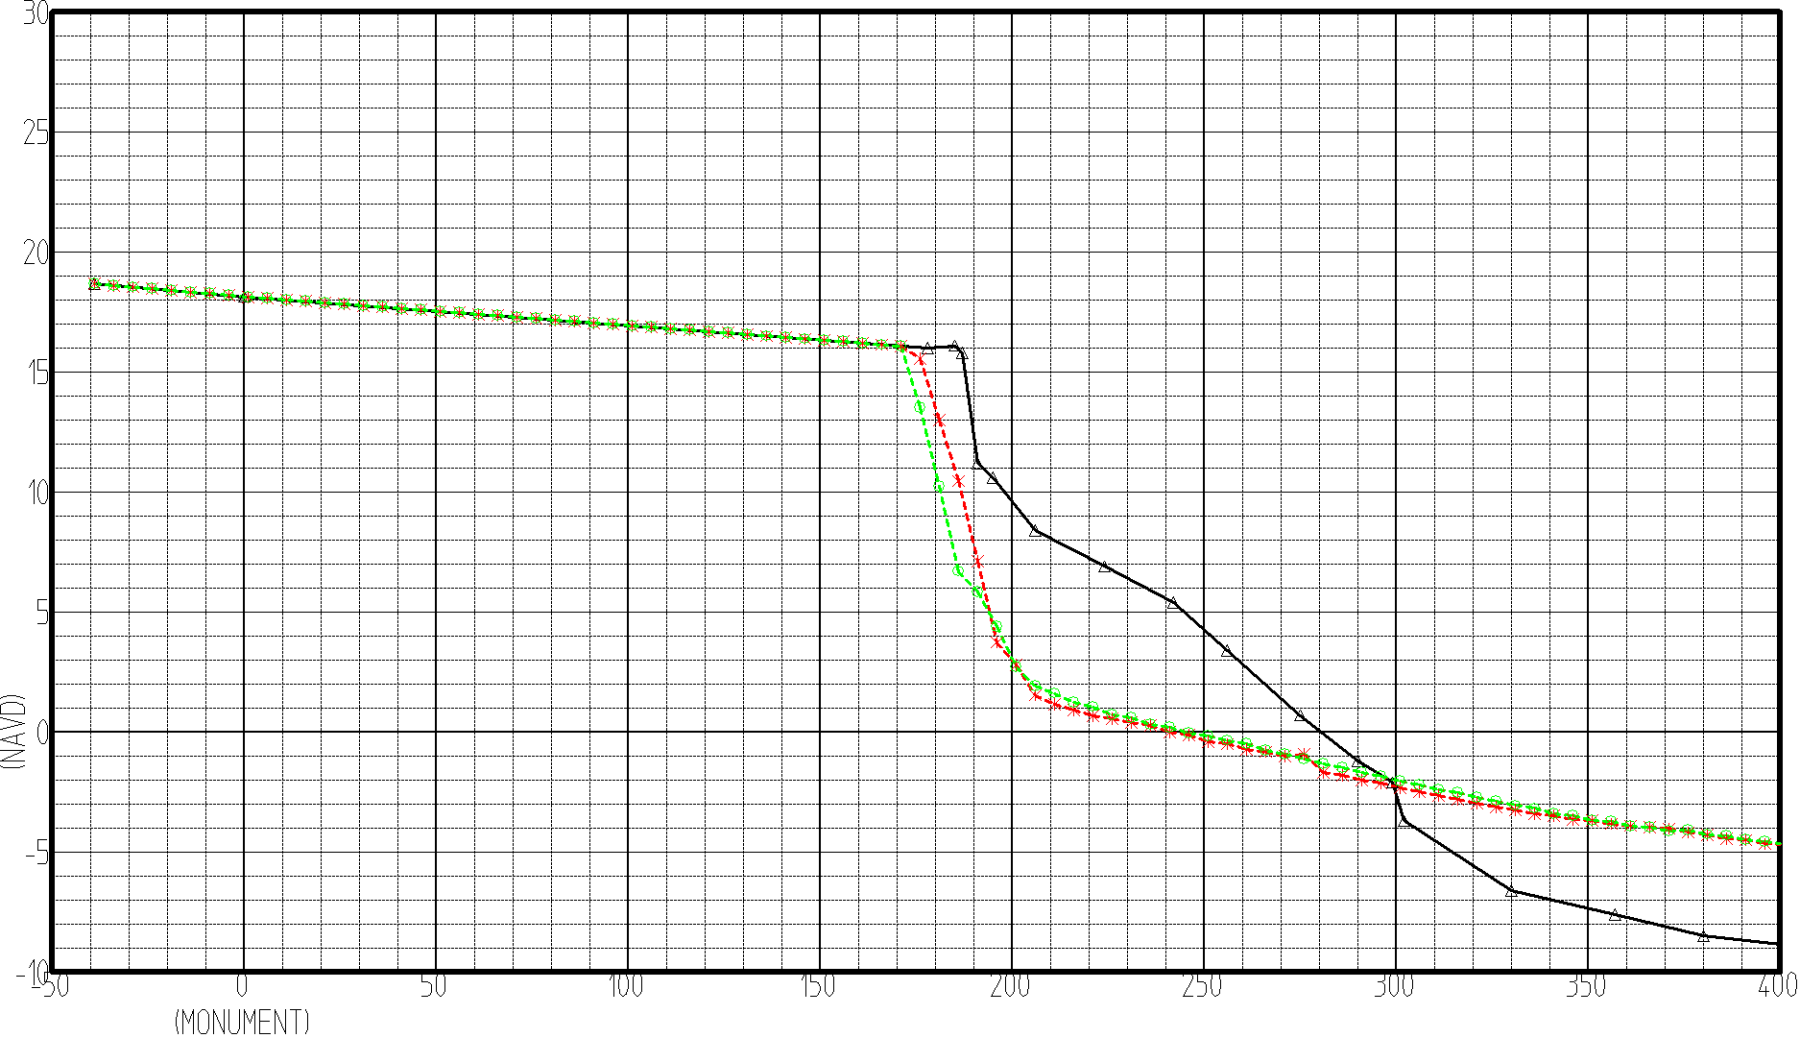
Range: R-158

—△—△— 2005-2008 INPUT PRF

- - * - - * - - 15-YR SBEACH ERODED PRF

- - o - - o - - 25-YR SBEACH ERODED PRF
