Appendix XI

SBEACH 15 and 25 yr. Storm Erosion Profiles

Brevard County

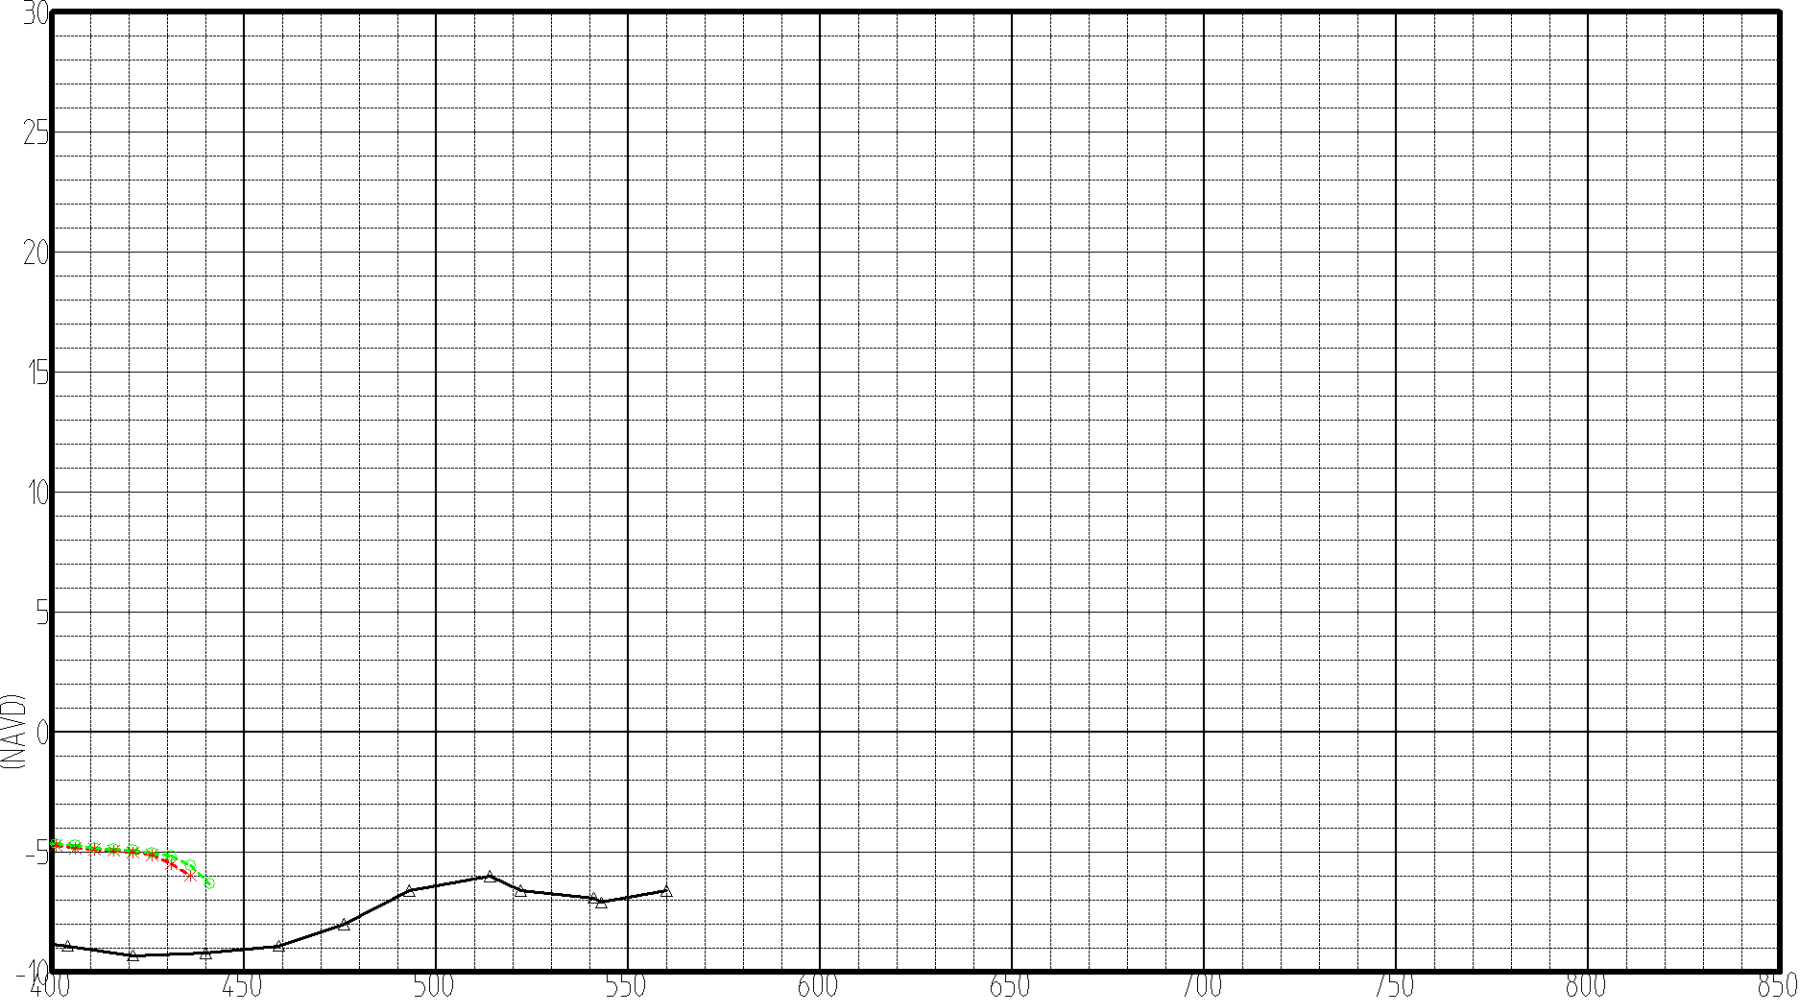
Range: R-158

—△—△— 2005-2008 INPUT PRF

- - - * - - - 15-YR SBEACH ERODED PRF

- - - o - - - 25-YR SBEACH ERODED PRF

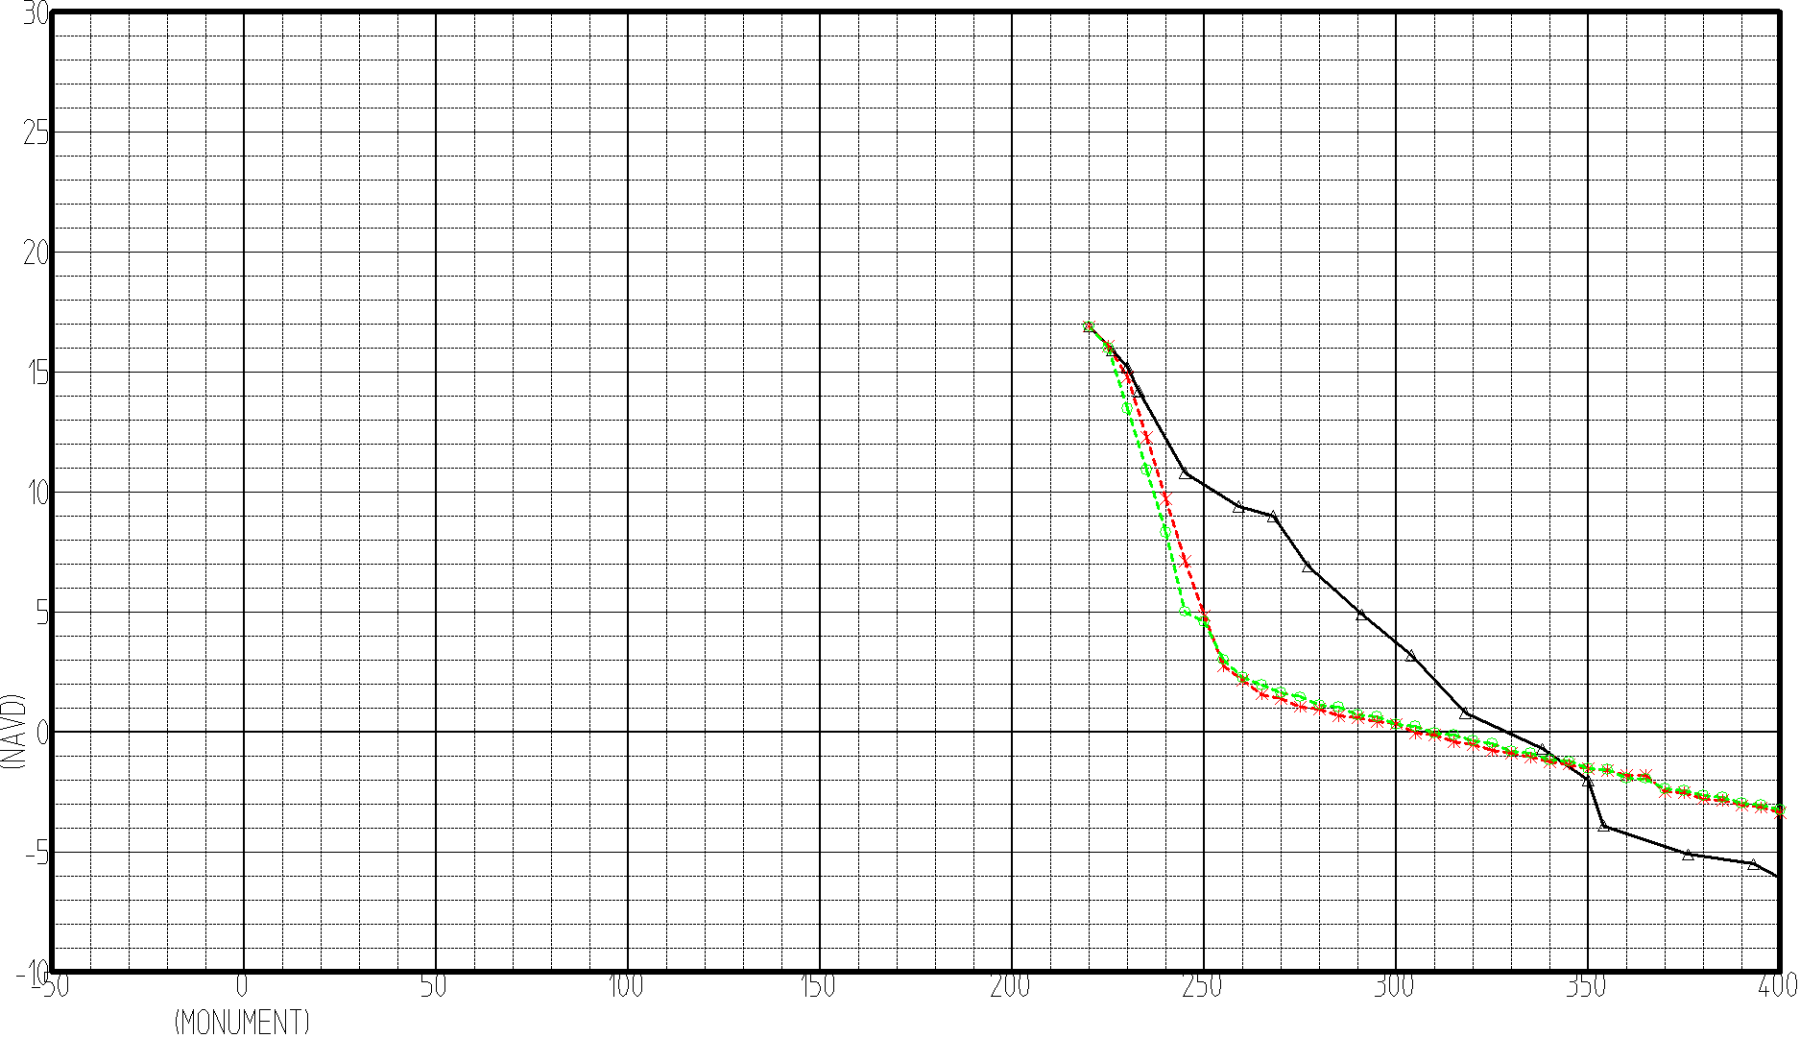
Range: R-159-T 1/2
 BEARING: 70.00

BEACH PROFILE
 —△—△— 2005-2008 INPUT PRF
 - - * - - 15-YR SBEACH ERODED PRF
 - - o - - 25-YR SBEACH ERODED PRF

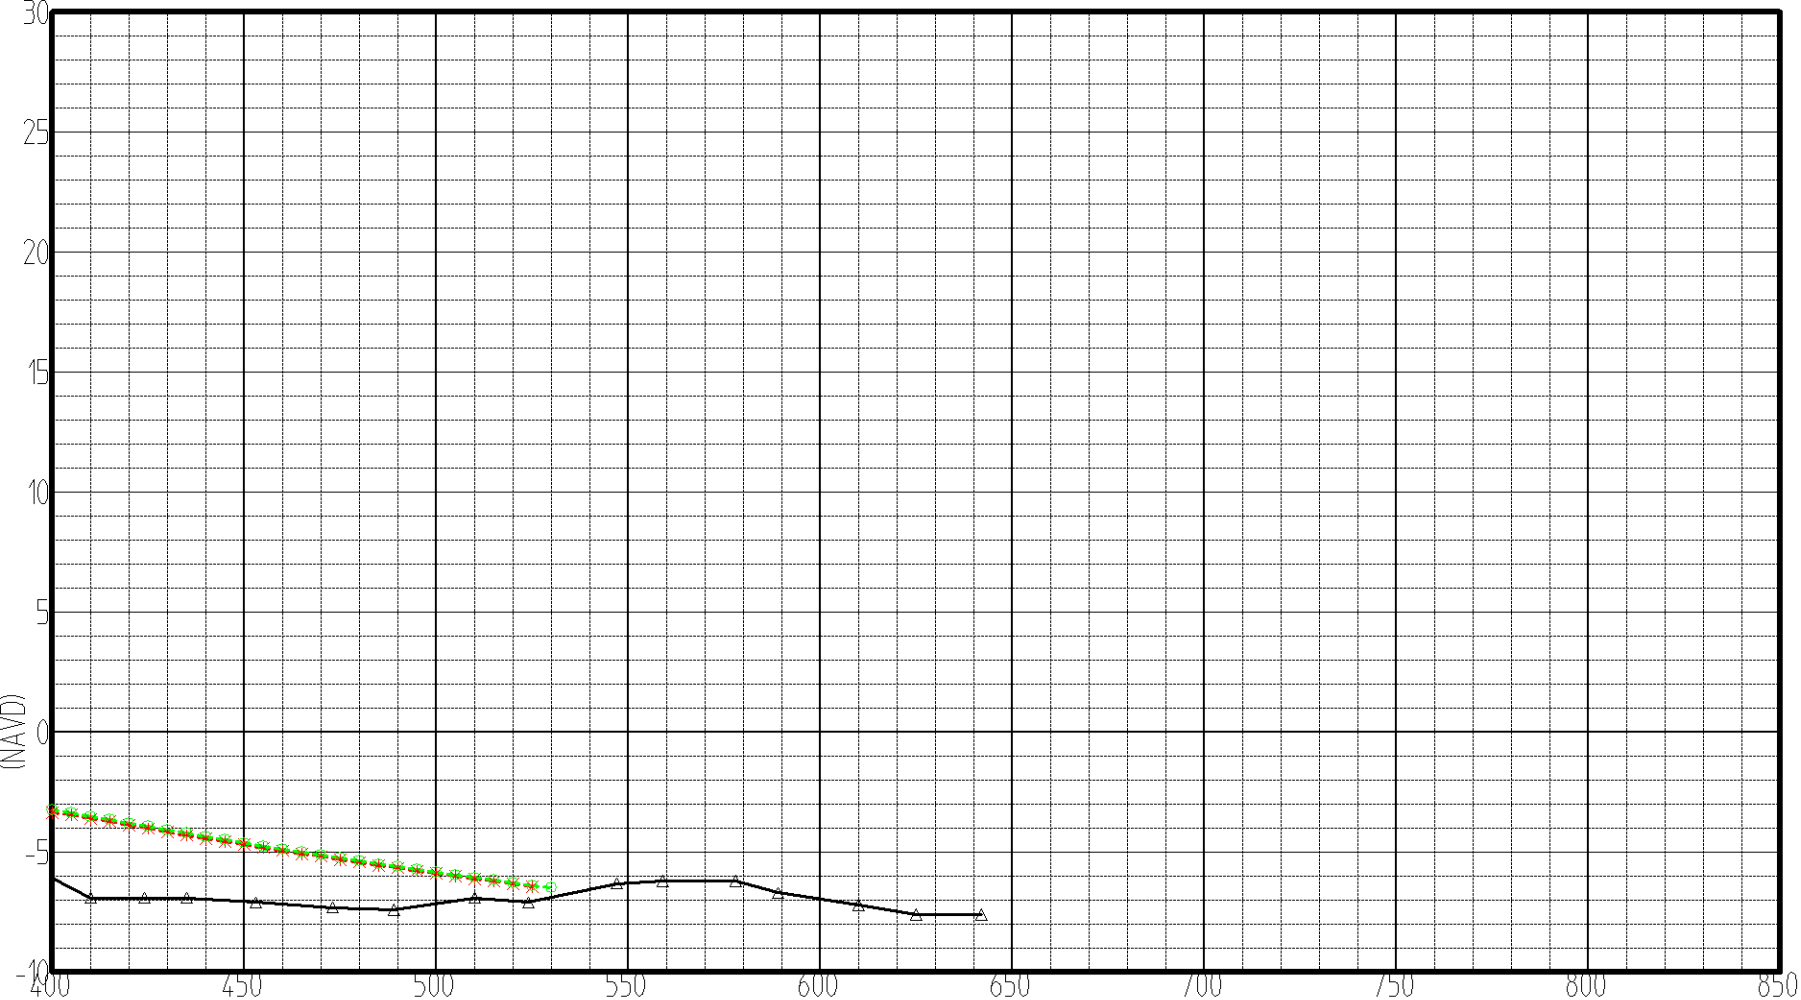
Range: R-159-T

—△—△— 2005-2008 INPUT PRF

- - - * - - - 15-YR SBEACH ERODED PRF

- - - o - - - 25-YR SBEACH ERODED PRF

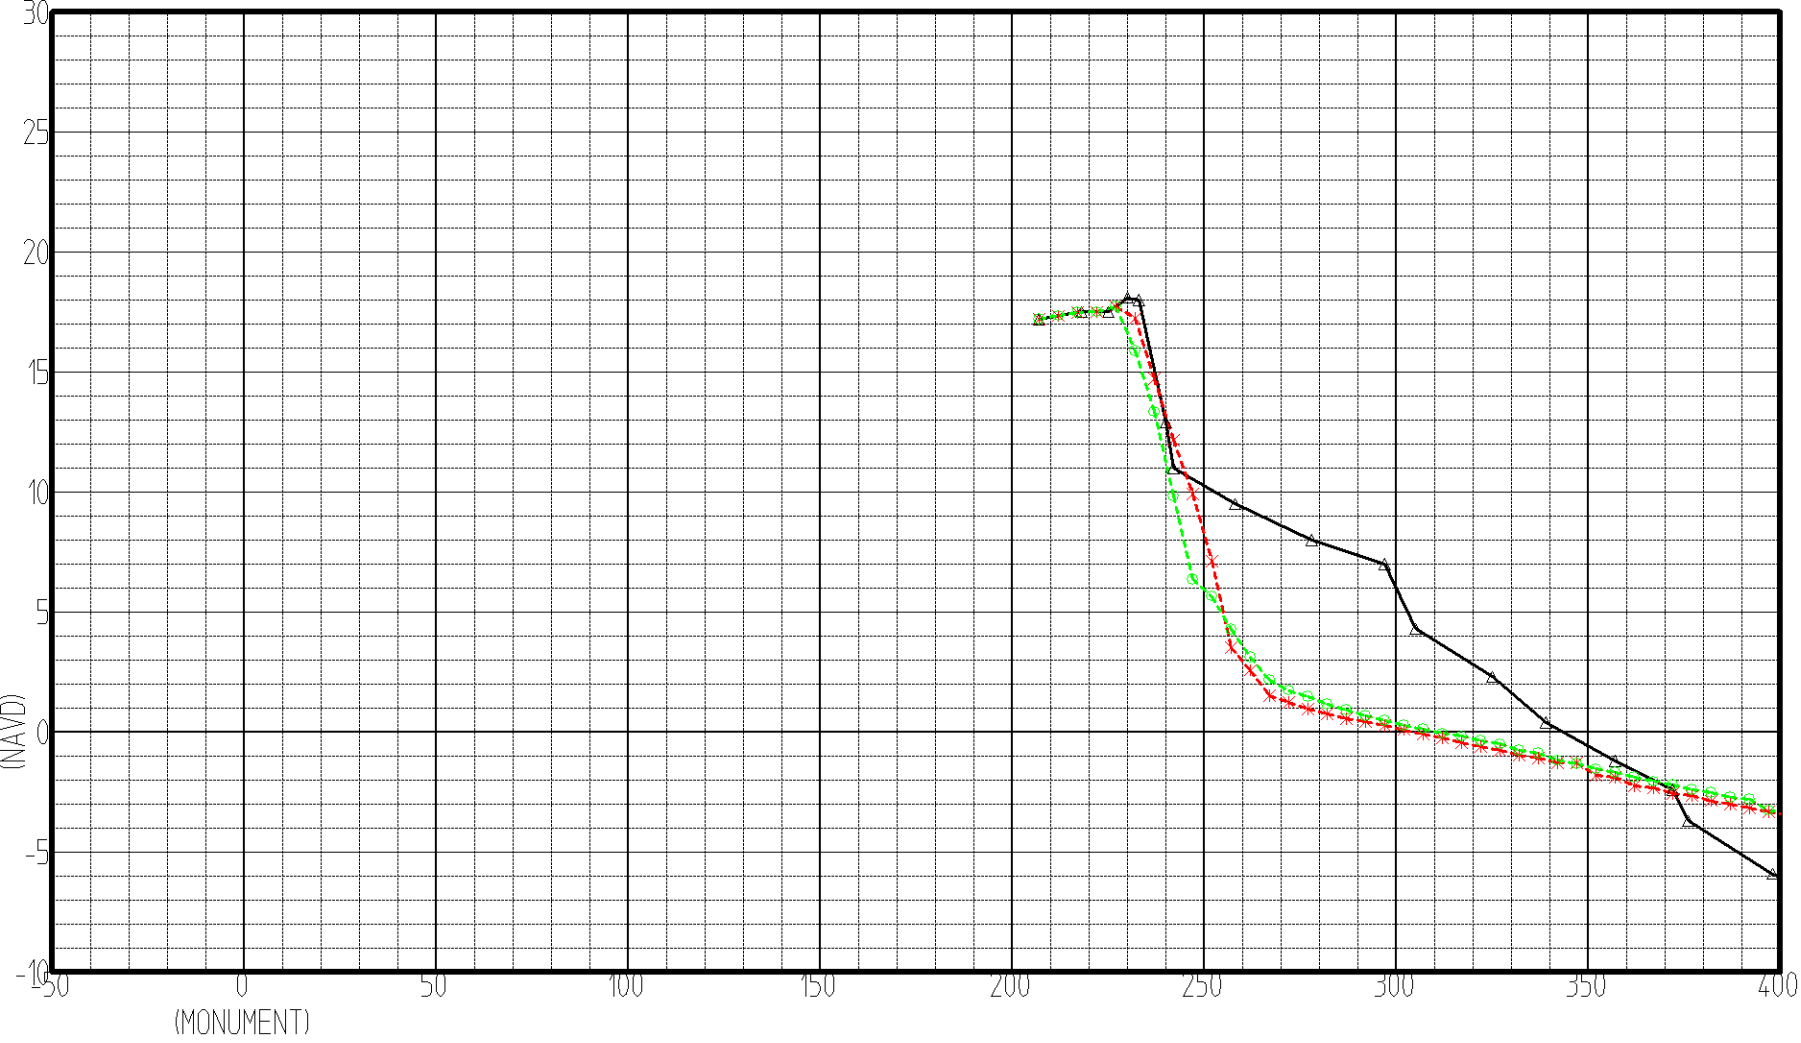
Range: R-160

—△—△— 2005-2008 INPUT PRF

- - * - - * - - 15-YR SBEACH ERODED PRF

- - o - - o - - 25-YR SBEACH ERODED PRF

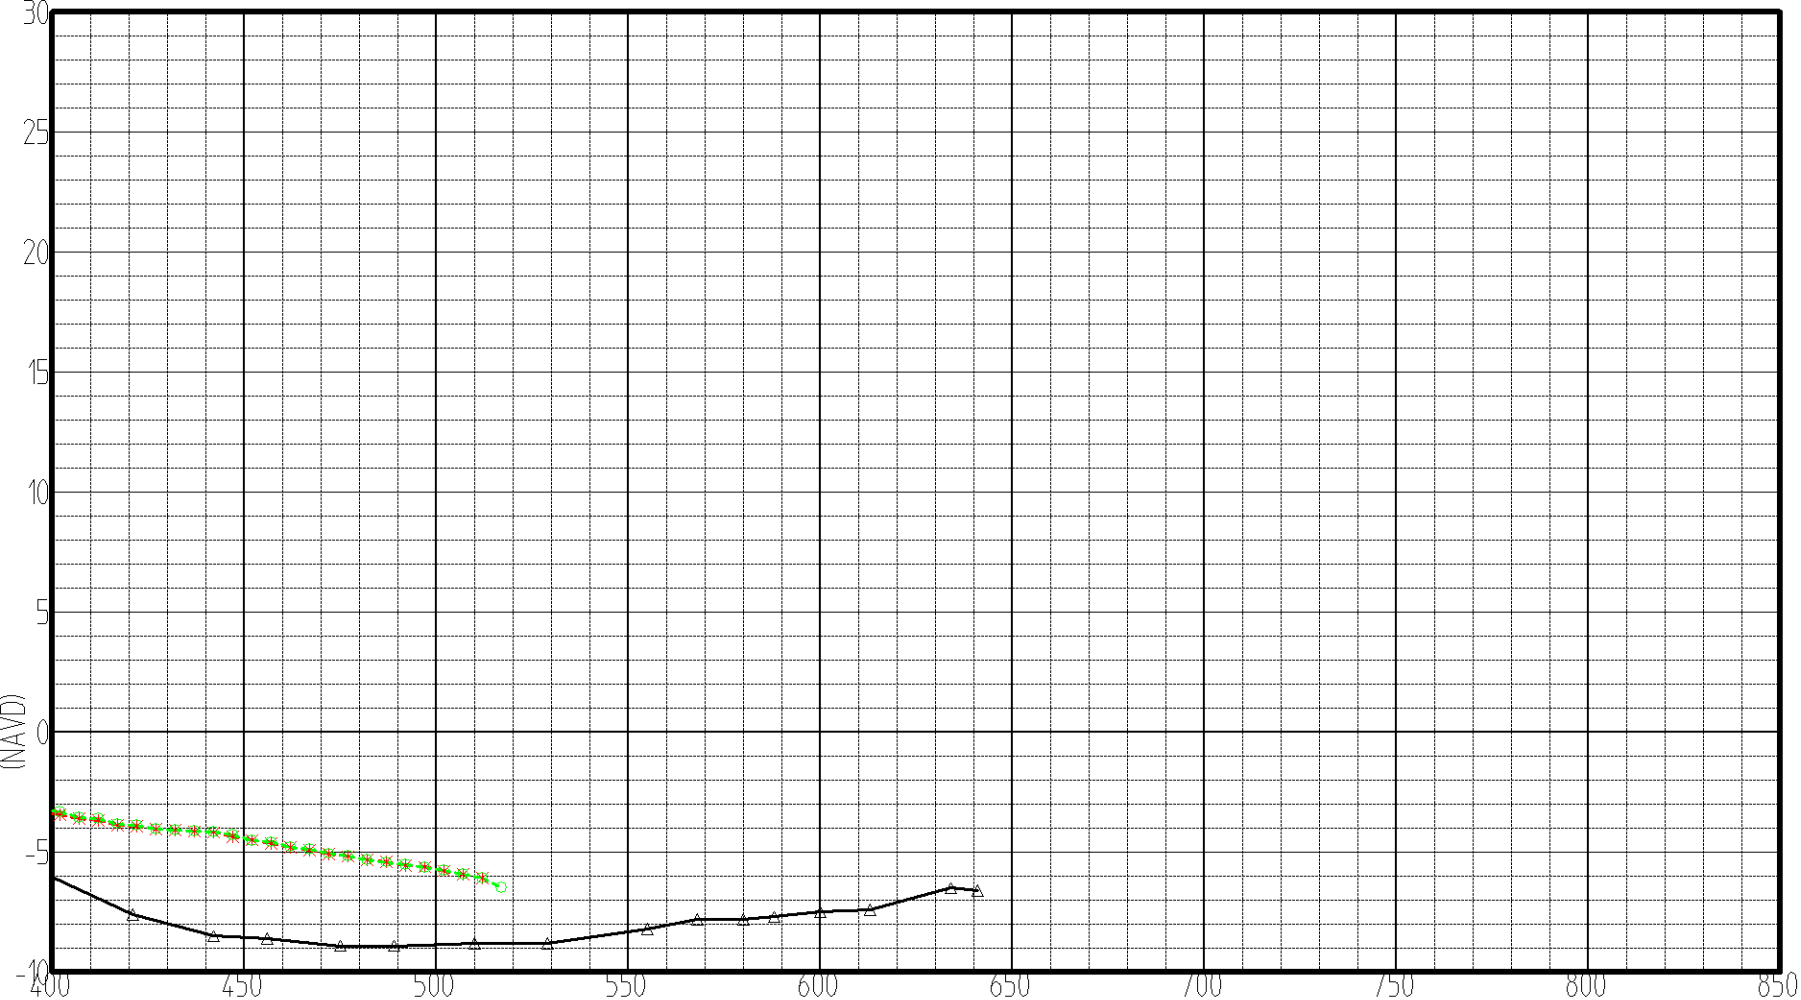
Range: R-160 2/2

- △—△— 2005-2008 INPUT PRF
- - - * - - - 15-YR SBEACH ERODED PRF
- - - o - - - 25-YR SBEACH ERODED PRF

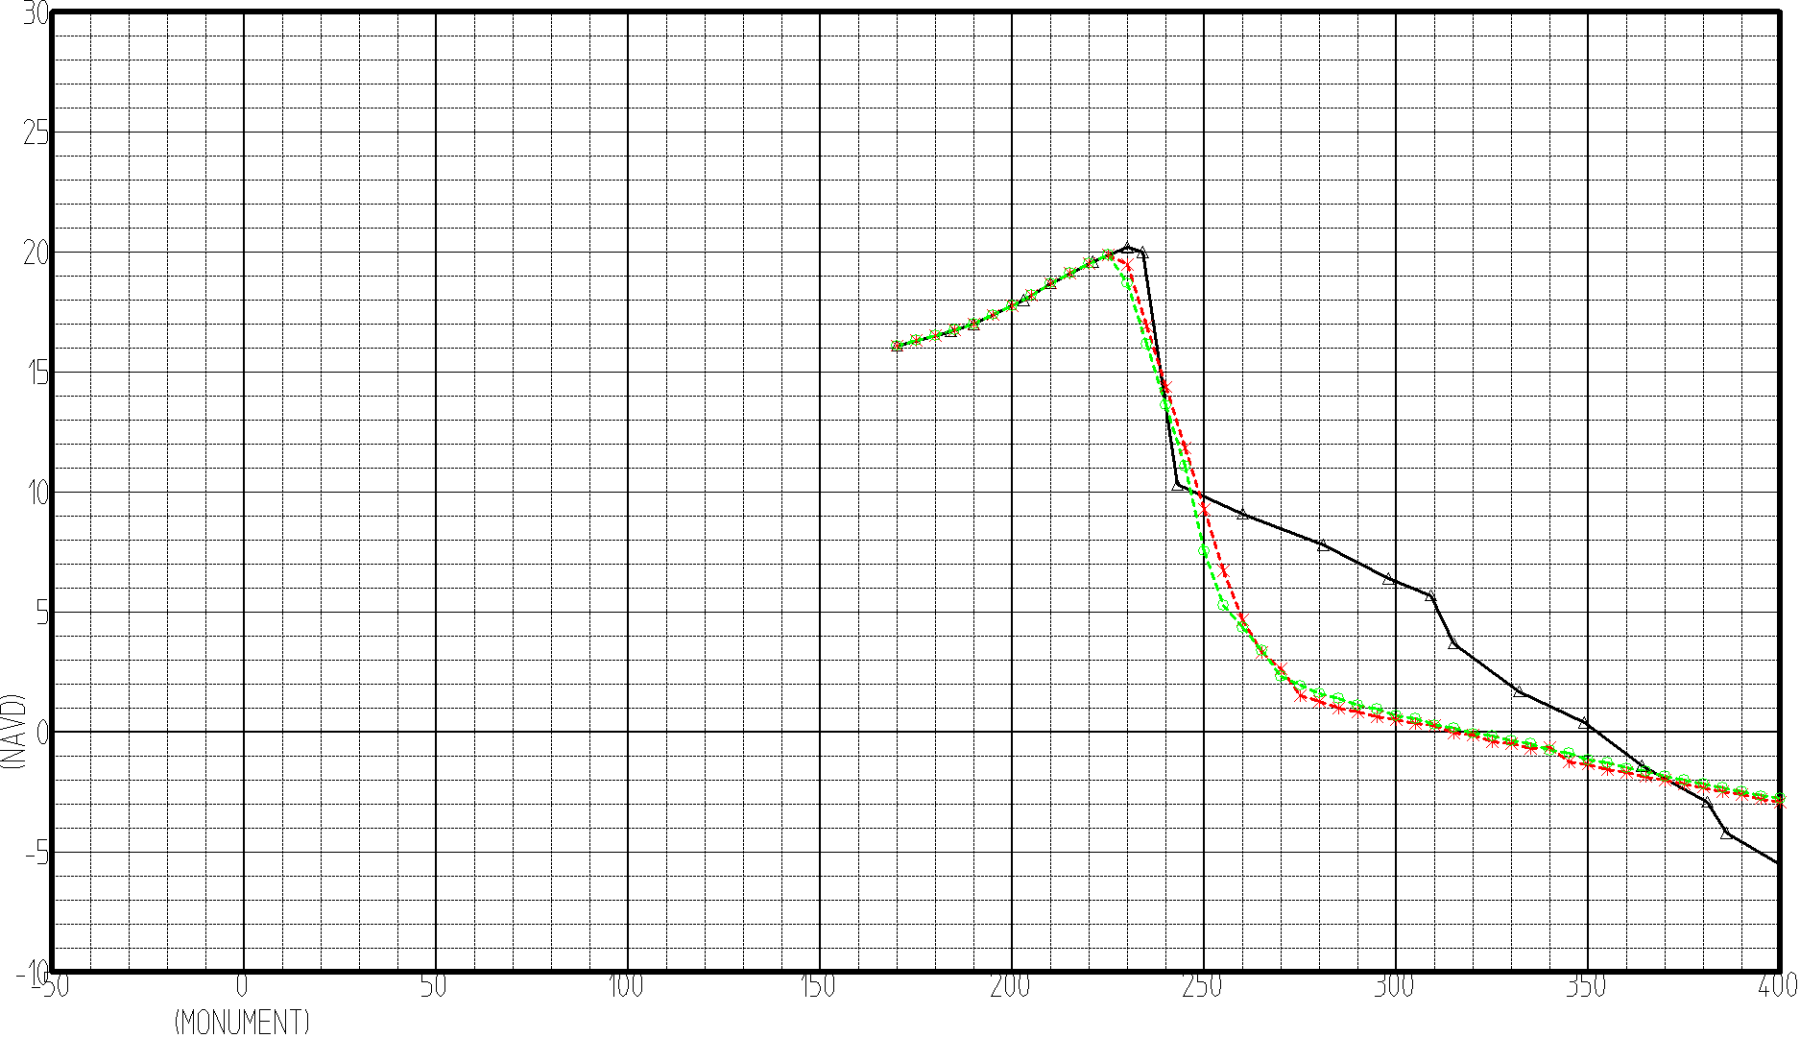
Range: R-161
 BEARING: 70.00
 1/2

BEACH PROFILE
 —△—△— 2005-2008 INPUT PRF
 - - * - - * - - 15-YR SBEACH ERODED PRF
 - - o - - o - - 25-YR SBEACH ERODED PRF

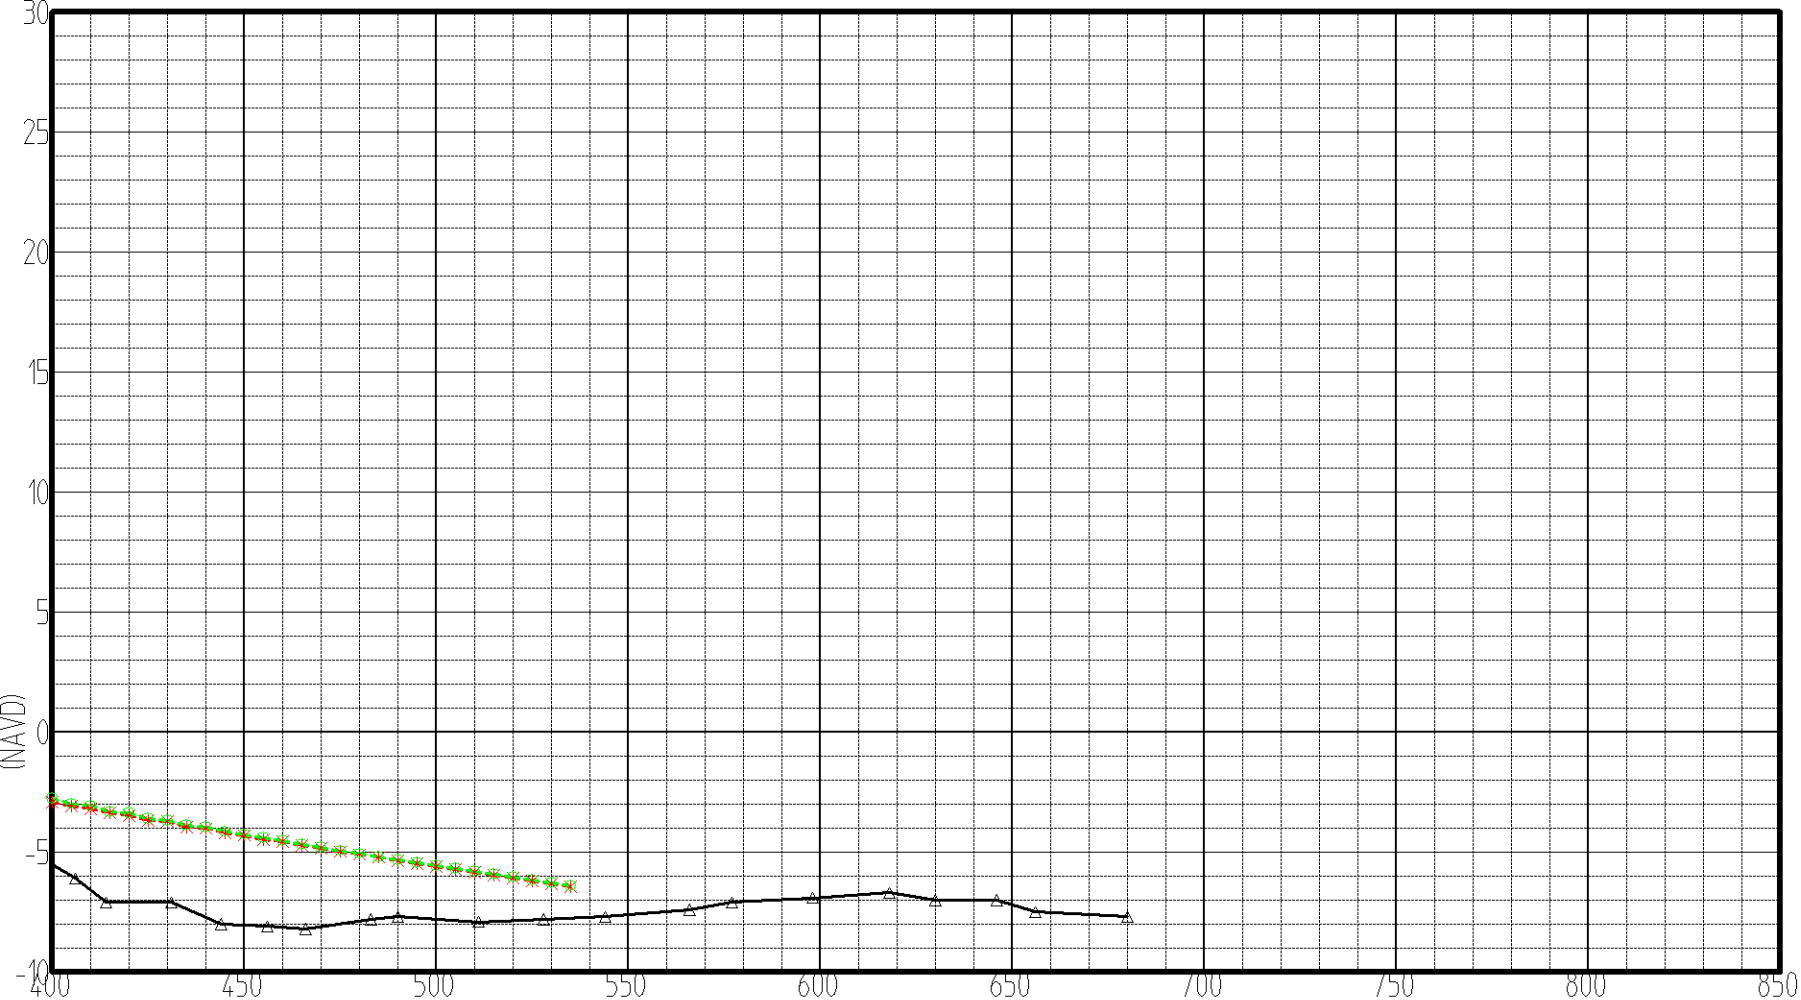
Range: R-161

—△—△— 2005-2008 INPUT PRF

- - - * - - - 15-YR SBEACH ERODED PRF

- - - o - - - 25-YR SBEACH ERODED PRF

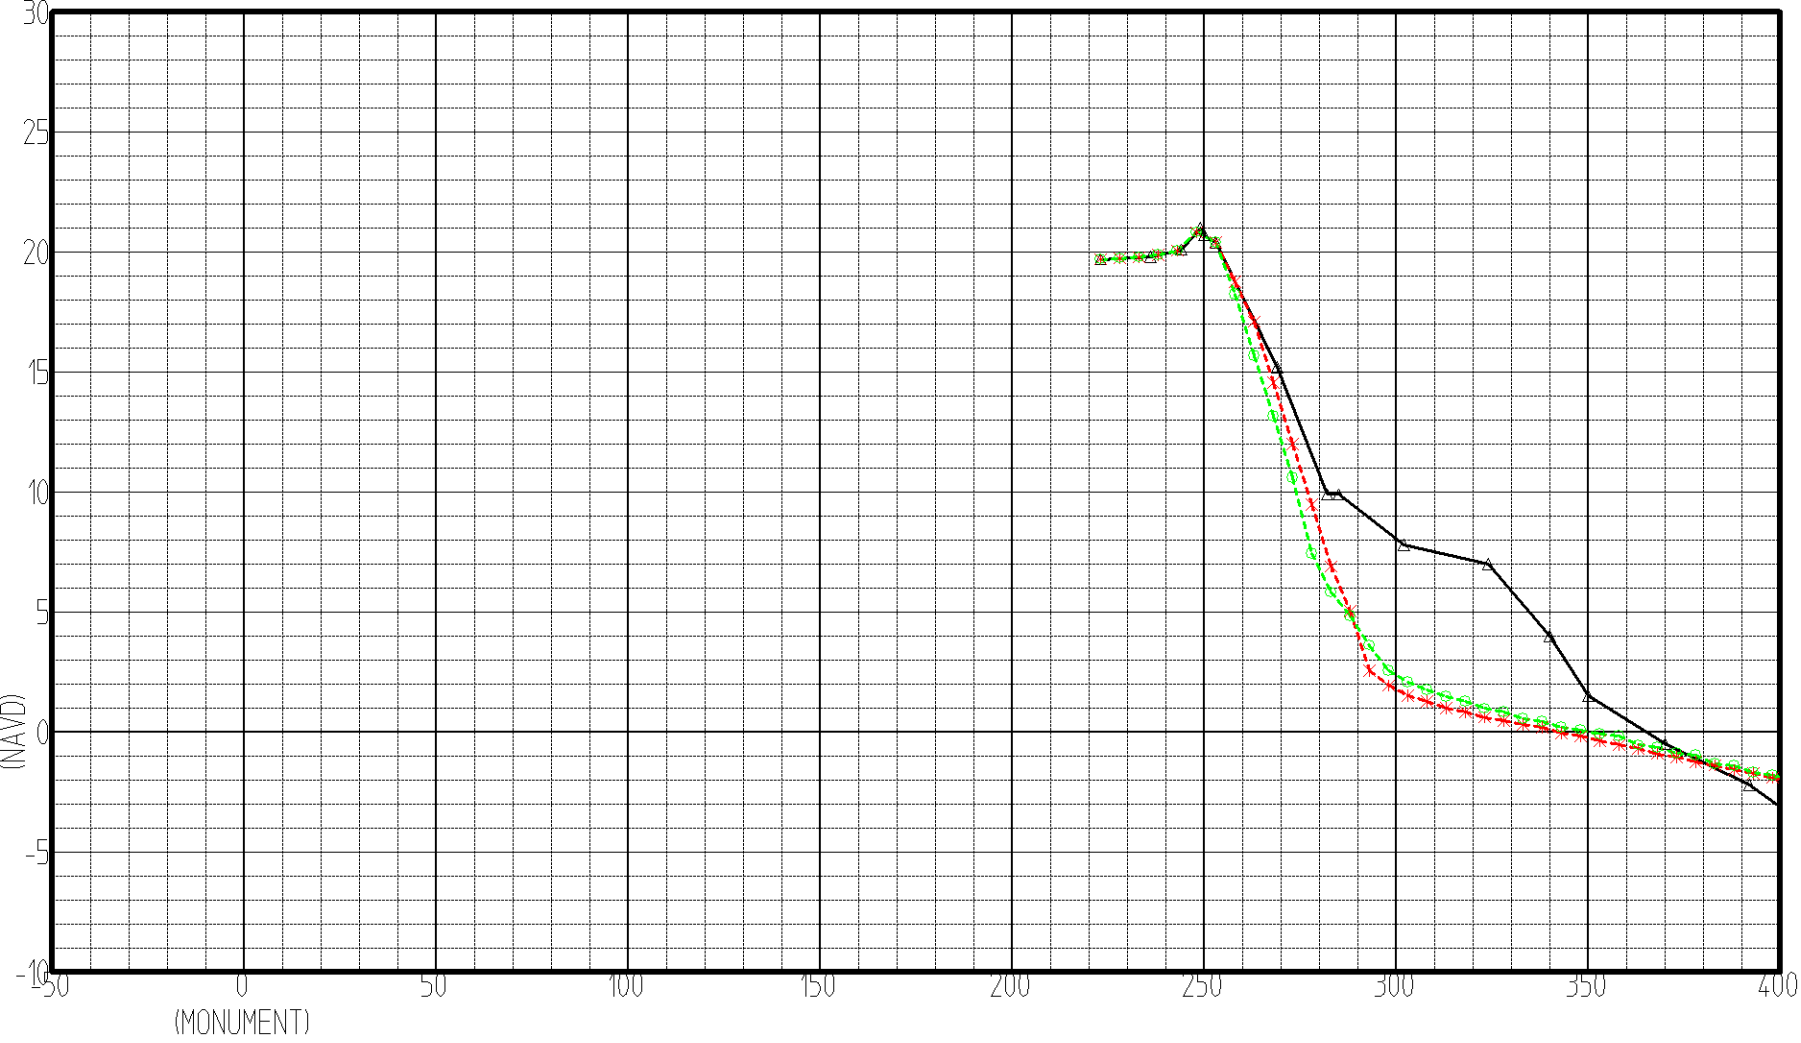
Range: R-162
 BEARING: 70.00
 1/2

BEACH PROFILE
 —△—△— 2005-2008 INPUT PRF
 - - - * - - - 15-YR SBEACH ERODED PRF
 - - - o - - - 25-YR SBEACH ERODED PRF

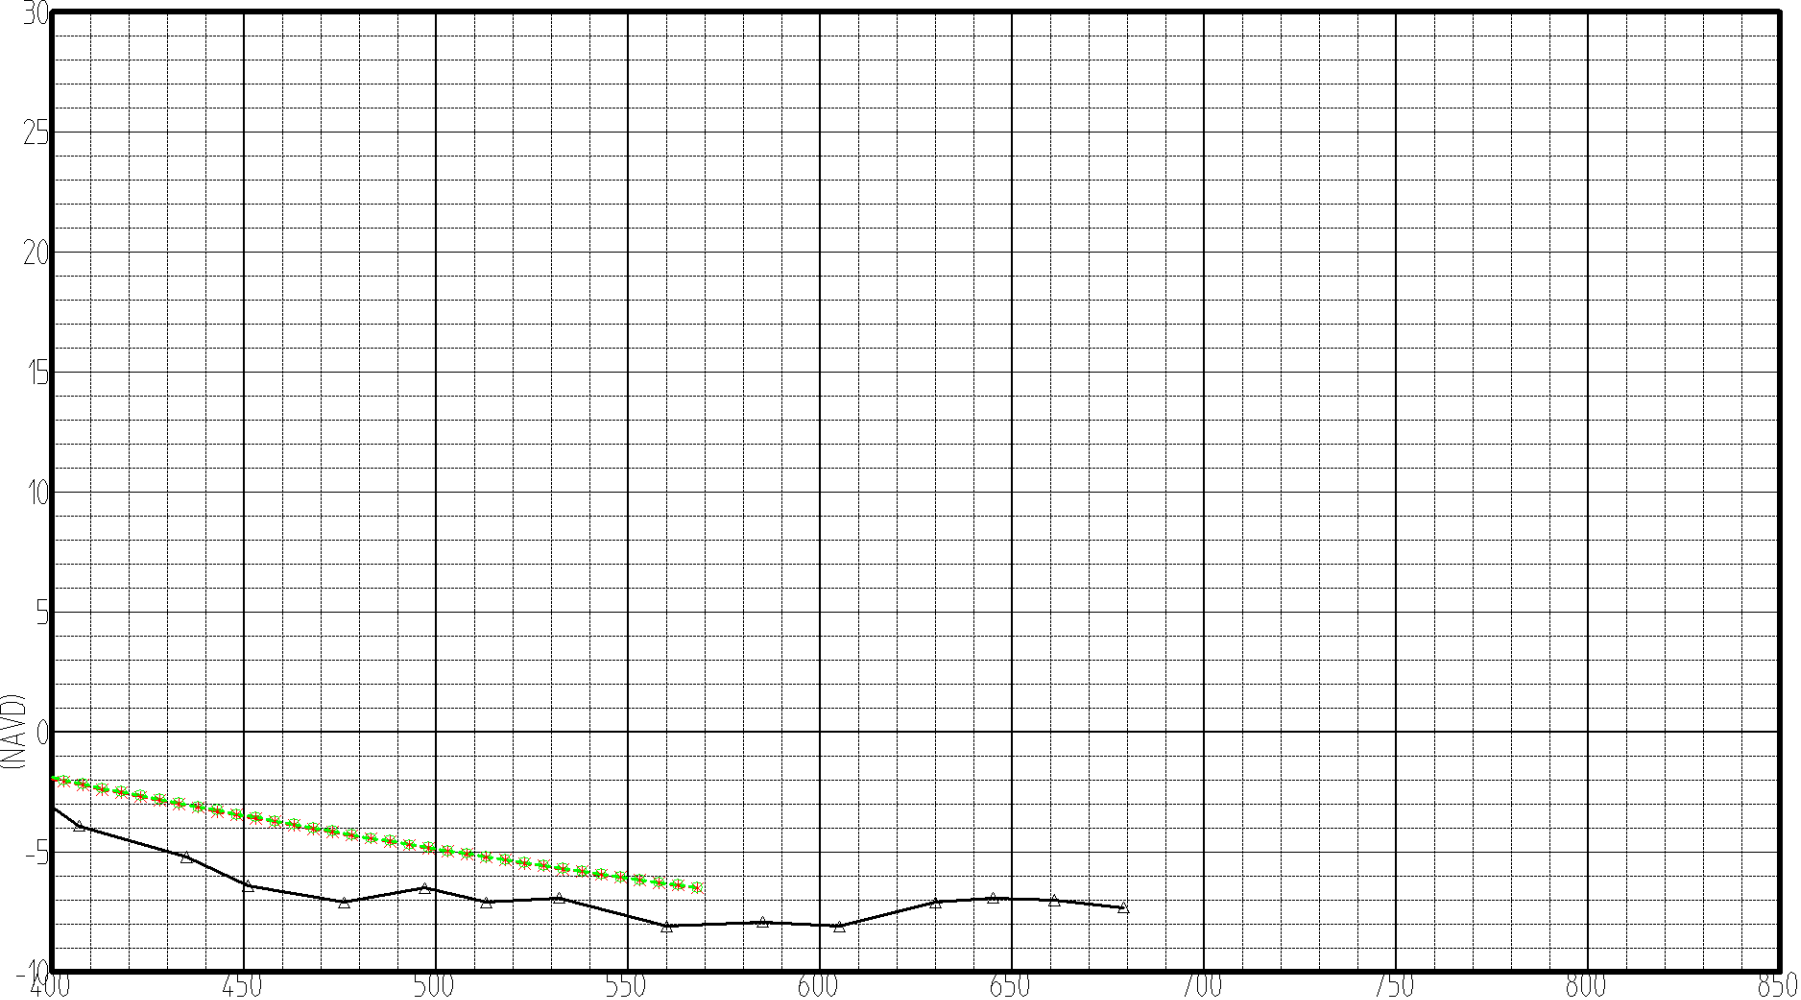
Range: R-162

- △—△— 2005-2008 INPUT PRF
- - - * - - - 15-YR SBEACH ERODED PRF
- - - o - - - 25-YR SBEACH ERODED PRF

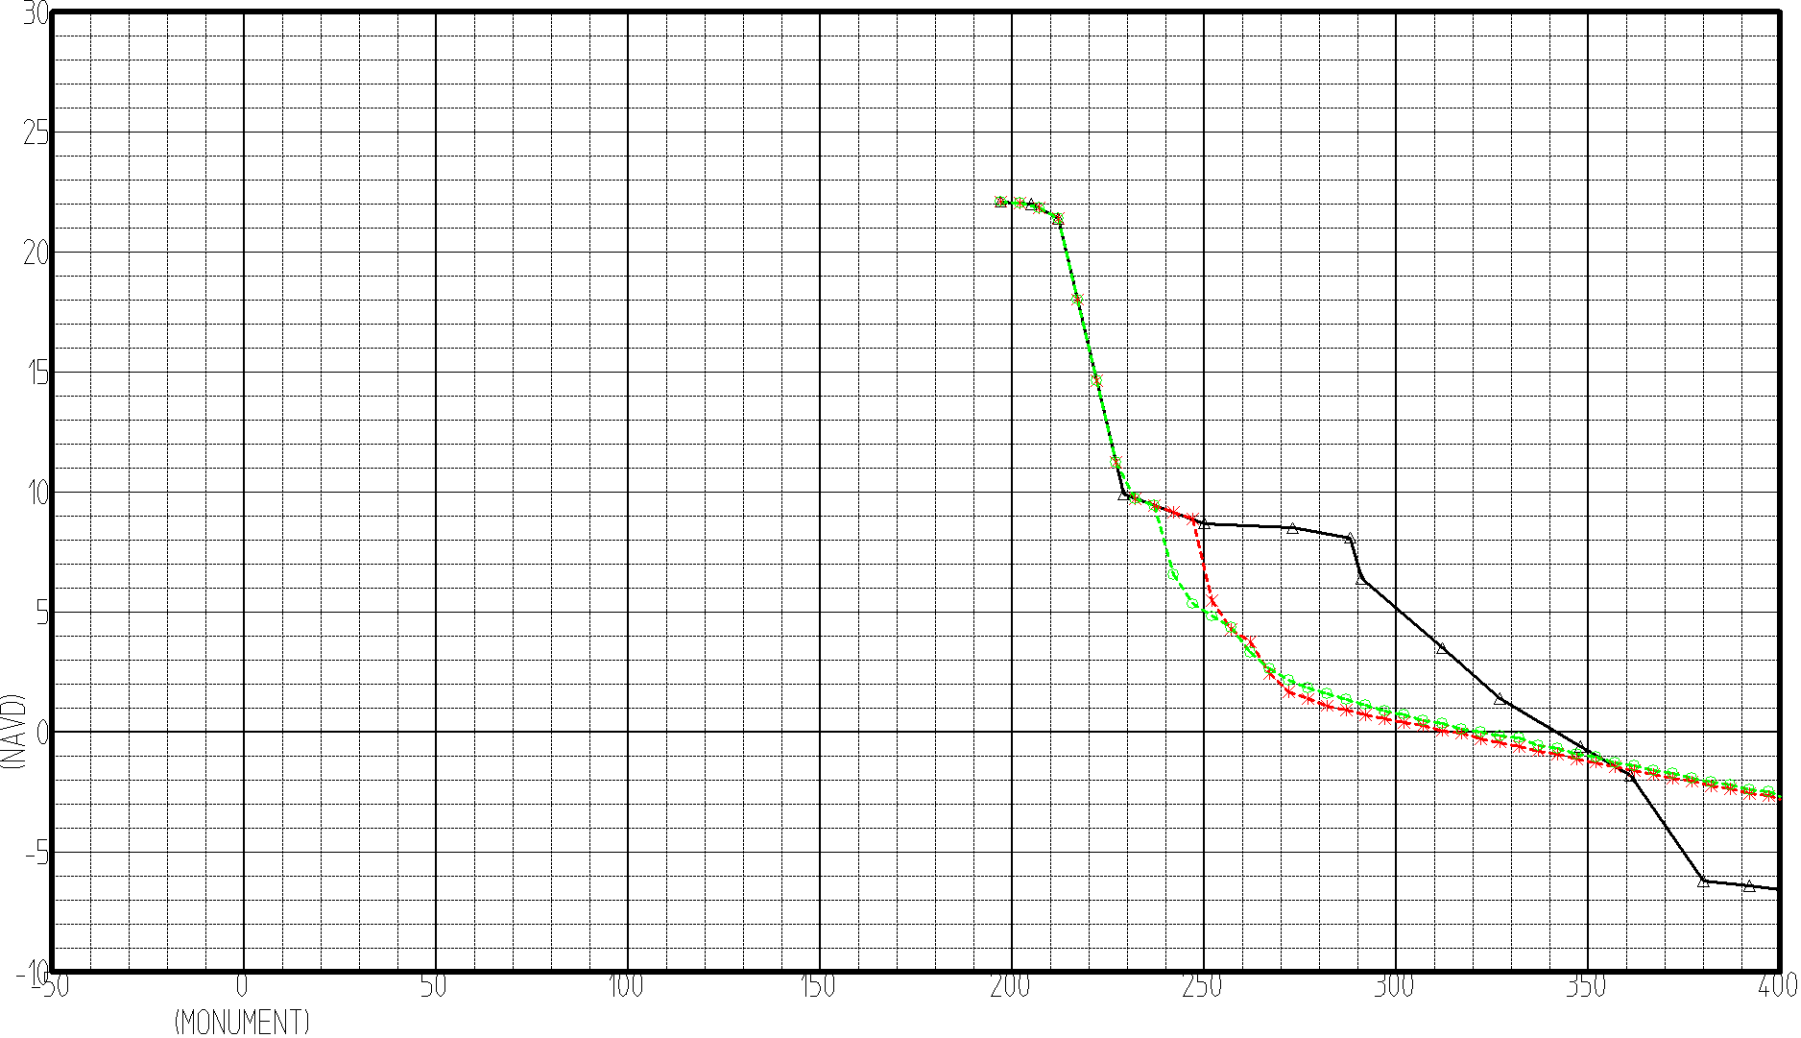
Range: R-163
 BEARING: 70.00
 1/2

BEACH PROFILE
 —△—△— 2005-2008 INPUT PRF
 - - * - - * - - 15-YR SBEACH ERODED PRF
 - - o - - o - - 25-YR SBEACH ERODED PRF

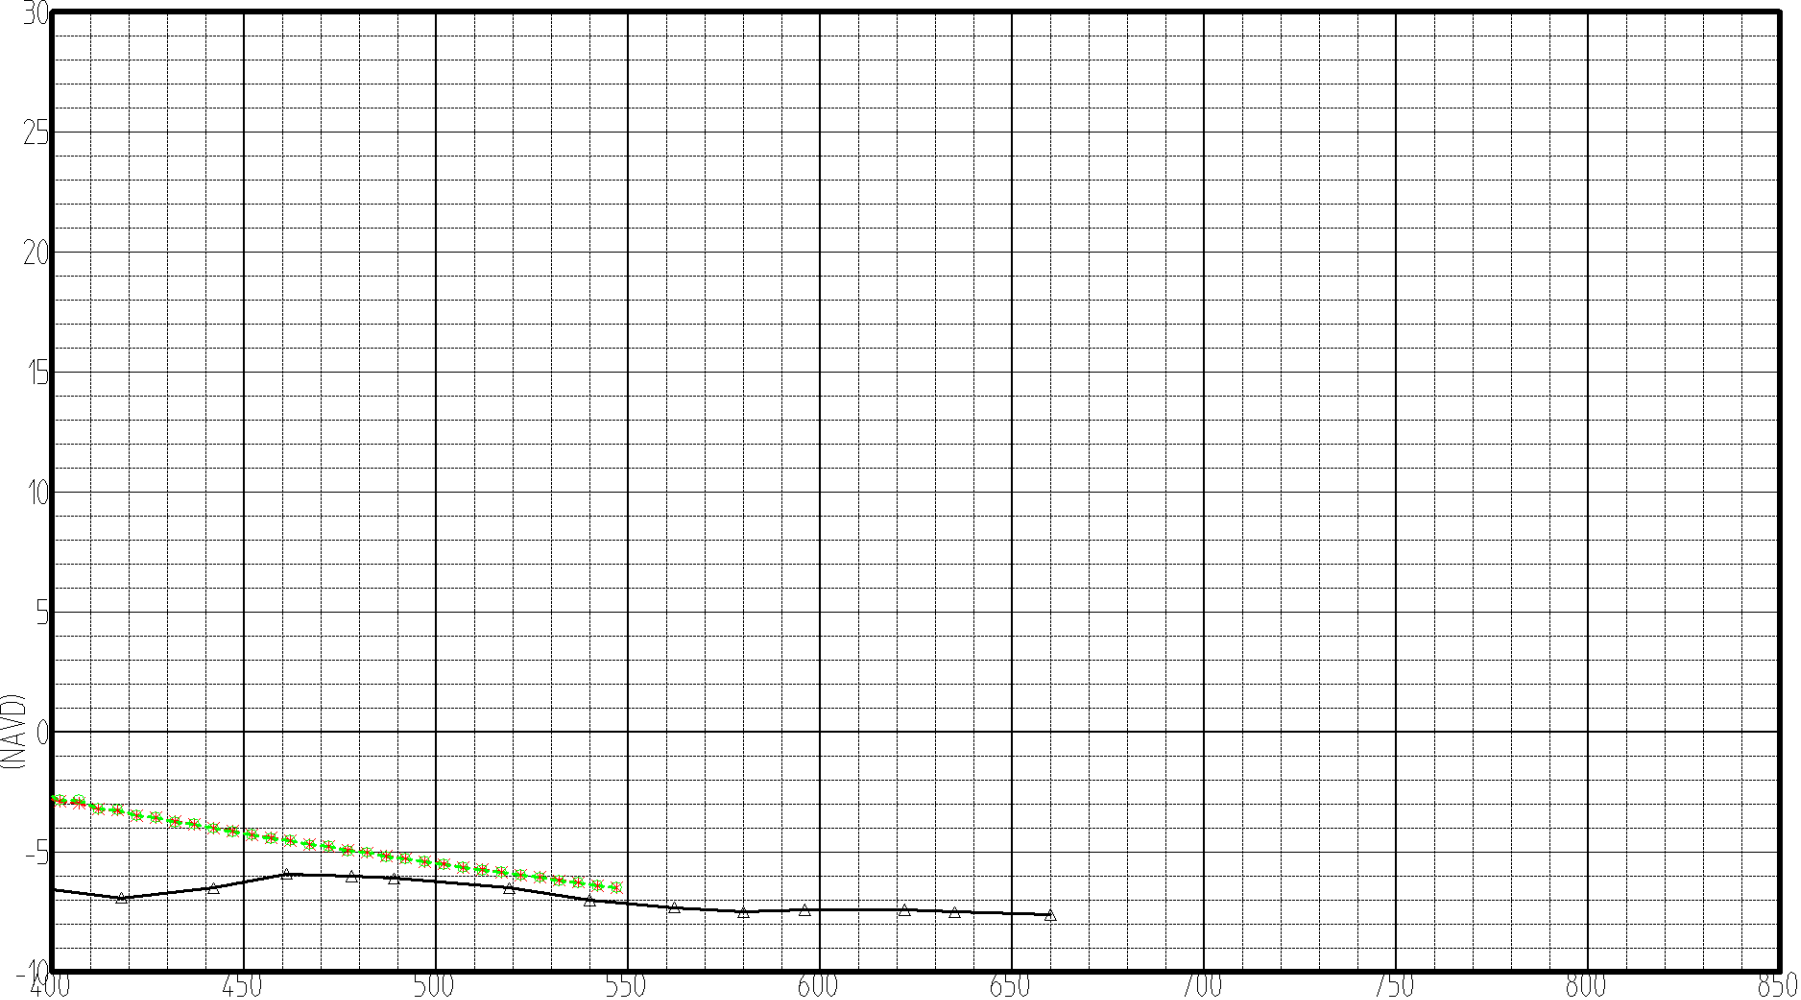
Range: R-163

—△—△— 2005-2008 INPUT PRF

- - - * - - - 15-YR SBEACH ERODED PRF

- - - o - - - 25-YR SBEACH ERODED PRF

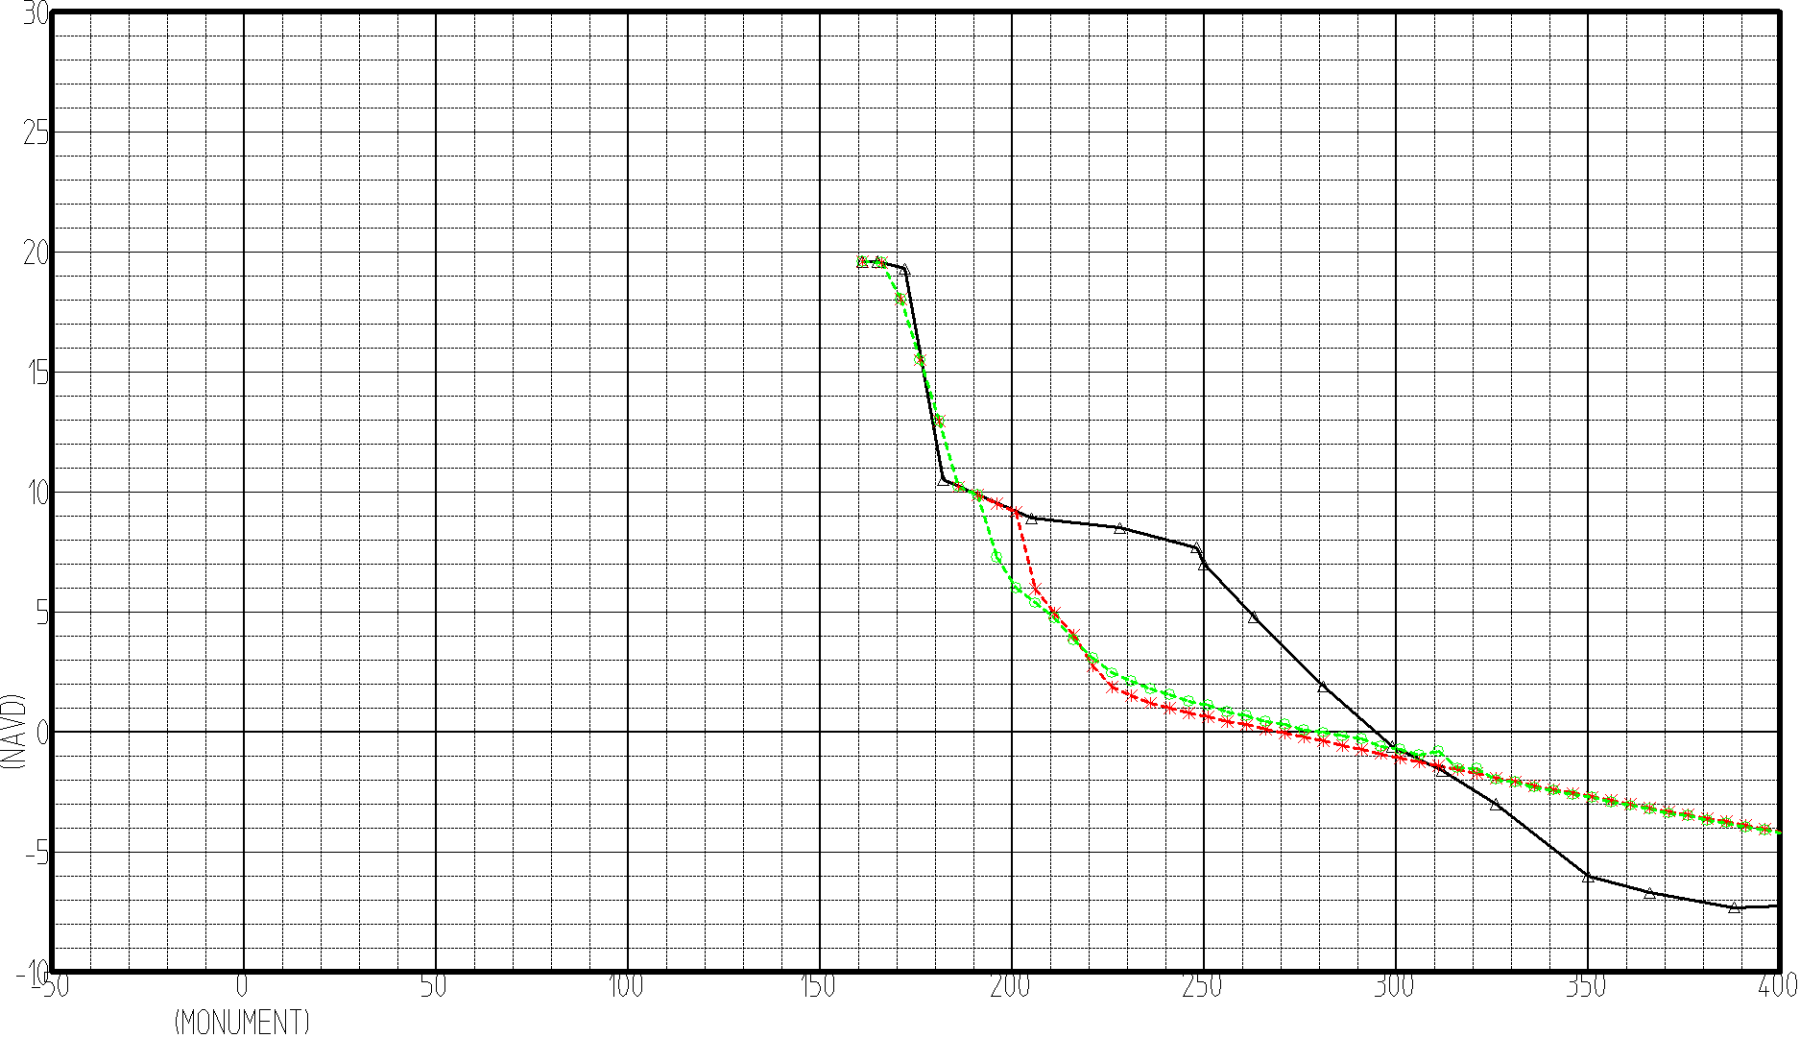
Range: R-164
 BEARING: 70.00
 1/2

BEACH PROFILE
 —△—△— 2005-2008 INPUT PRF
 - - * - - * - - 15-YR SBEACH ERODED PRF
 - - o - - o - - 25-YR SBEACH ERODED PRF
