Appendix XI

SBEACH 15 and 25 yr. Storm Erosion Profiles

Brevard County

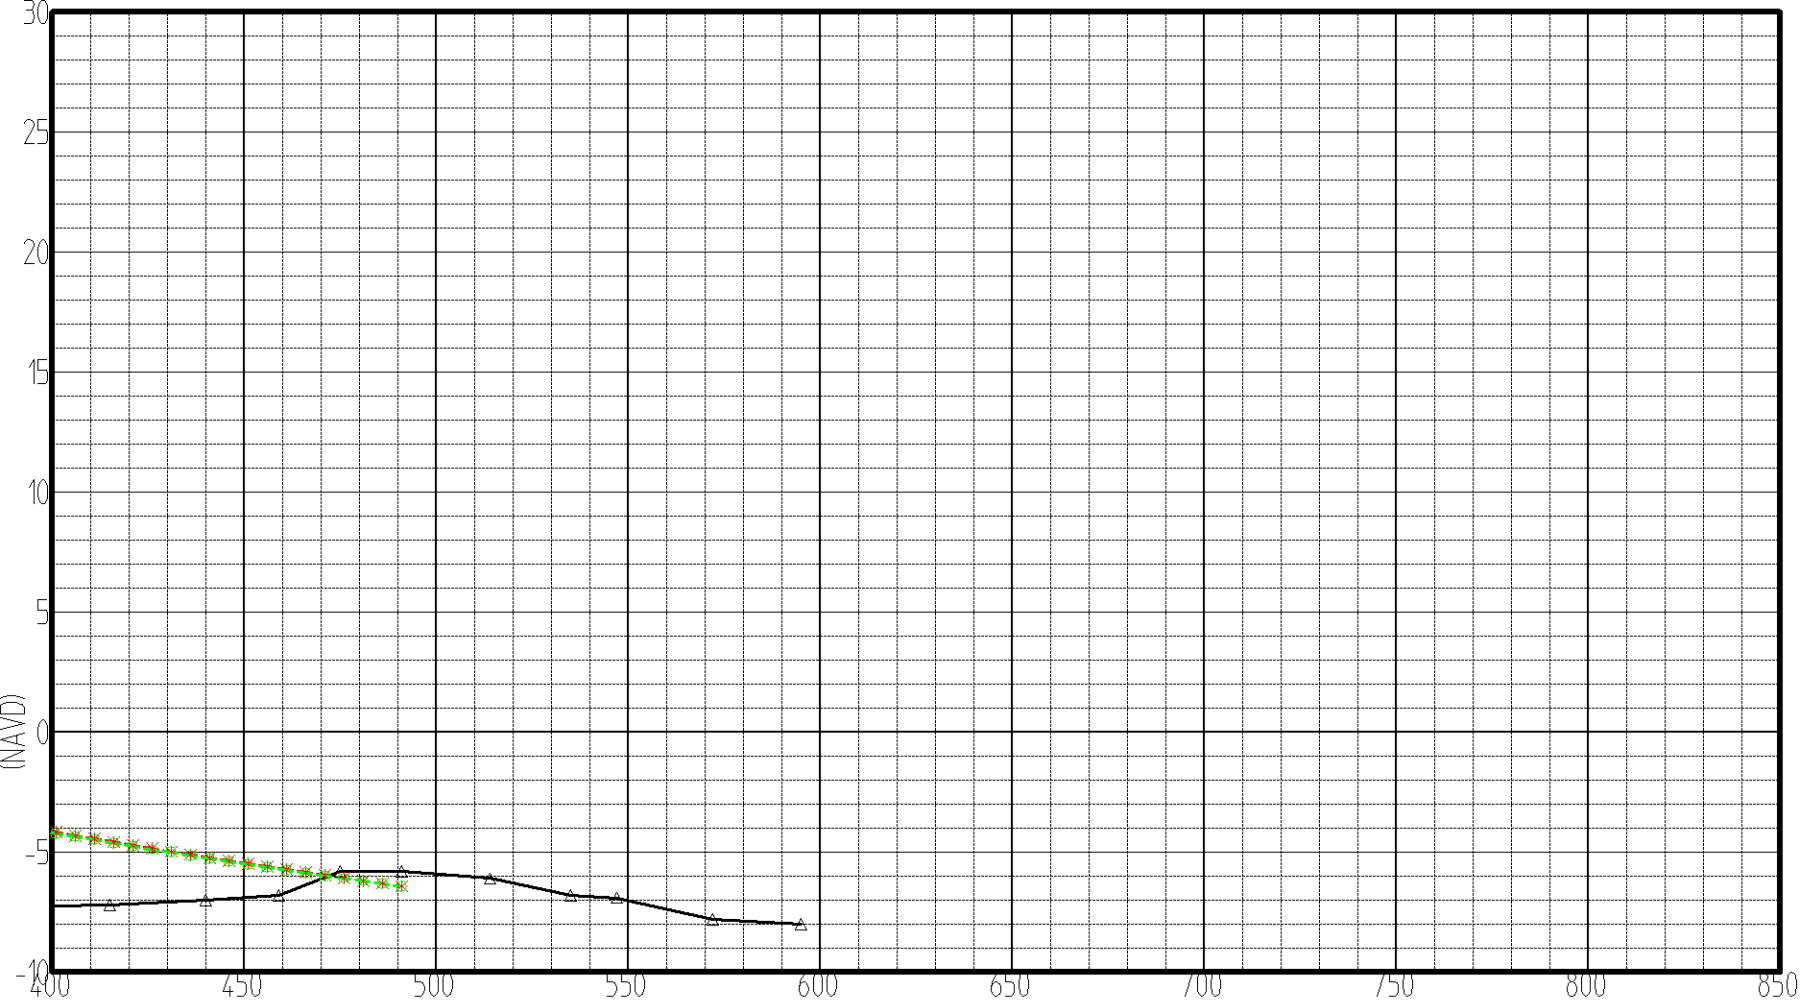
Range: R-164

—△—△— 2005-2008 INPUT PRF

- - - * - - - 15-YR SBEACH ERODED PRF

- - - o - - - 25-YR SBEACH ERODED PRF

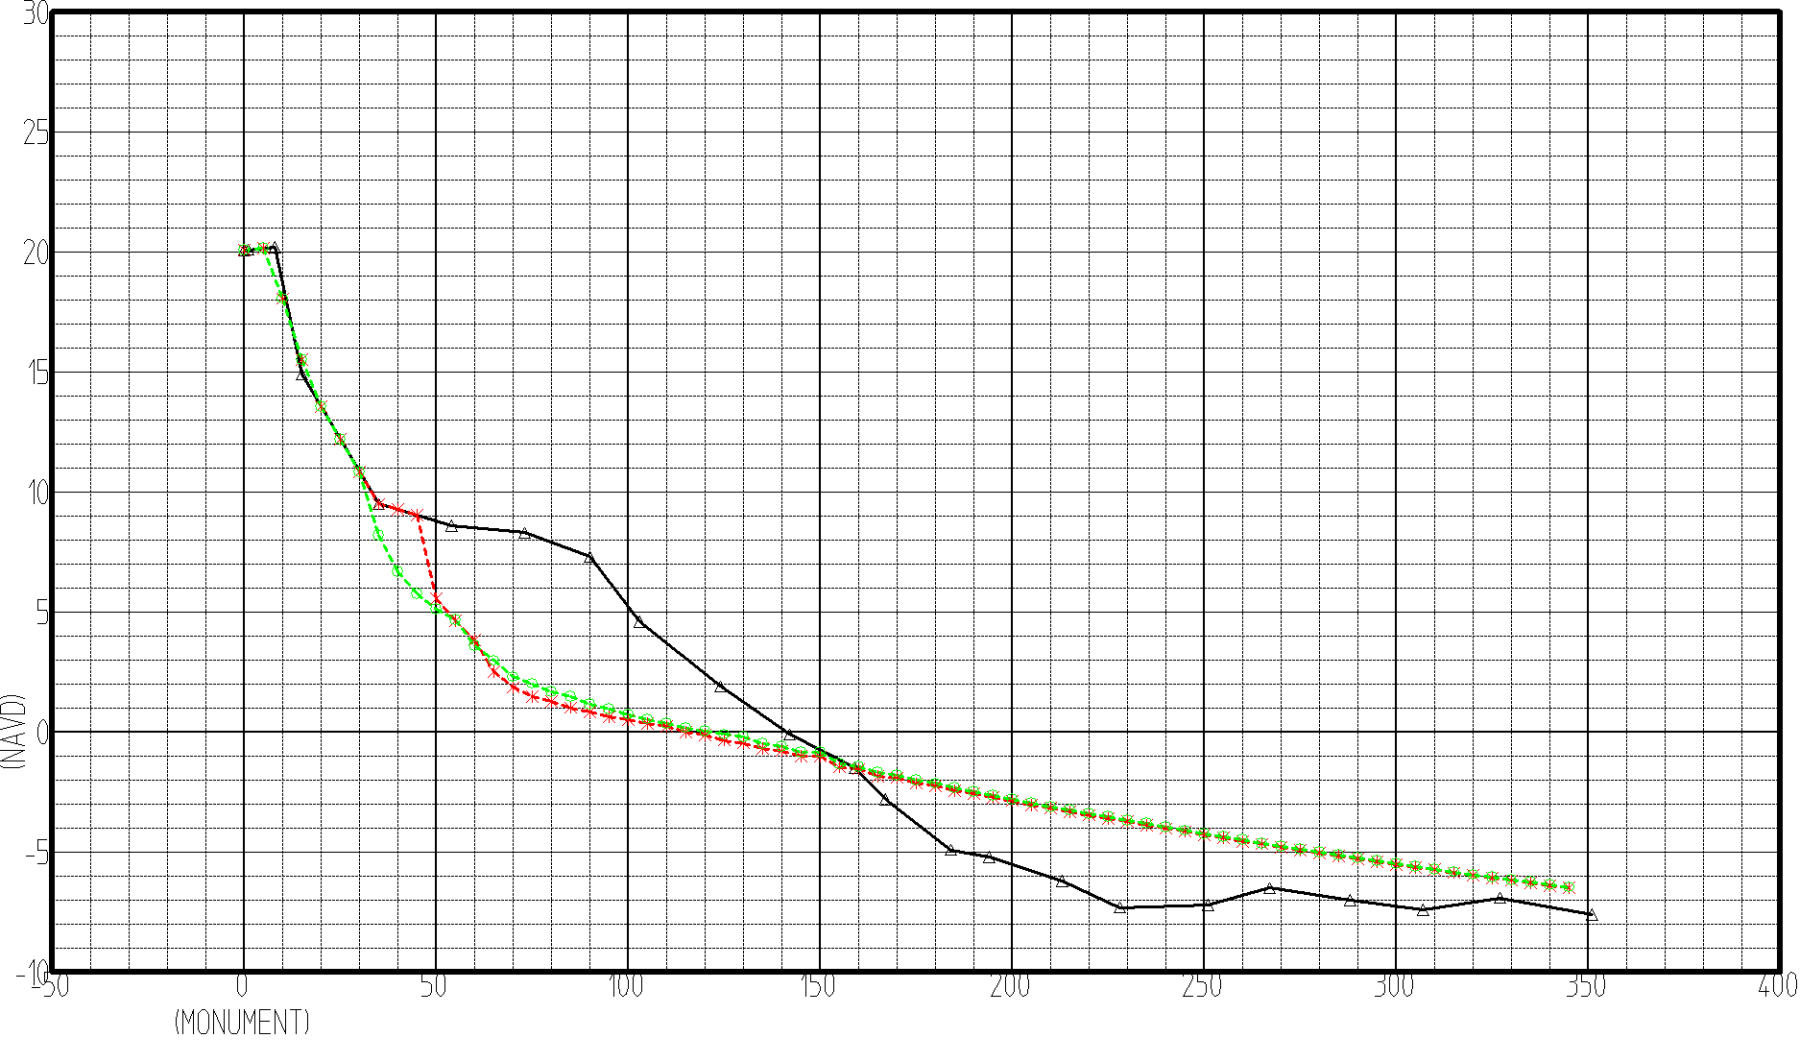
Range: R-165
 BEARING: 70.00
 1/1

BEACH PROFILE
 —△—△— 2005-2008 INPUT PRF
 - - * - - 15-YR SBEACH ERODED PRF
 - - o - - 25-YR SBEACH ERODED PRF

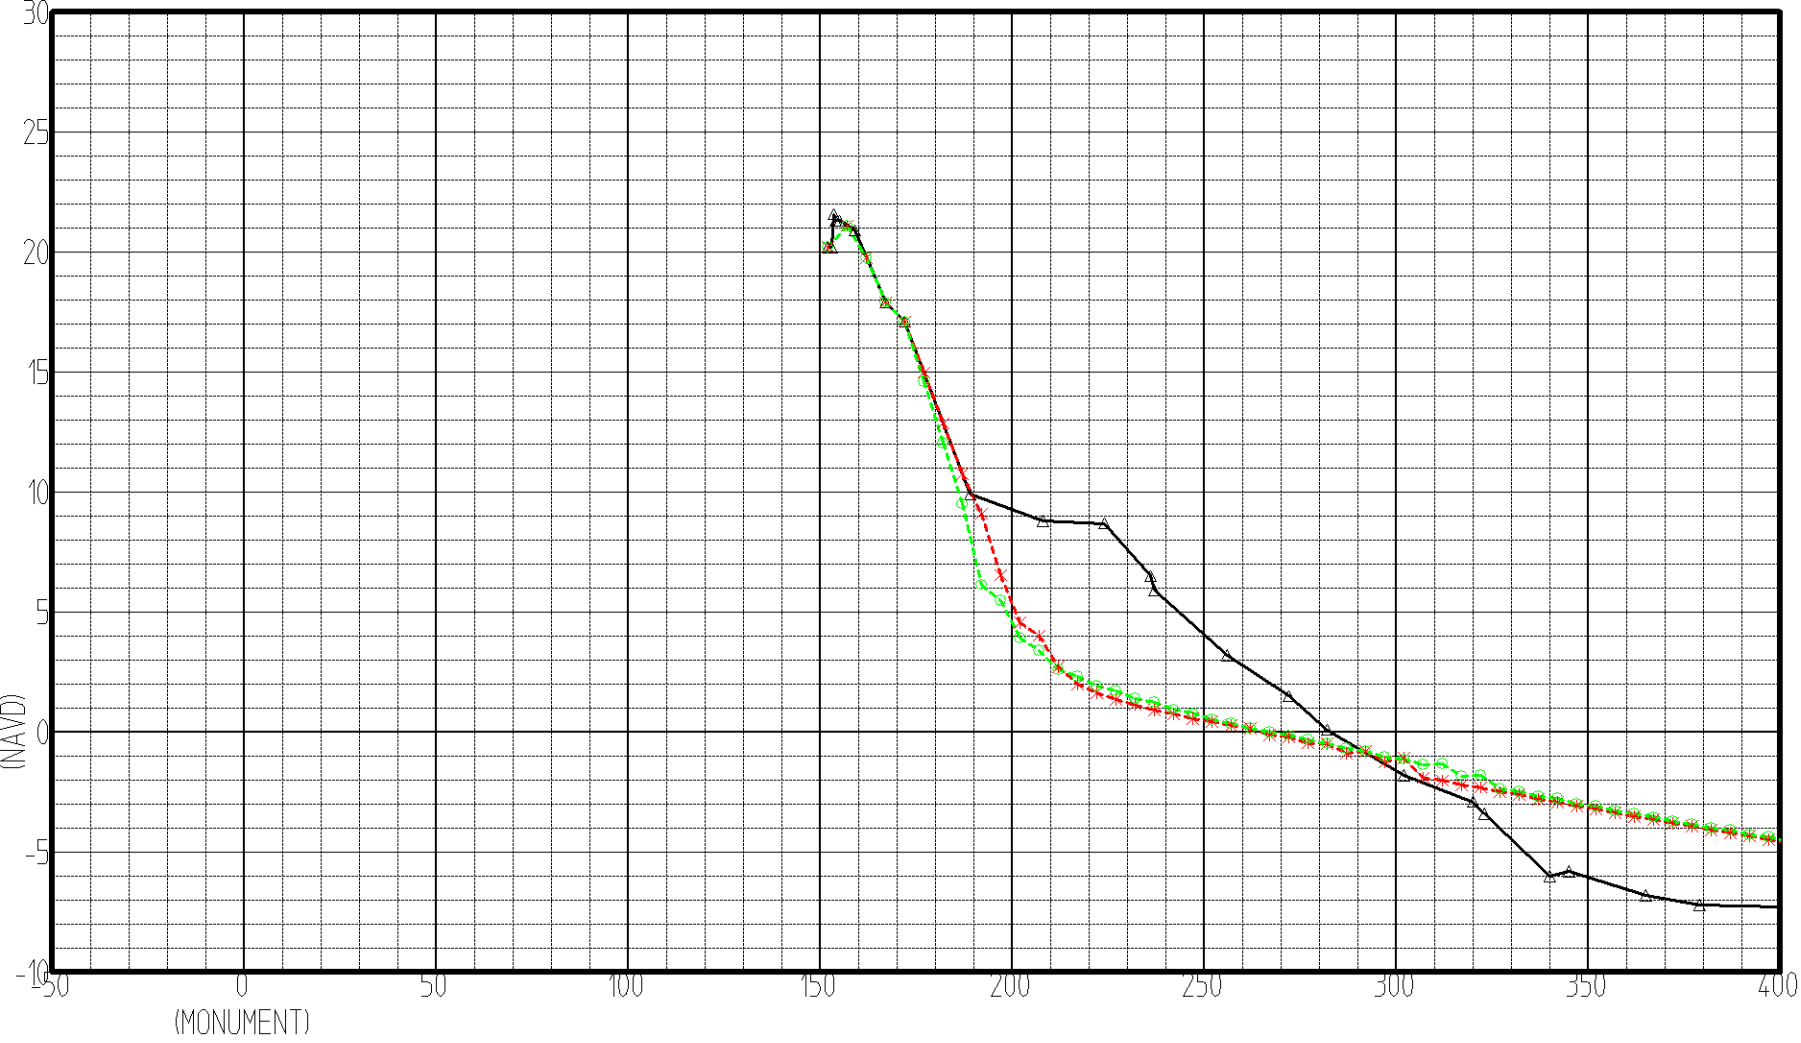
Range: R-166
 BEARING: 70.00
 1/2

BEACH PROFILE
 —△—△— 2005-2008 INPUT PRF
 - - * - - * - - 15-YR SBEACH ERODED PRF
 - - o - - o - - 25-YR SBEACH ERODED PRF

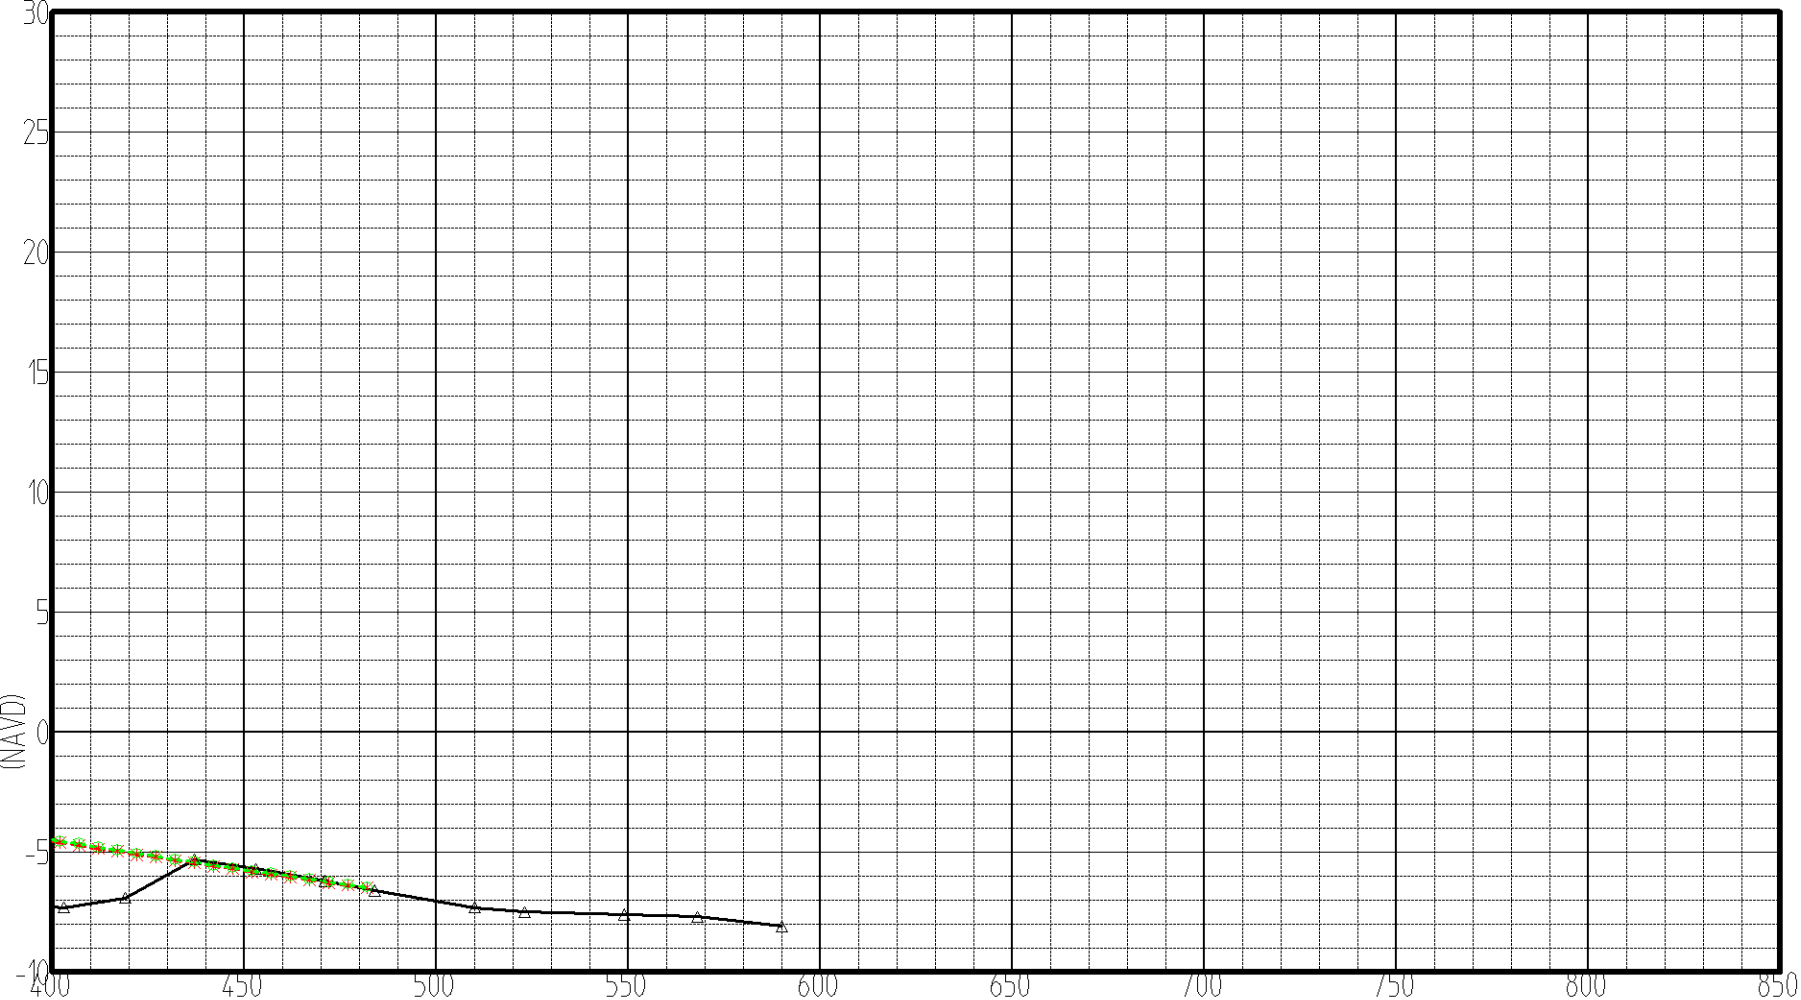
Range: R-166

—△—△— 2005-2008 INPUT PRF

- - - * - - - 15-YR SBEACH ERODED PRF

- - - o - - - 25-YR SBEACH ERODED PRF

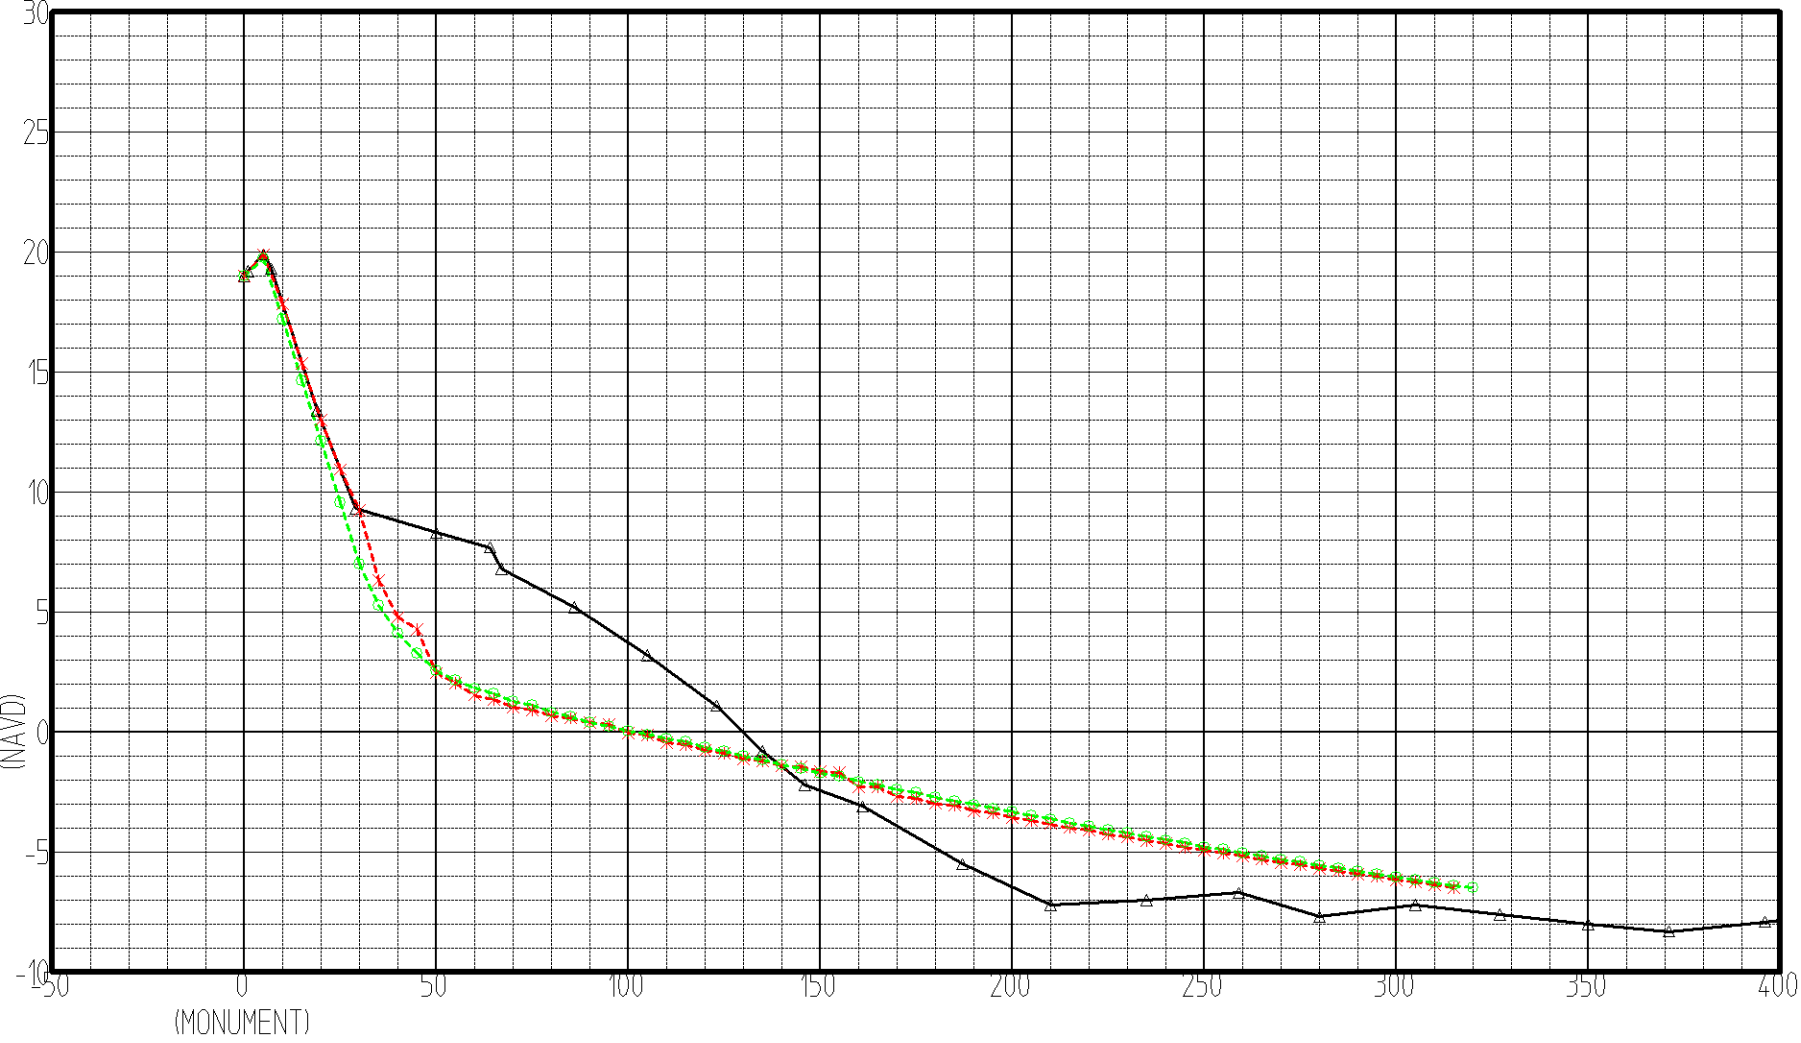
Range: R-167
 BEARING: 70.00
 1/2

BEACH PROFILE
 —△—△— 2005-2008 INPUT PRF
 - - * - - 15-YR SBEACH ERODED PRF
 - - o - - 25-YR SBEACH ERODED PRF

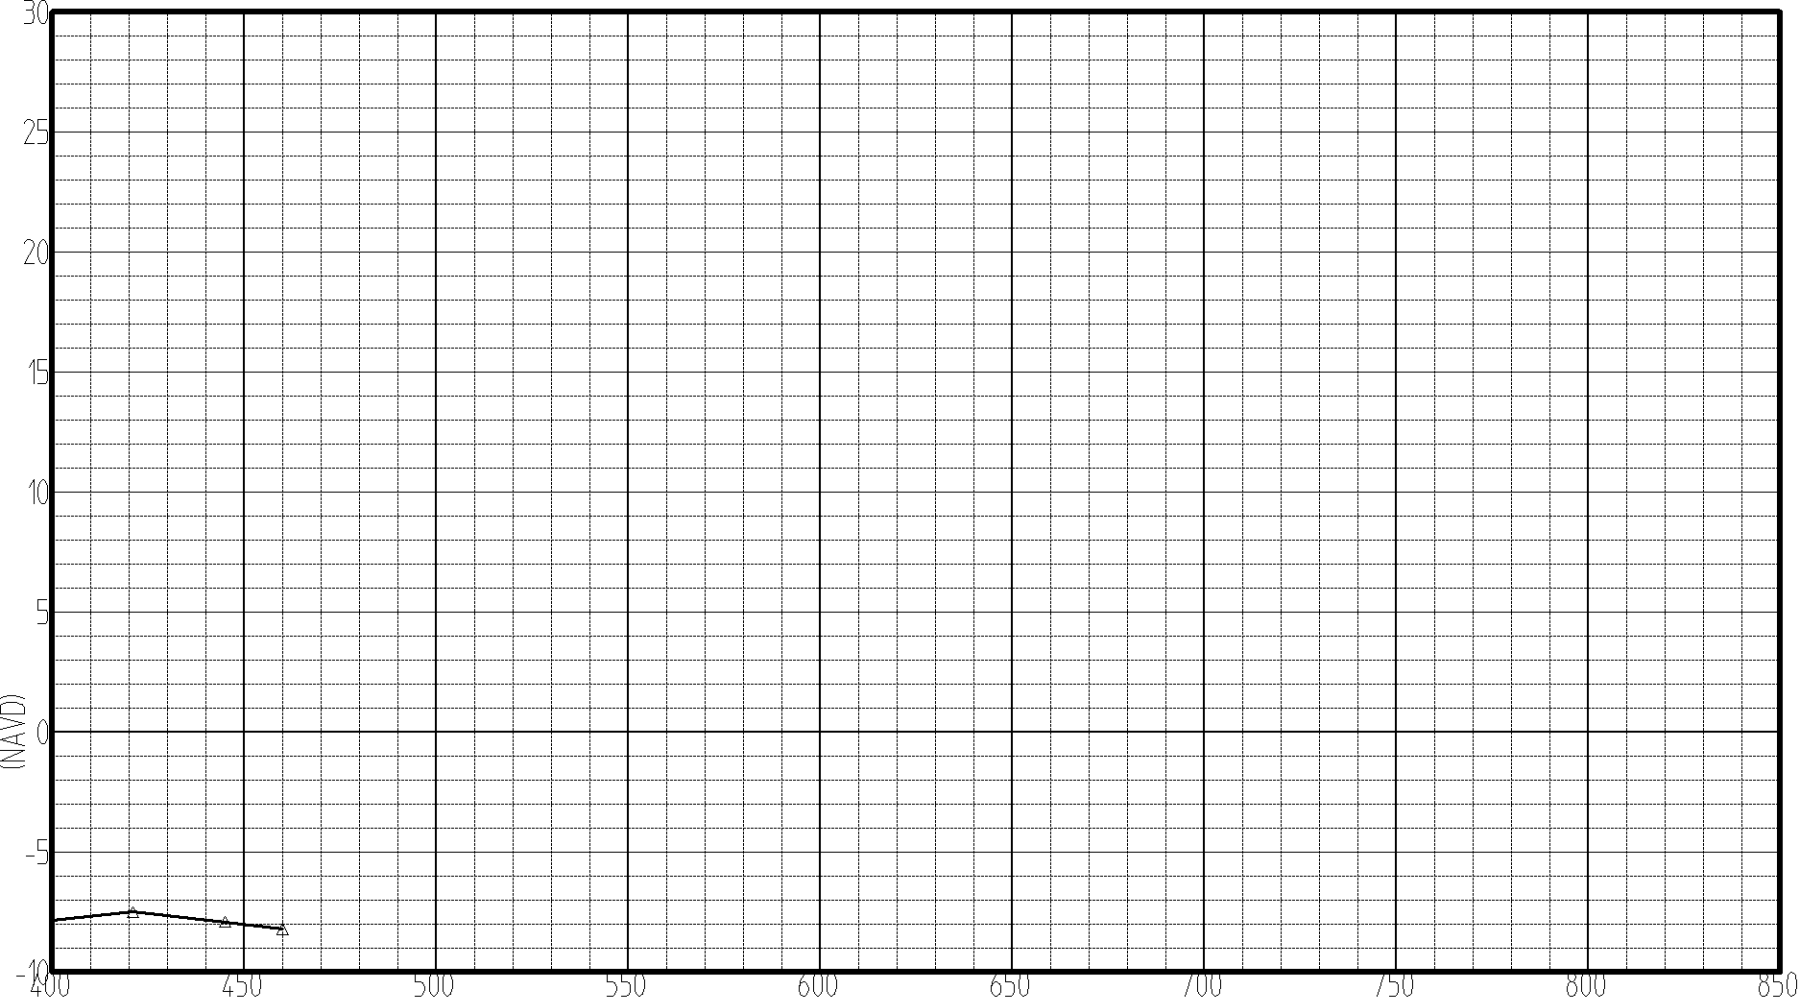
Range: R-167 2/2

- △—△— 2005-2008 INPUT PRF
- - - * - - - 15-YR SBEACH ERODED PRF
- - - o - - - 25-YR SBEACH ERODED PRF

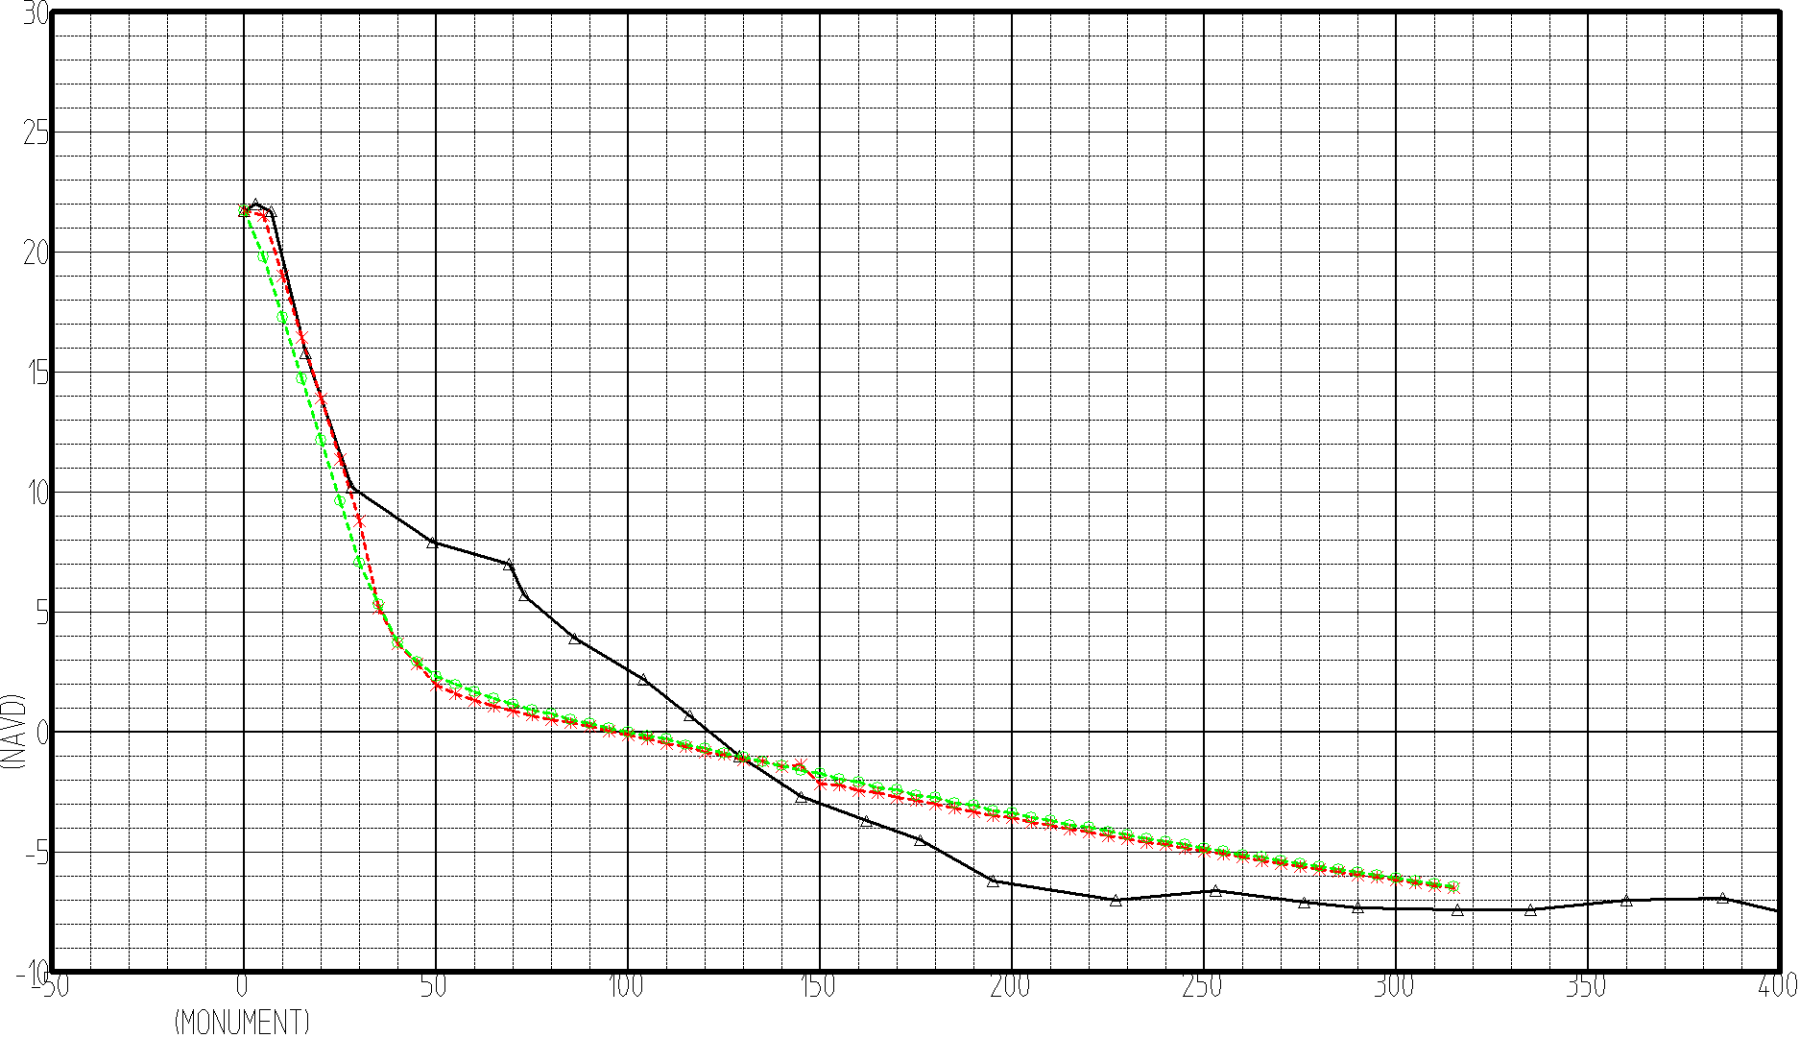
Range: R-168
 BEARING: 70.00
 1/2

BEACH PROFILE
 —△—△— 2005-2008 INPUT PRF
 - - * - - 15-YR SBEACH ERODED PRF
 - - o - - 25-YR SBEACH ERODED PRF

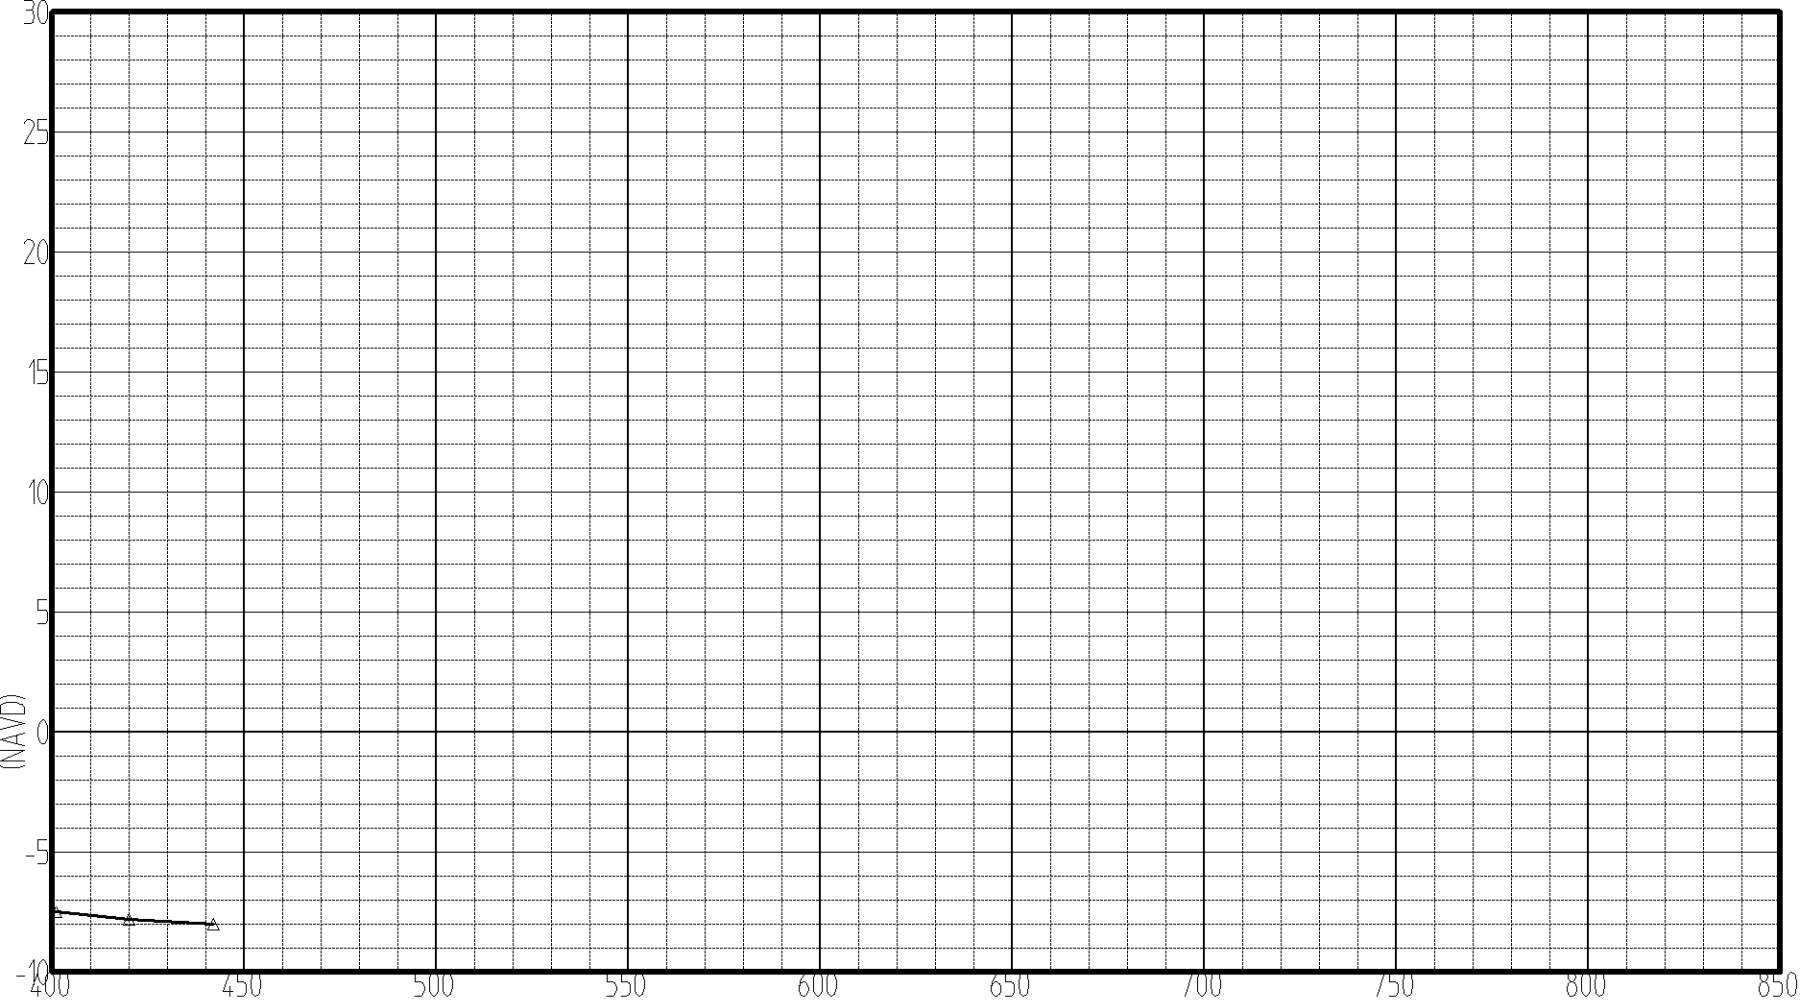
Range: R-168 2/2

- △—△— 2005-2008 INPUT PRF
- - - * - - - 15-YR SBEACH ERODED PRF
- - - o - - - 25-YR SBEACH ERODED PRF

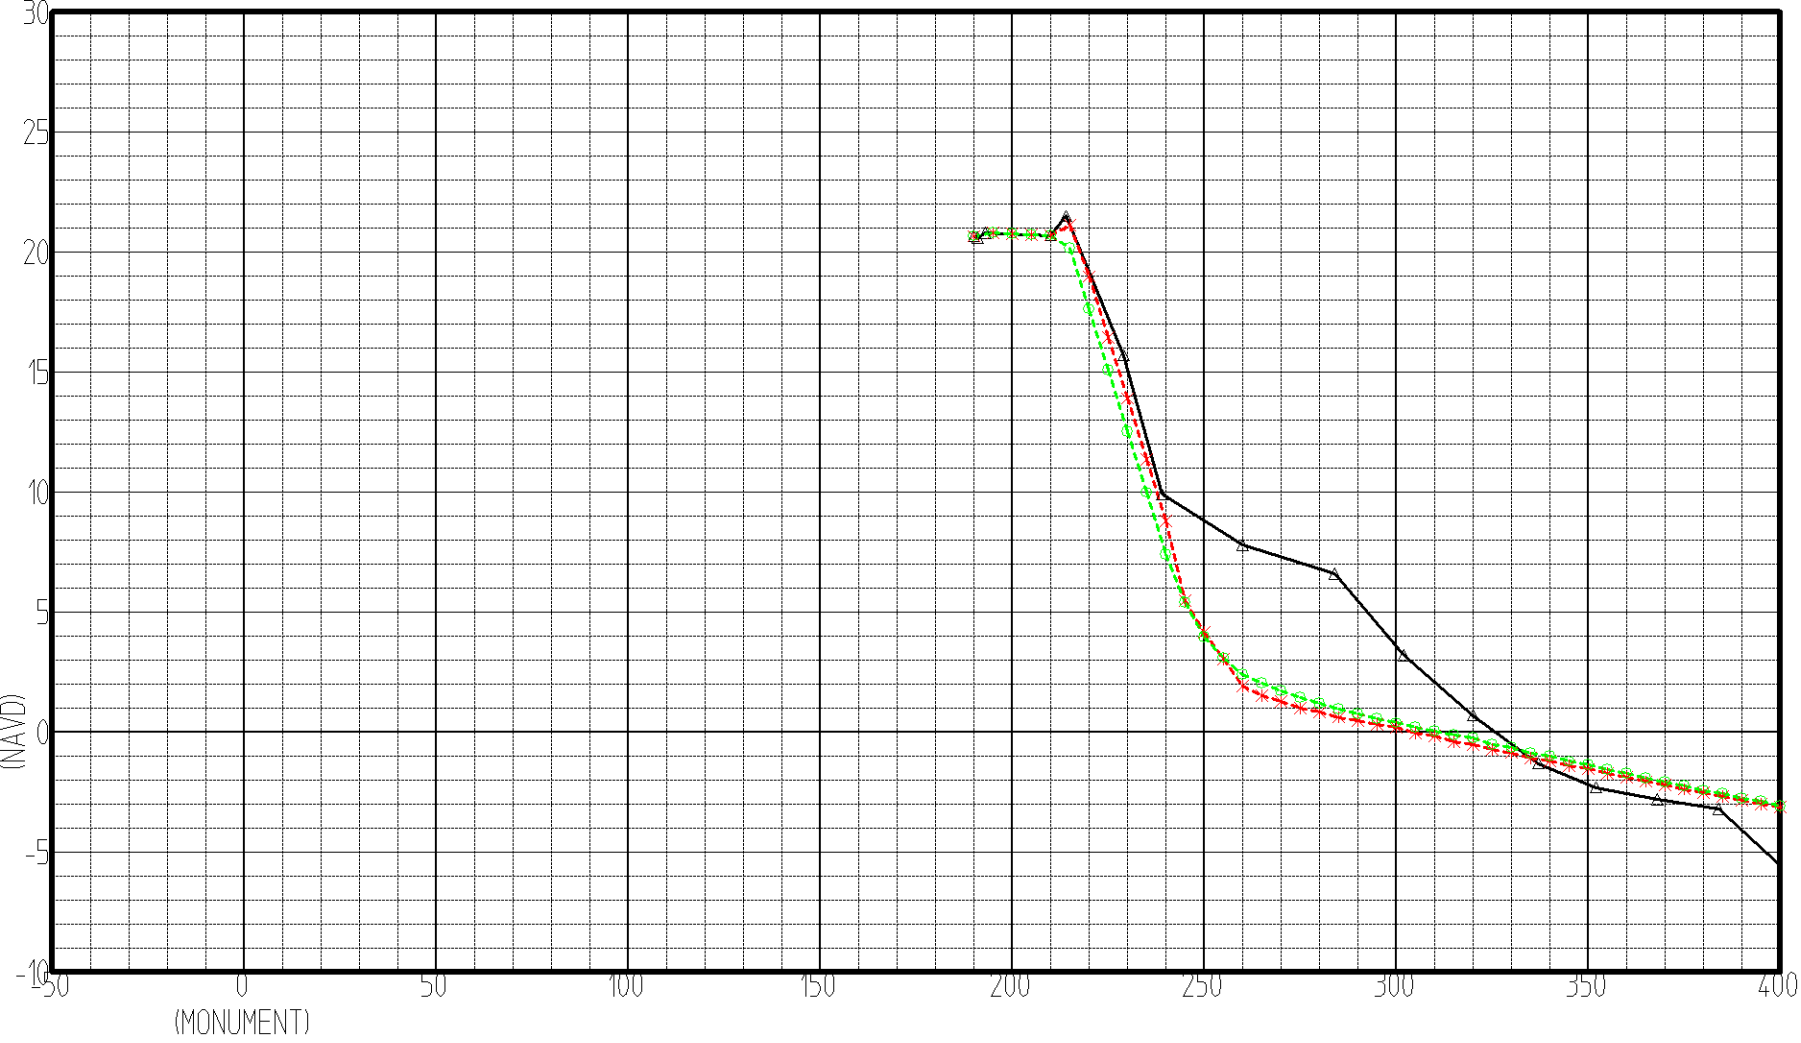
Range: R-169

—△—△— 2005-2008 INPUT PRF

- - * - - * - - 15-YR SBEACH ERODED PRF

- - ○ - - ○ - - 25-YR SBEACH ERODED PRF

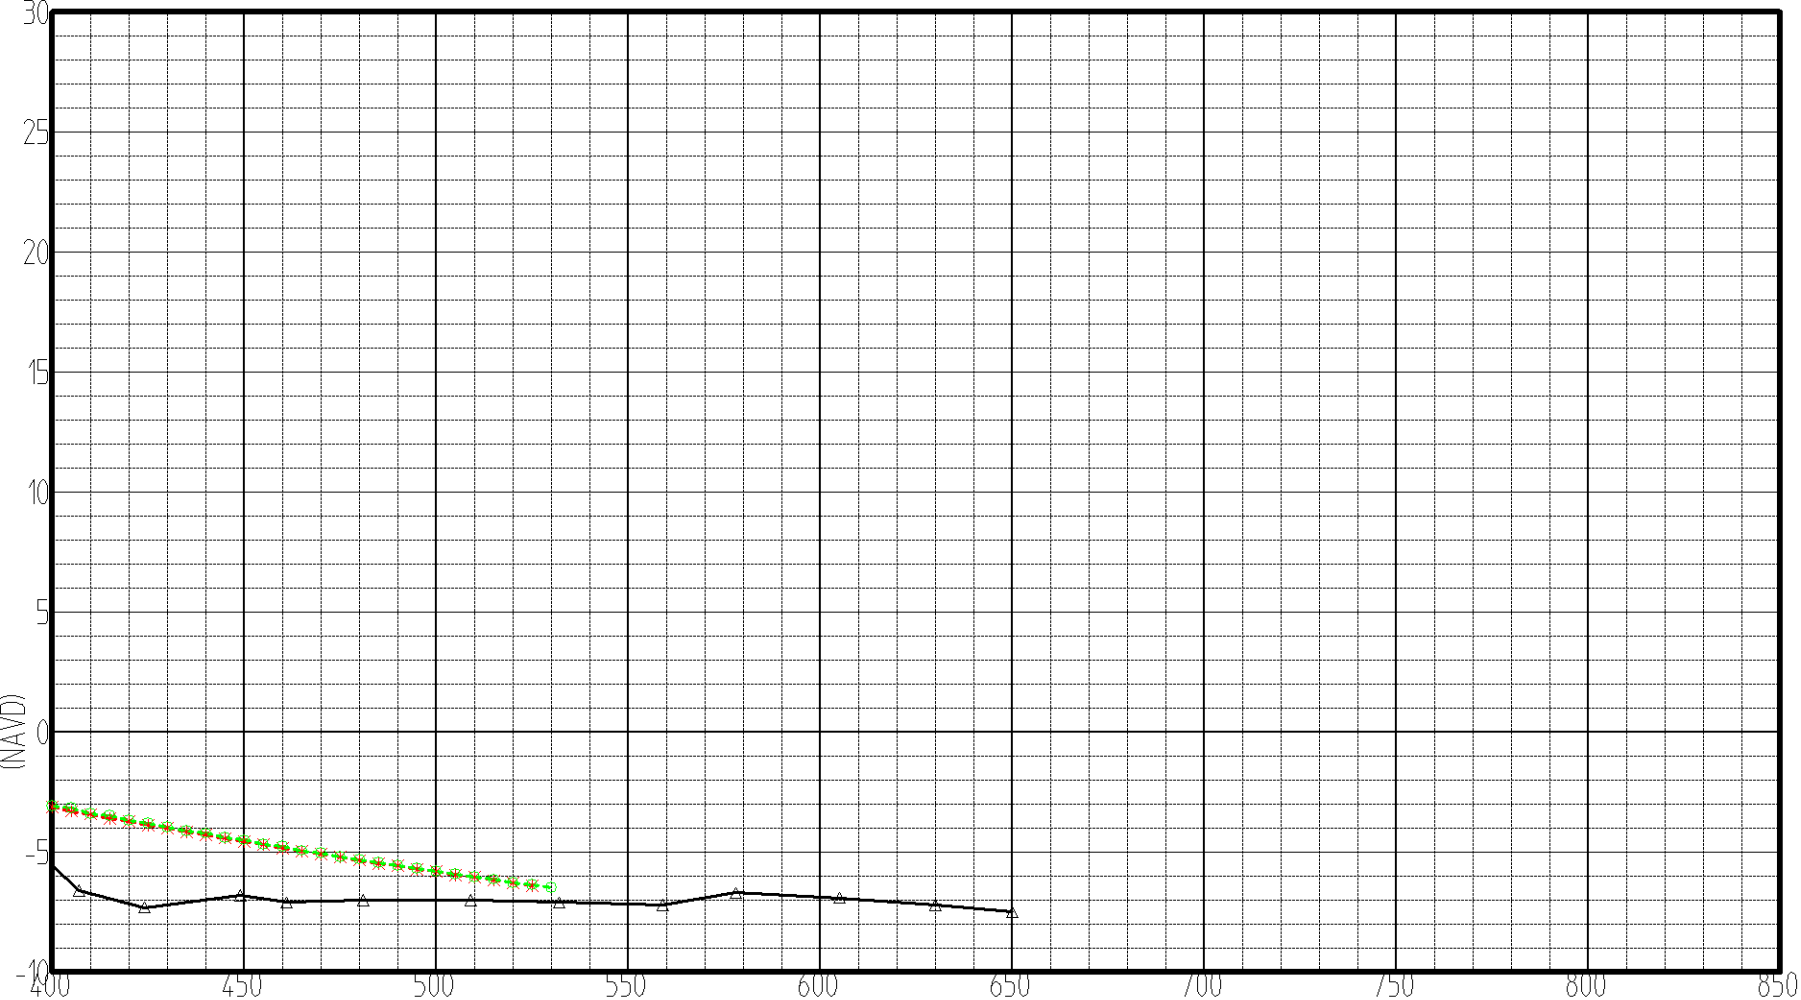
Range: R-169
 BEARING: 70.00
 2/2

BEACH PROFILE
 —△—△— 2005-2008 INPUT PRF
 - - * - - * - - 15-YR SBEACH ERODED PRF
 - - o - - o - - 25-YR SBEACH ERODED PRF

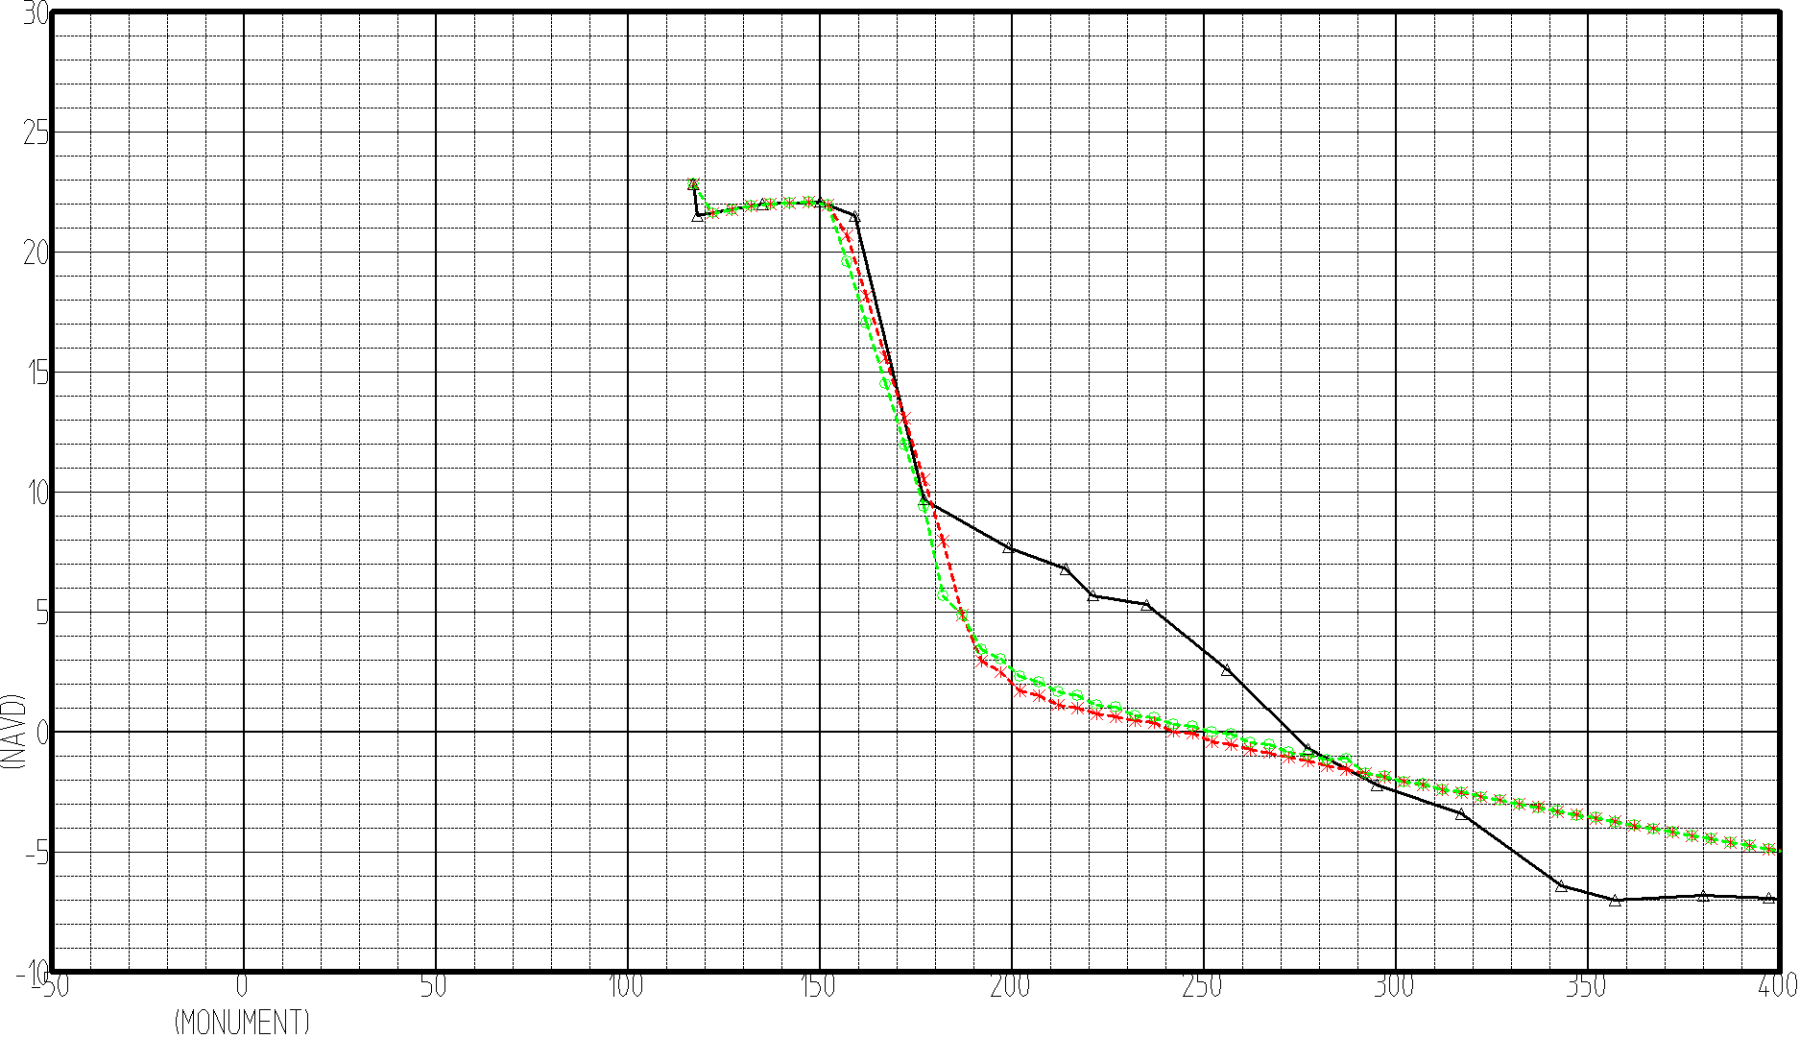
Range: R-170-T

—△—△— 2005-2008 INPUT PRF

- - * - - * - - 15-YR SBEACH ERODED PRF

- - o - - o - - 25-YR SBEACH ERODED PRF

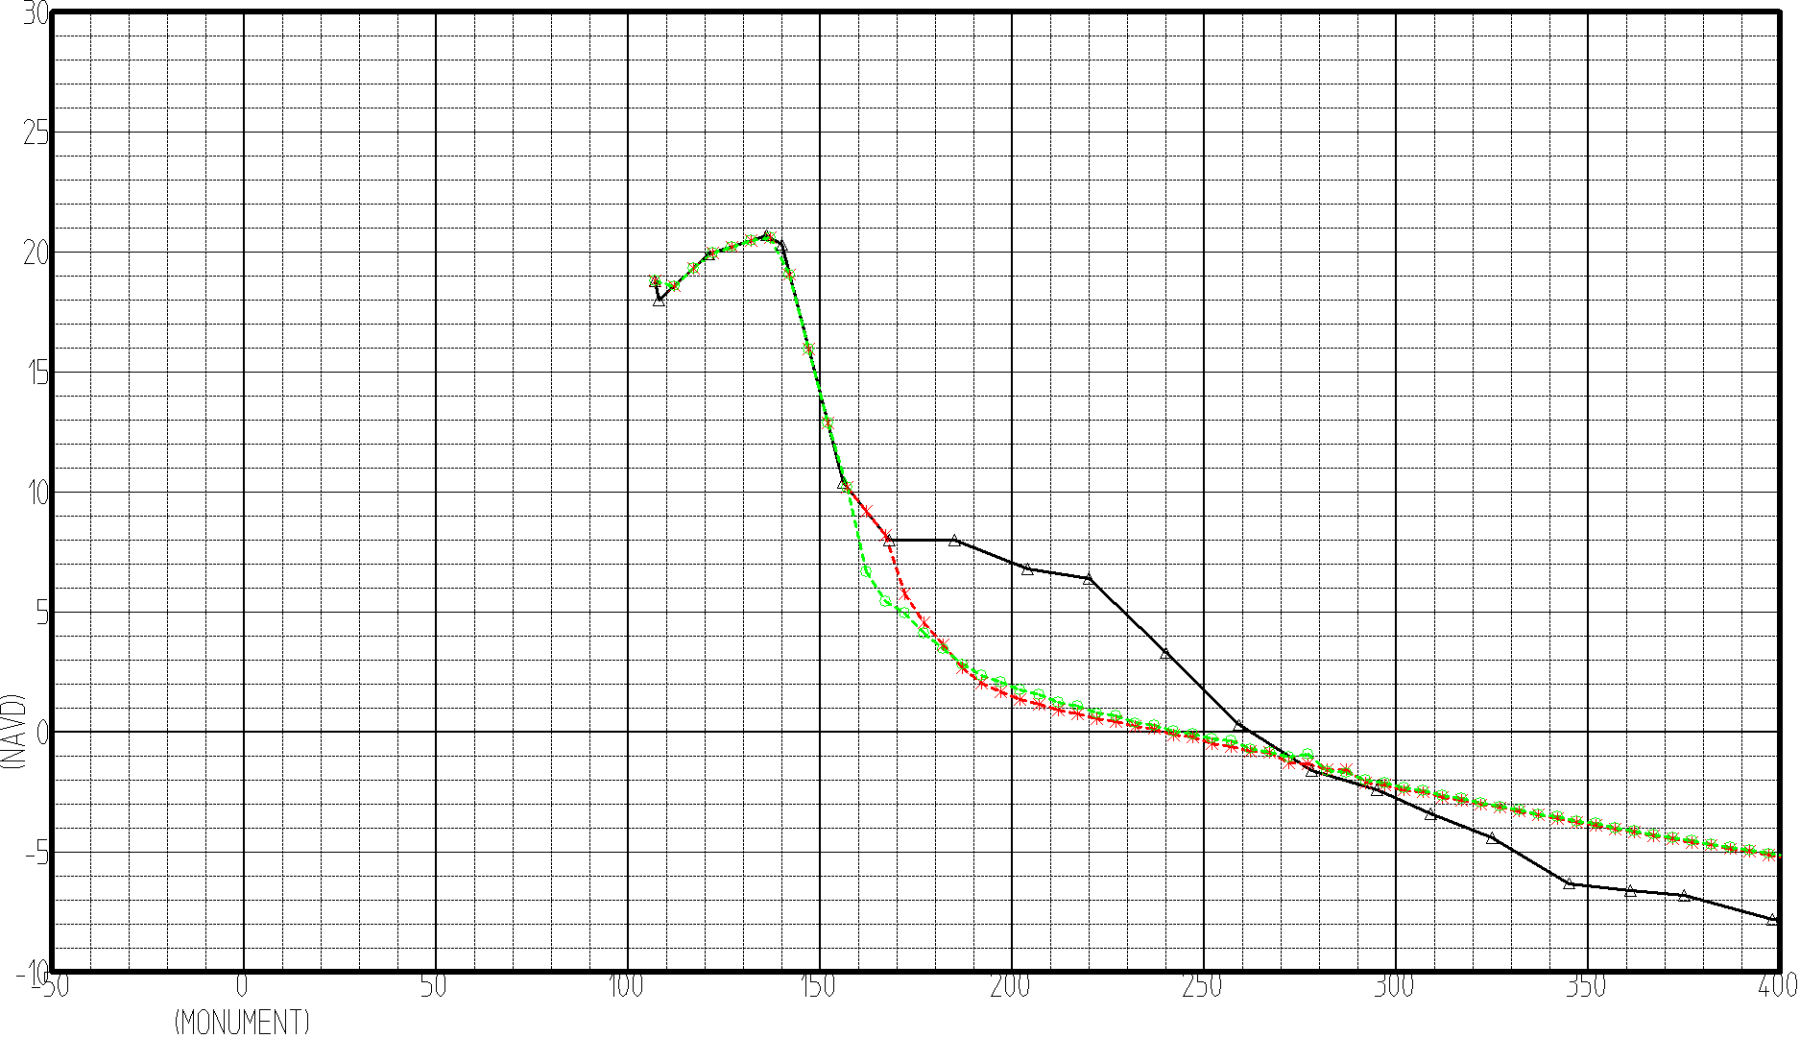
Range: R-171-T

BEACH PROFILE

—△—△— 2005-2008 INPUT PRF

- - - * - - - 15-YR SBEACH ERODED PRF

- - - o - - - 25-YR SBEACH ERODED PRF
