Appendix XI

SBEACH 15 and 25 yr. Storm Erosion Profiles

Brevard County

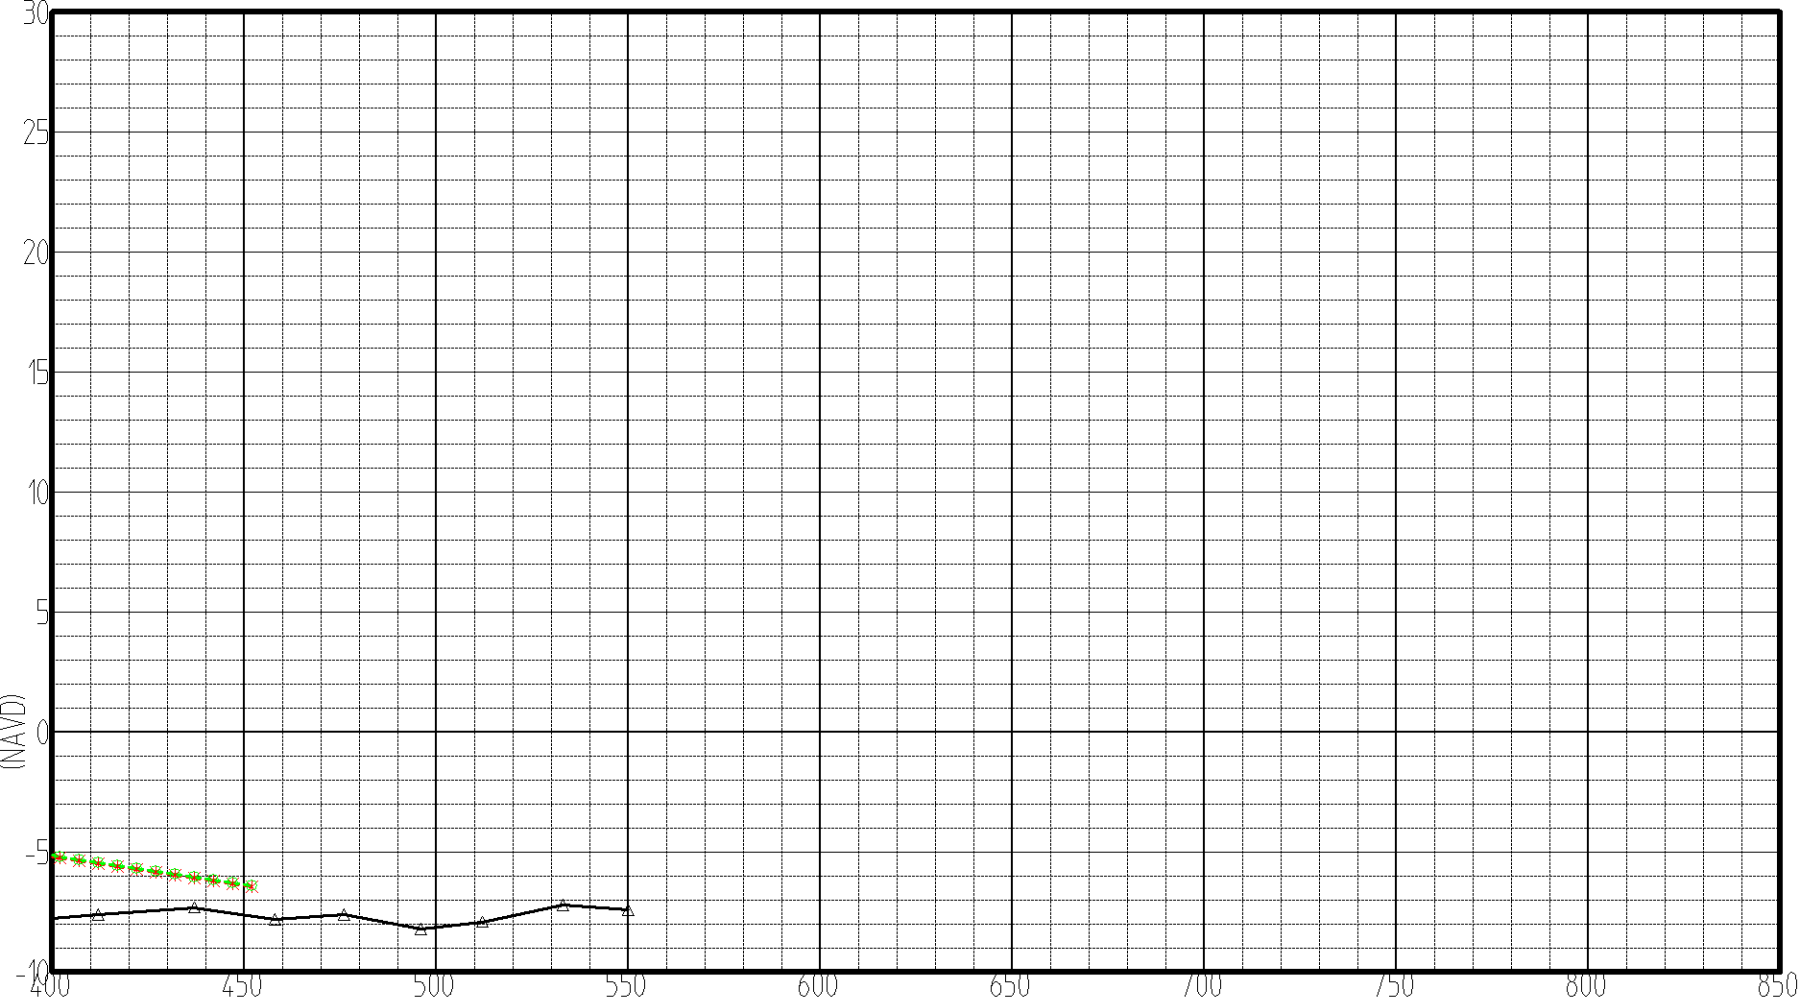
Range: R-171-T 2/2

BEACH PROFILE

—△—△— 2005-2008 INPUT PRF

- - - * - - - 15-YR SBEACH ERODED PRF

- - - o - - - 25-YR SBEACH ERODED PRF

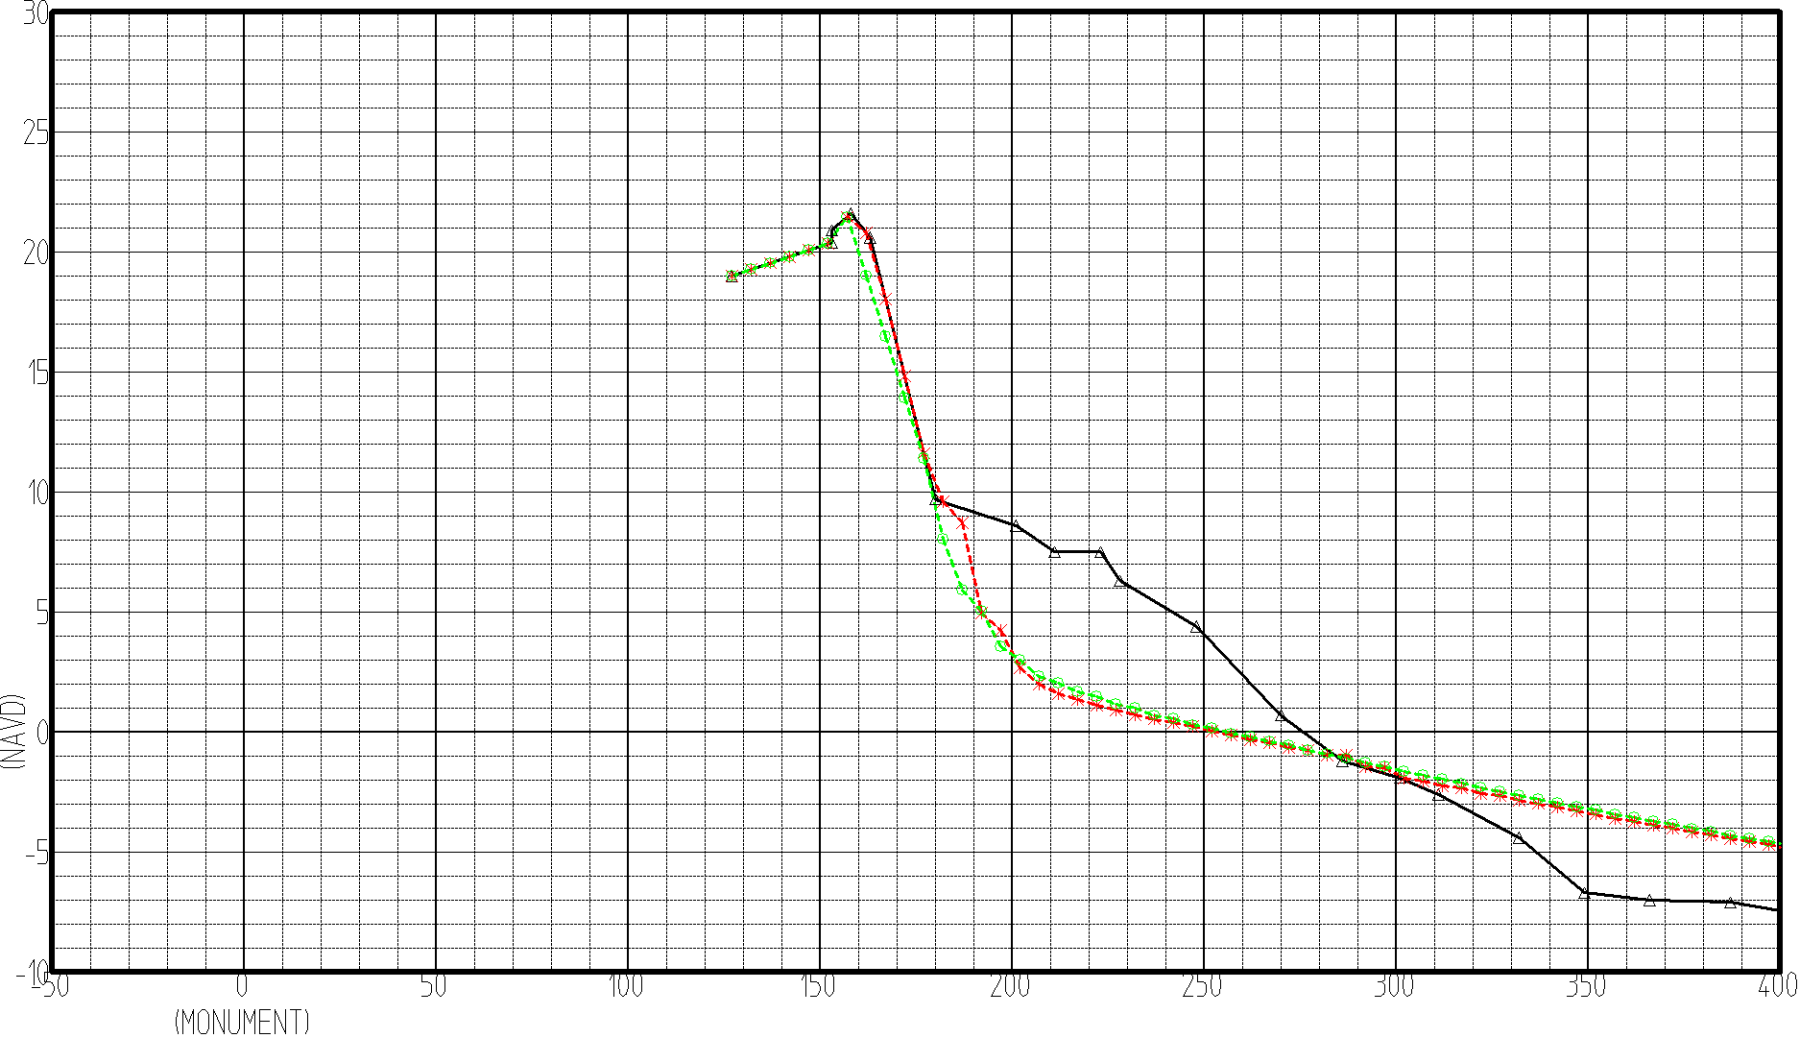
Range: R-172

BEACH PROFILE

—△—△— 2005-2008 INPUT PRF

- - - * - - - 15-YR SBEACH ERODED PRF

- - - o - - - 25-YR SBEACH ERODED PRF

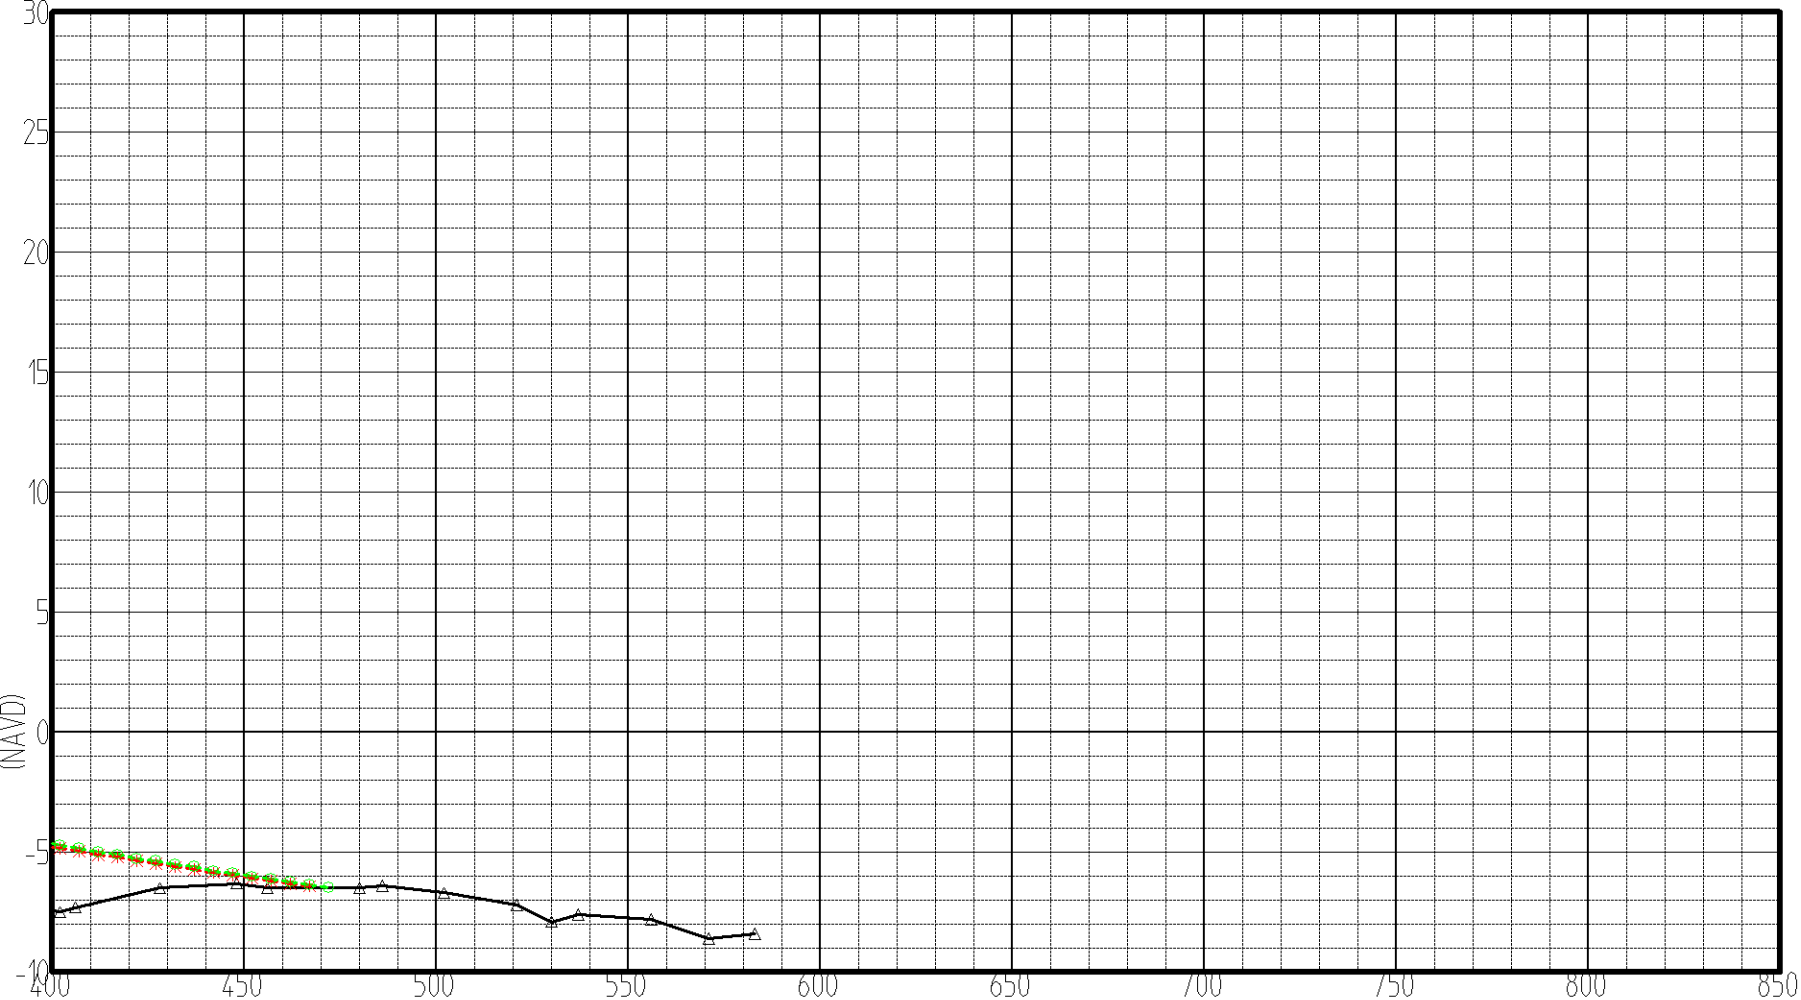
Range: R-172
 BEARING: 70.00
 2/2

BEACH PROFILE
 —△—△— 2005-2008 INPUT PRF
 - - * - - * - - 15-YR SBEACH ERODED PRF
 - - o - - o - - 25-YR SBEACH ERODED PRF

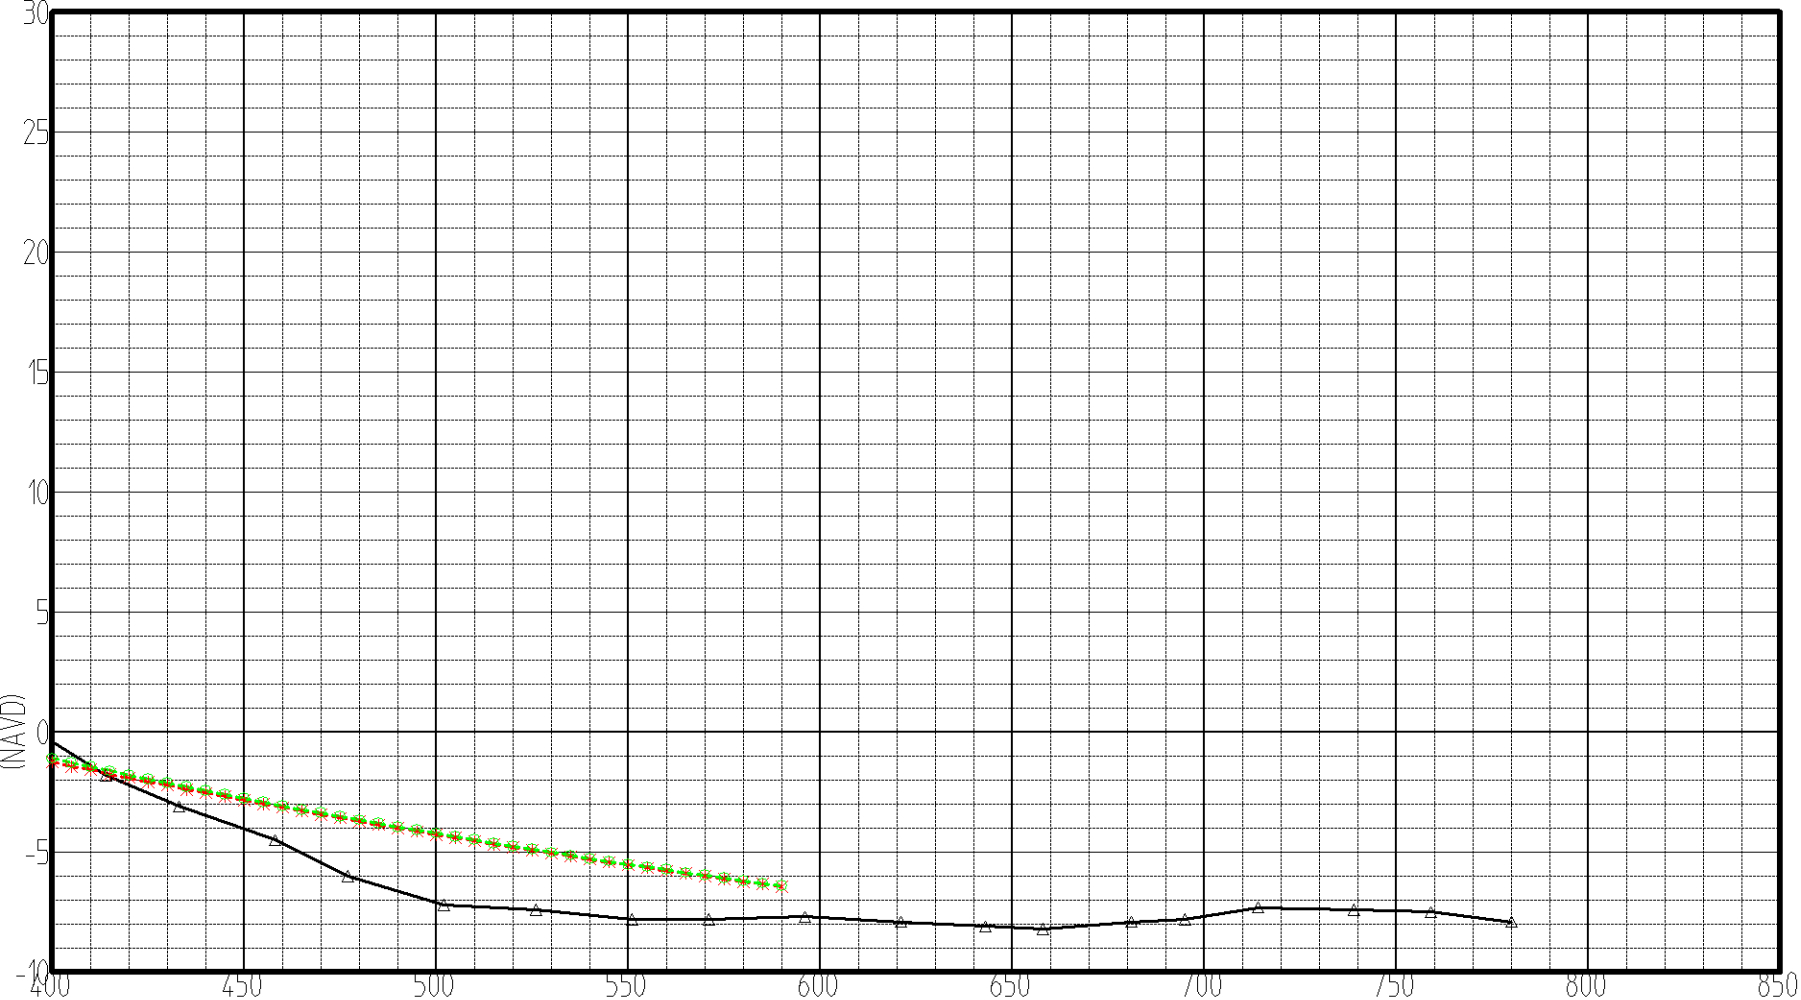
Range: R-173

BEACH PROFILE

—△—△— 2005-2008 INPUT PRF
 - - - * - - - 15-YR SBEACH ERODED PRF
 - - - o - - - 25-YR SBEACH ERODED PRF

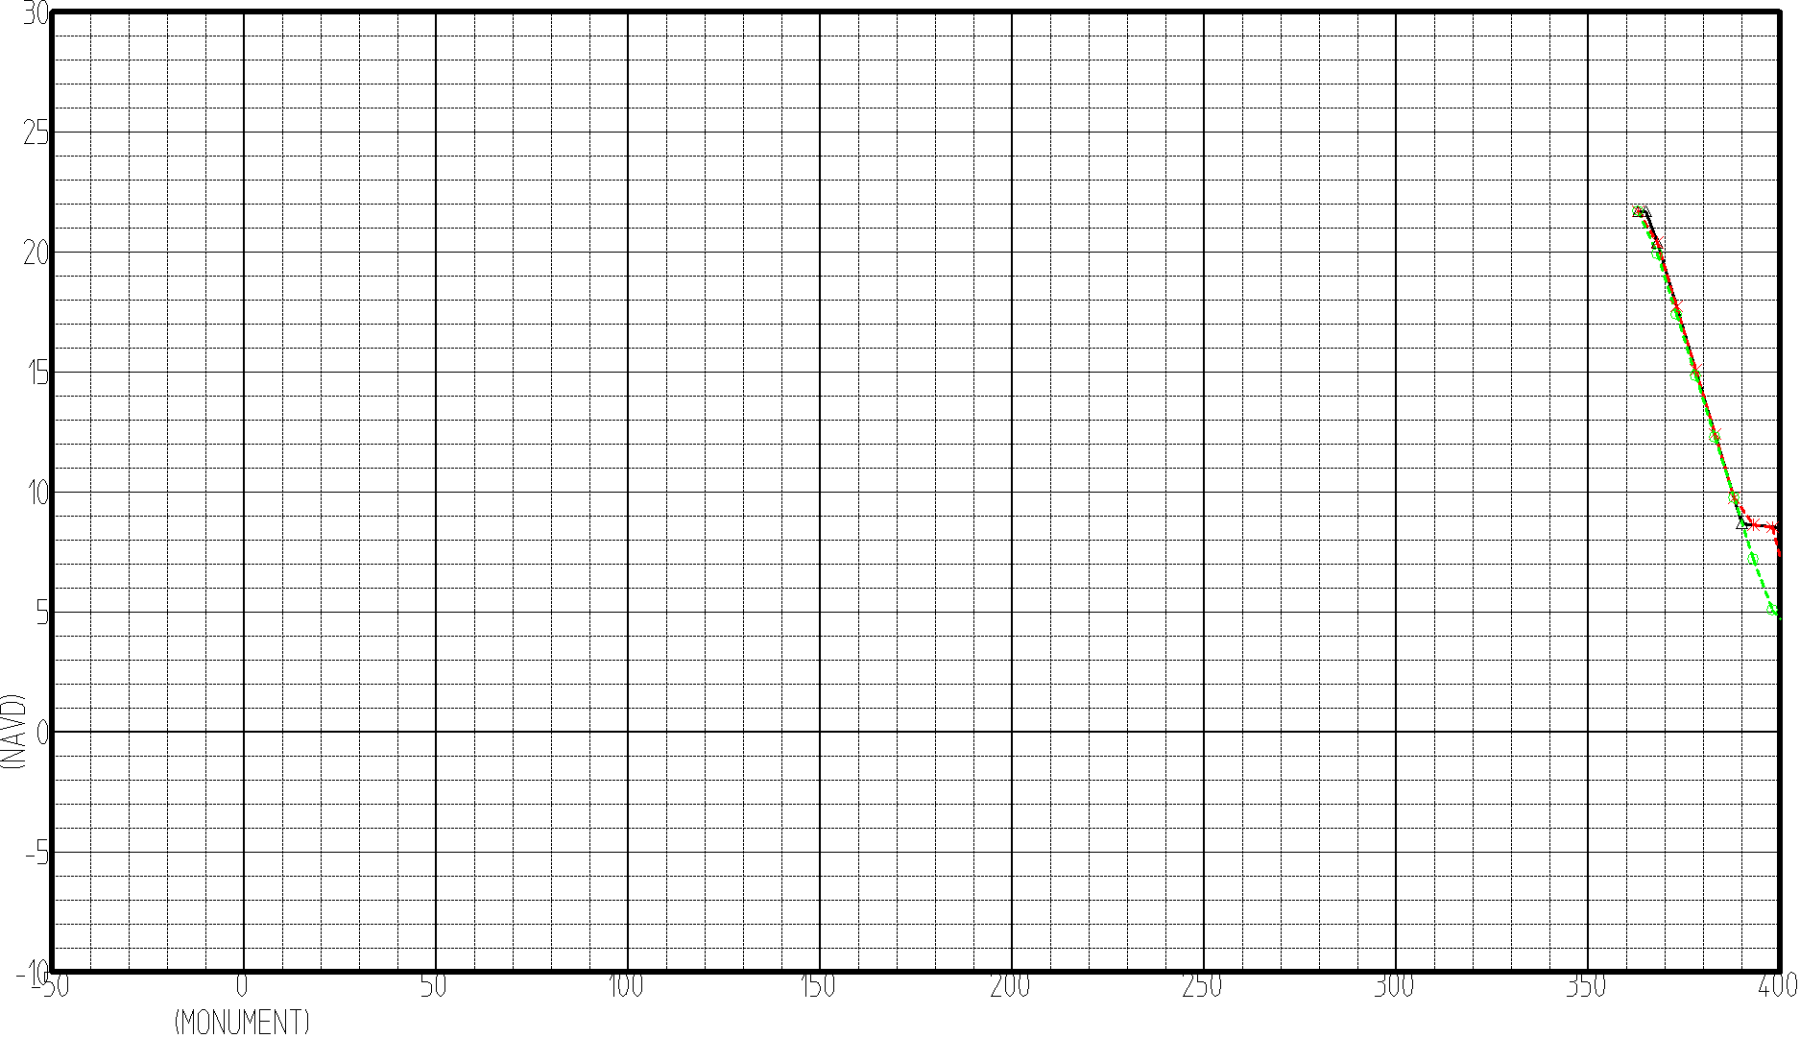
Range: R-174

BEACH PROFILE

—△—△— 2005-2008 INPUT PRF

- - - * - - - 15-YR SBEACH ERODED PRF

- - - o - - - 25-YR SBEACH ERODED PRF

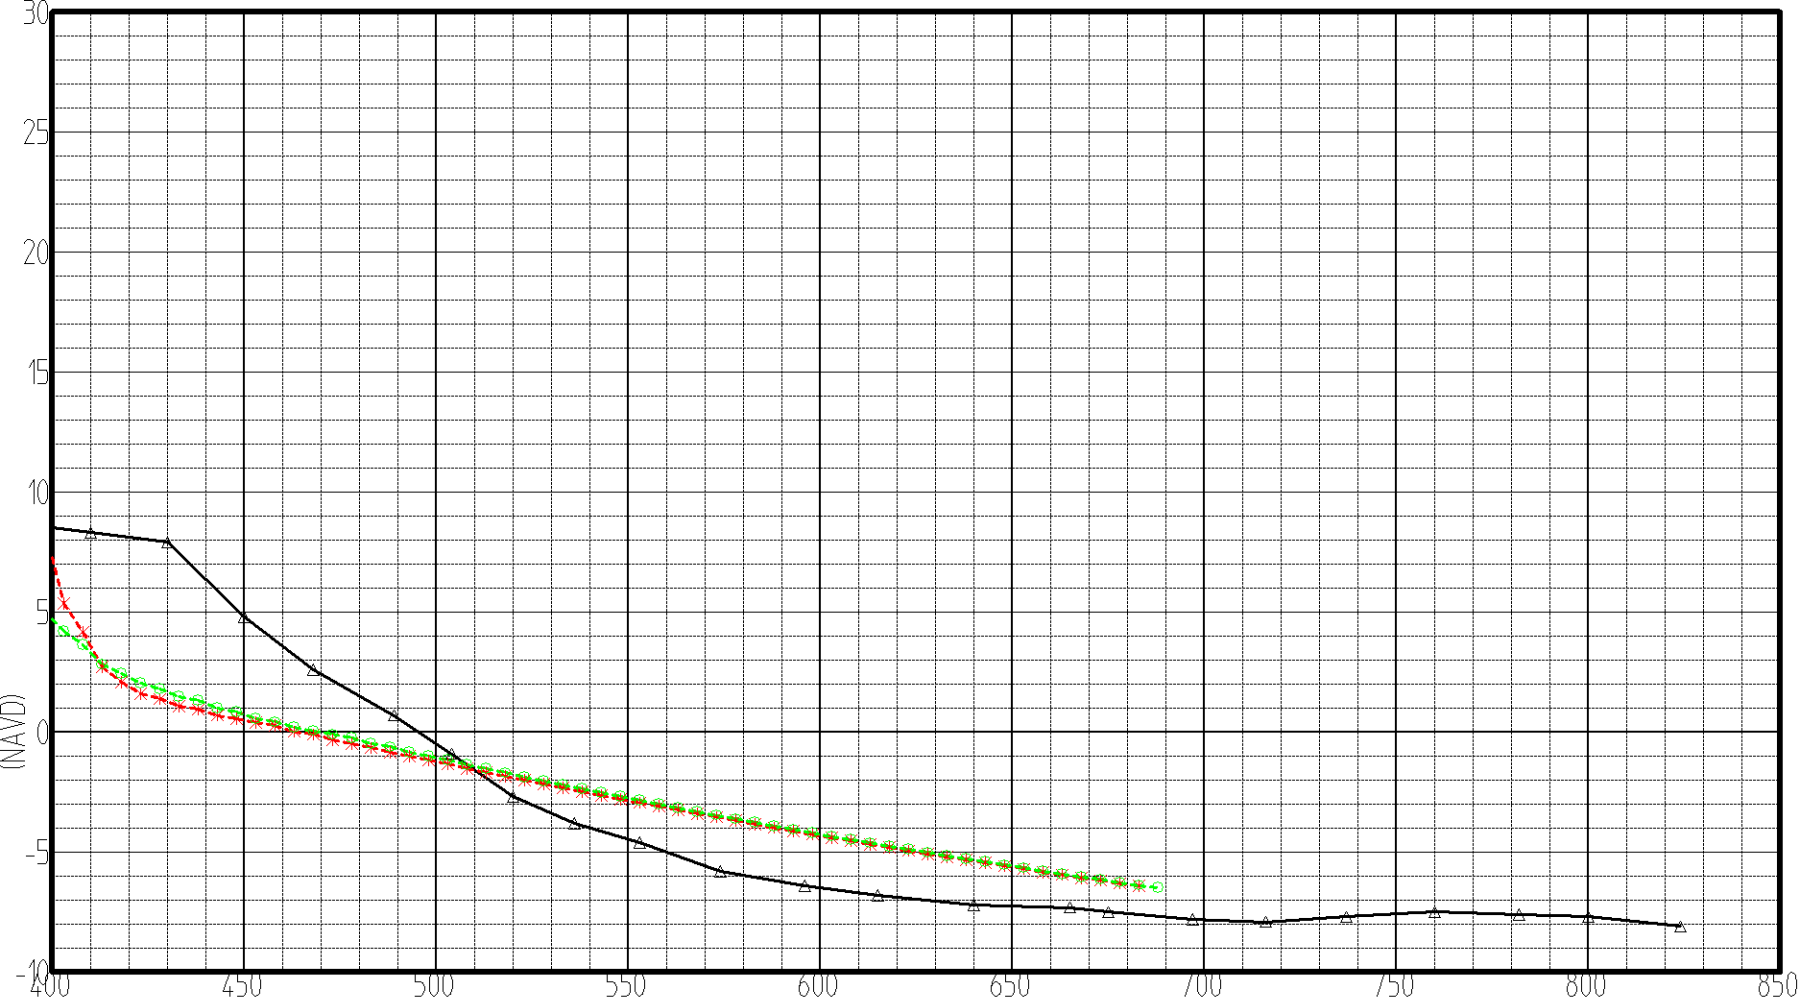
Range: R-174

BEACH PROFILE

—△—△— 2005-2008 INPUT PRF

- - - * - - - 15-YR SBEACH ERODED PRF

- - - o - - - 25-YR SBEACH ERODED PRF

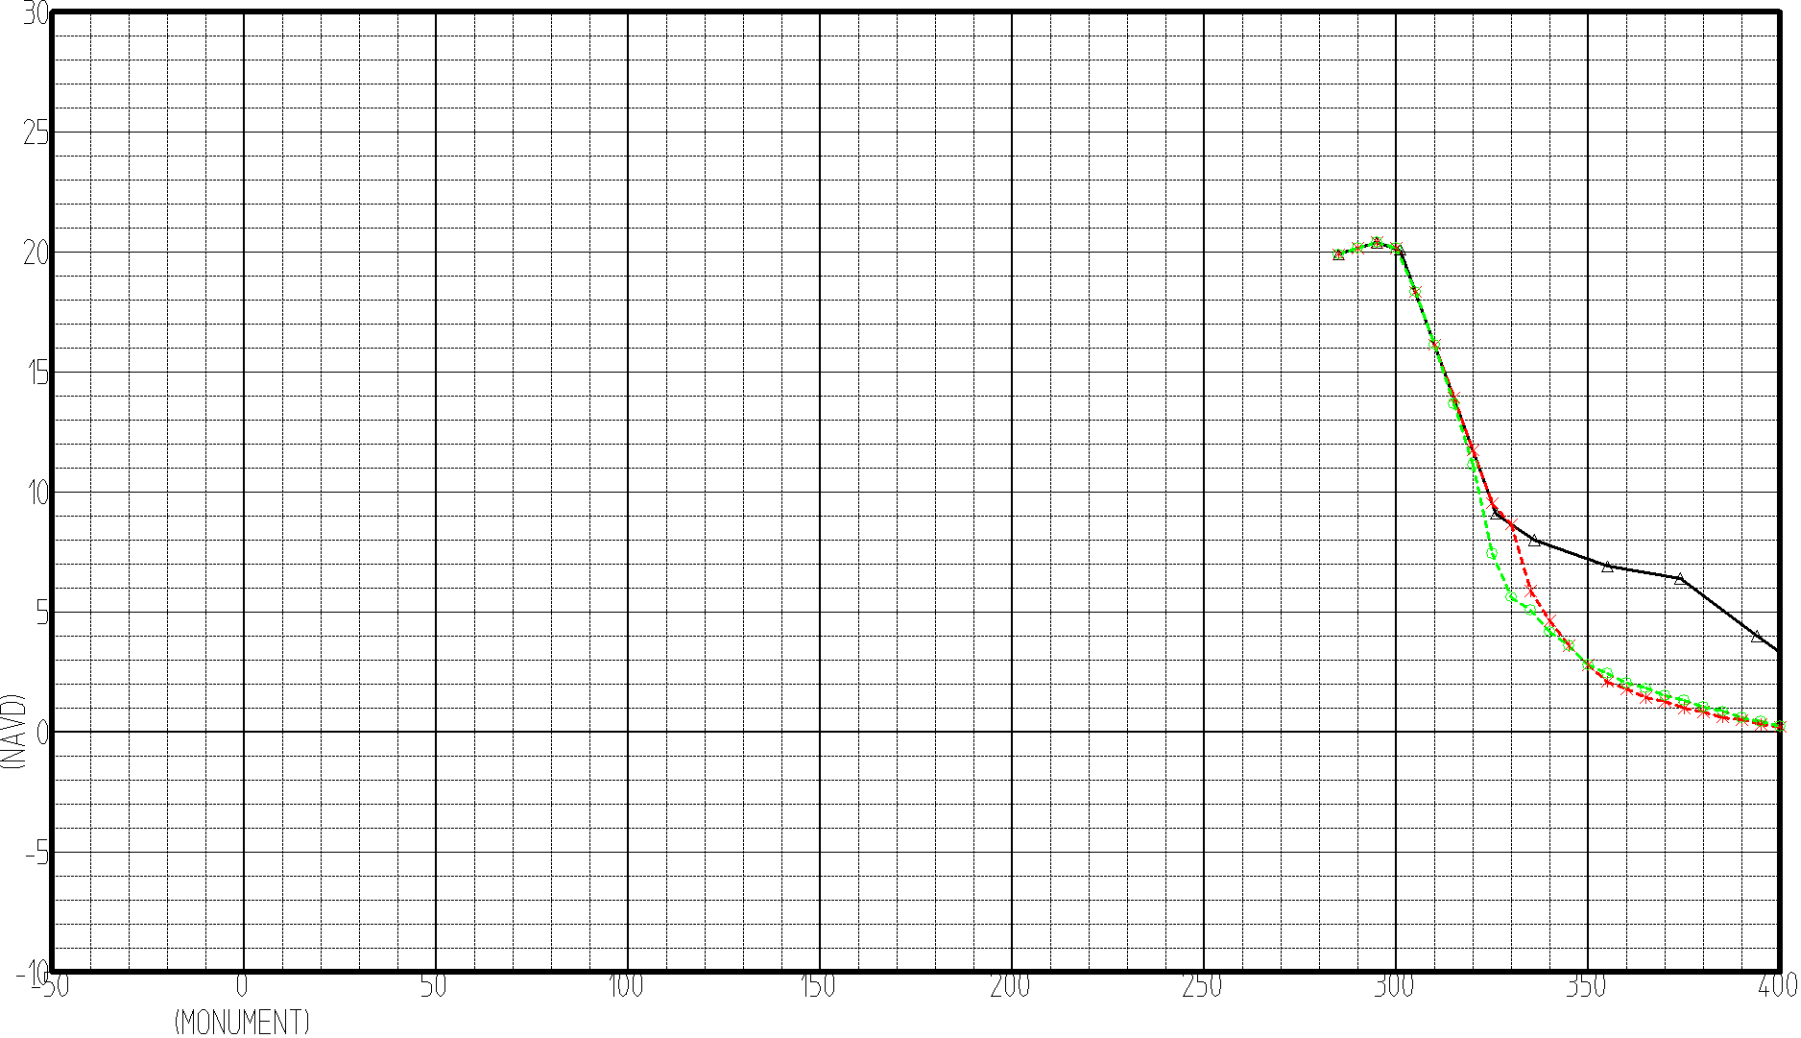
Range: R-175-T 1/2

BEACH PROFILE

—△—△— 2005-2008 INPUT PRF

- - - * - - - 15-YR SBEACH ERODED PRF

- - - o - - - 25-YR SBEACH ERODED PRF

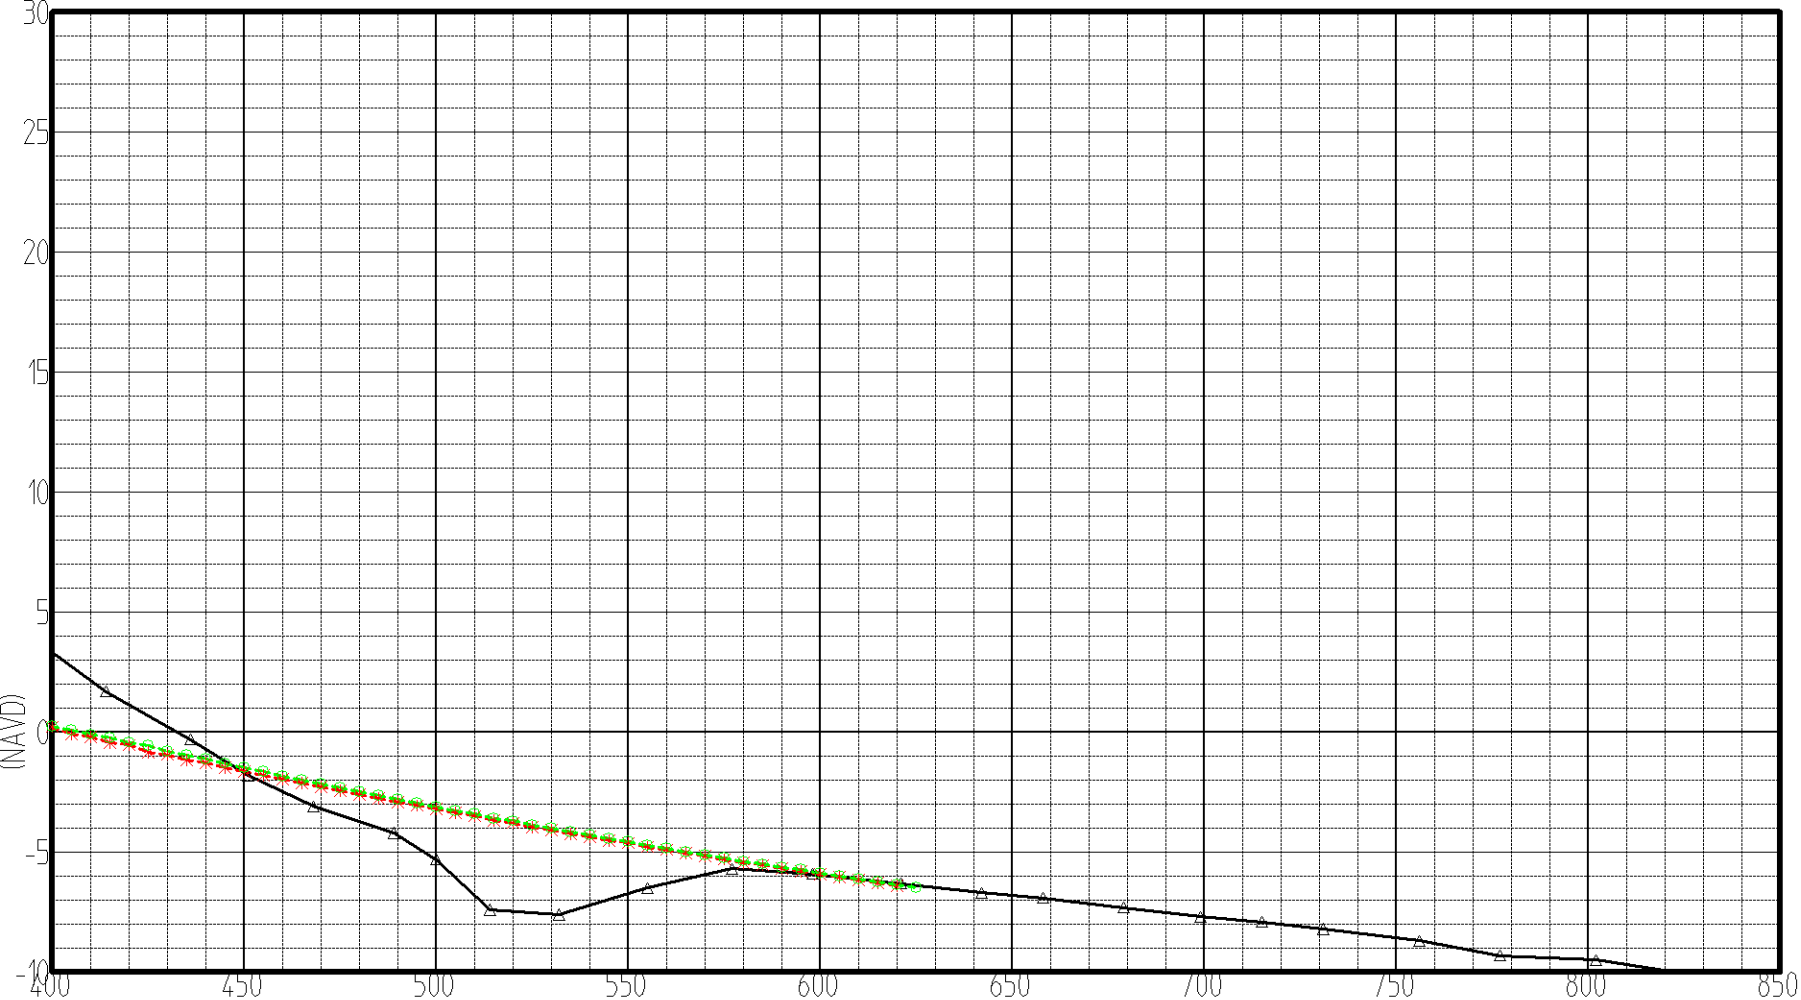
Range: R-175-T 2/2
 BEARING: 70.00

BEACH PROFILE
 —△—△— 2005-2008 INPUT PRF
 - - * - - * - - 15-YR SBEACH ERODED PRF
 - - o - - o - - 25-YR SBEACH ERODED PRF

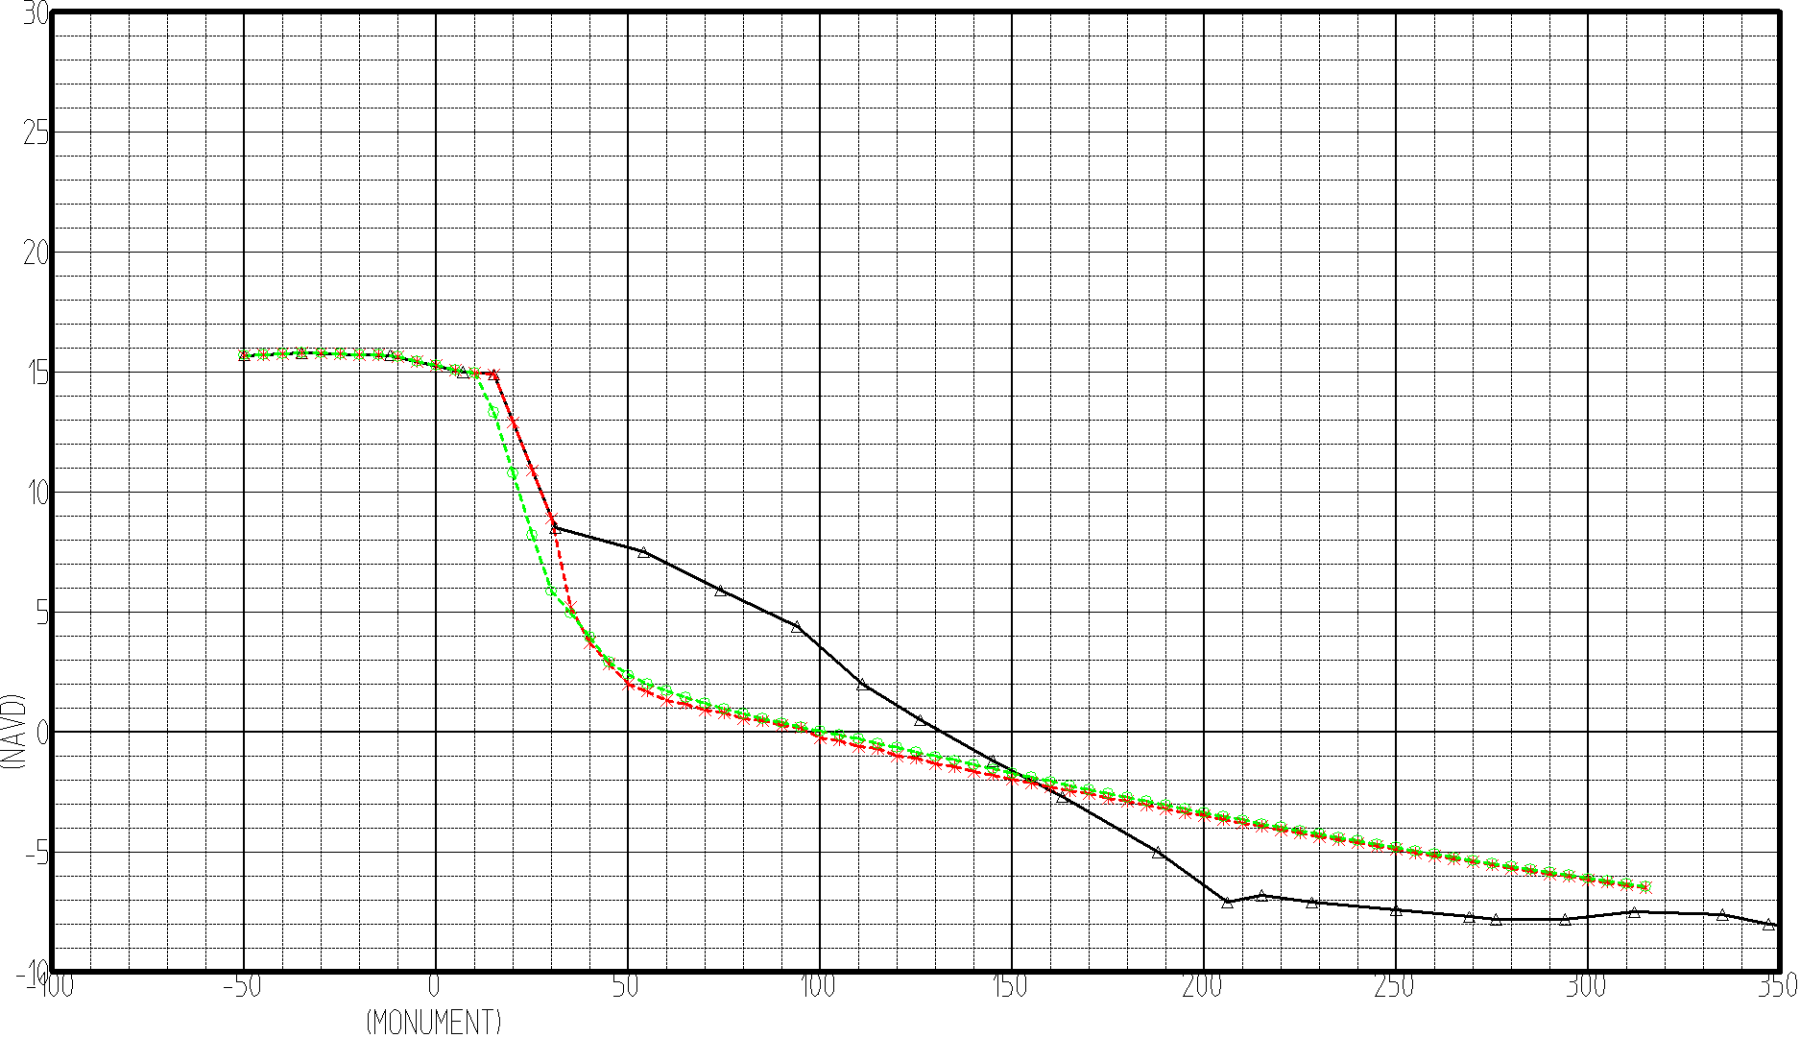
Range: R-176

BEACH PROFILE

—△—△— 2005-2008 INPUT PRF

- - - * - - - 15-YR SBEACH ERODED PRF

- - - o - - - 25-YR SBEACH ERODED PRF

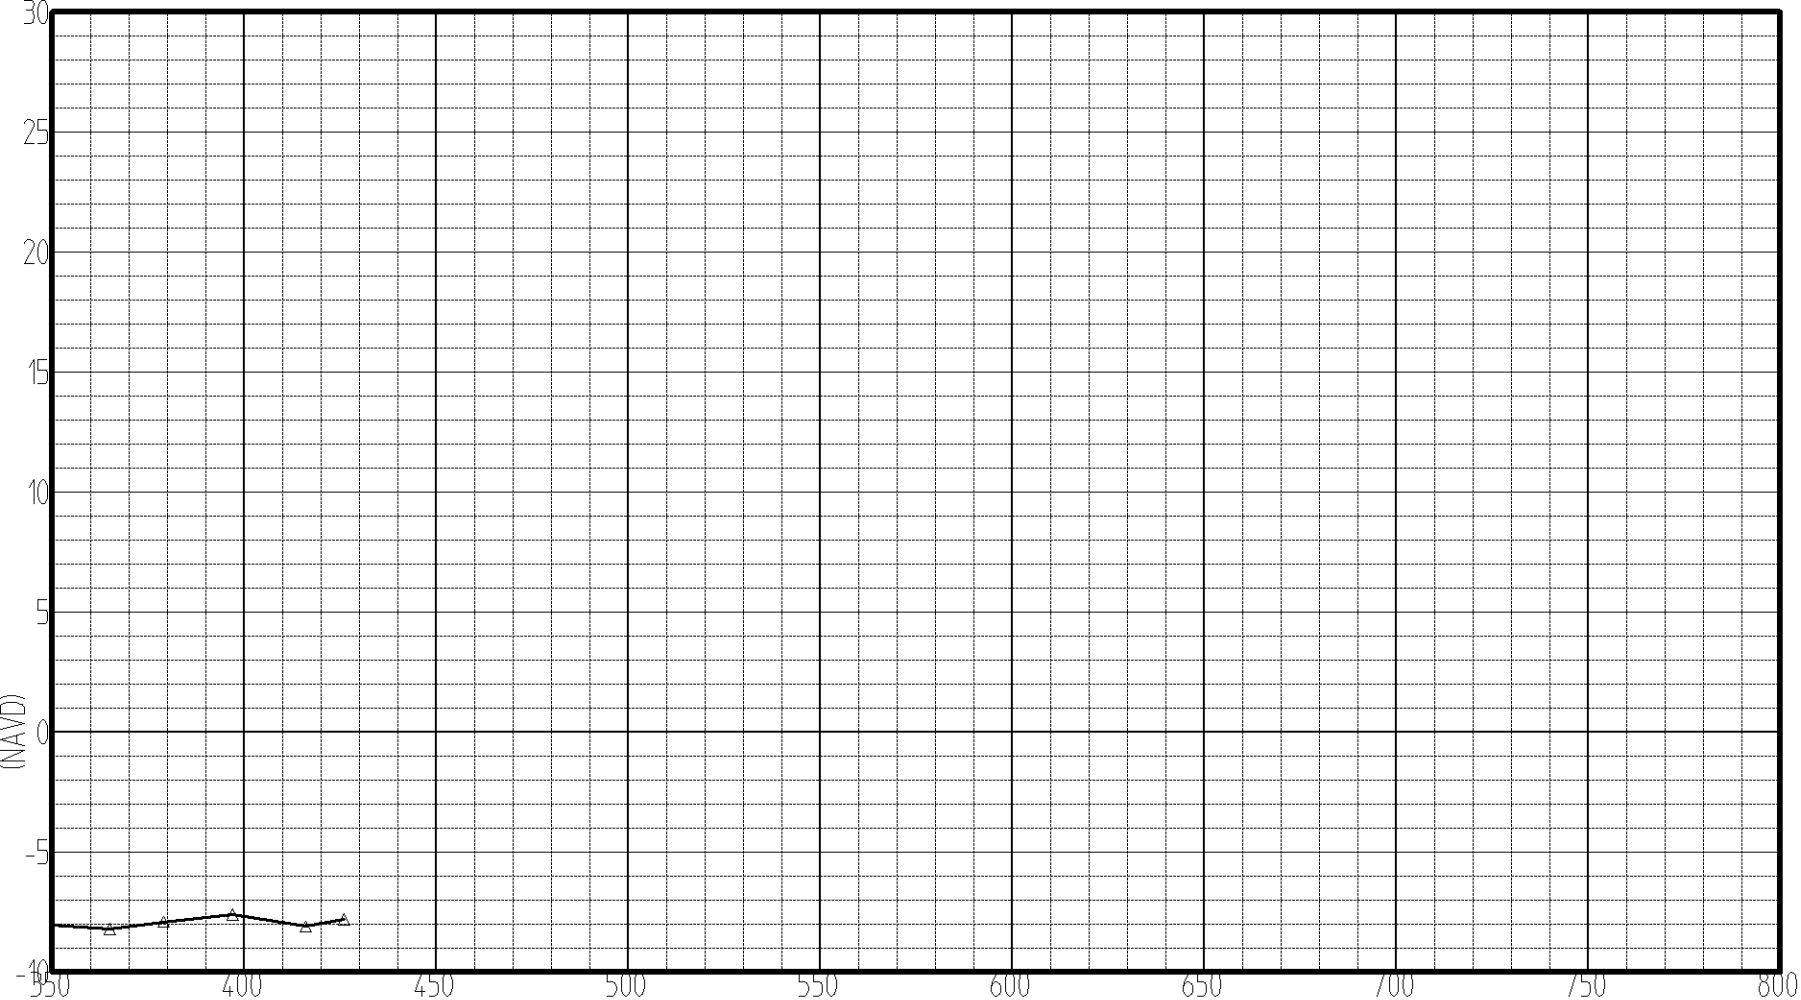
Range: R-176
 BEARING: 70.00
 2/2

BEACH PROFILE
 —△—△— 2005-2008 INPUT PRF
 - - * - - * - - 15-YR SBEACH ERODED PRF
 - - o - - o - - 25-YR SBEACH ERODED PRF

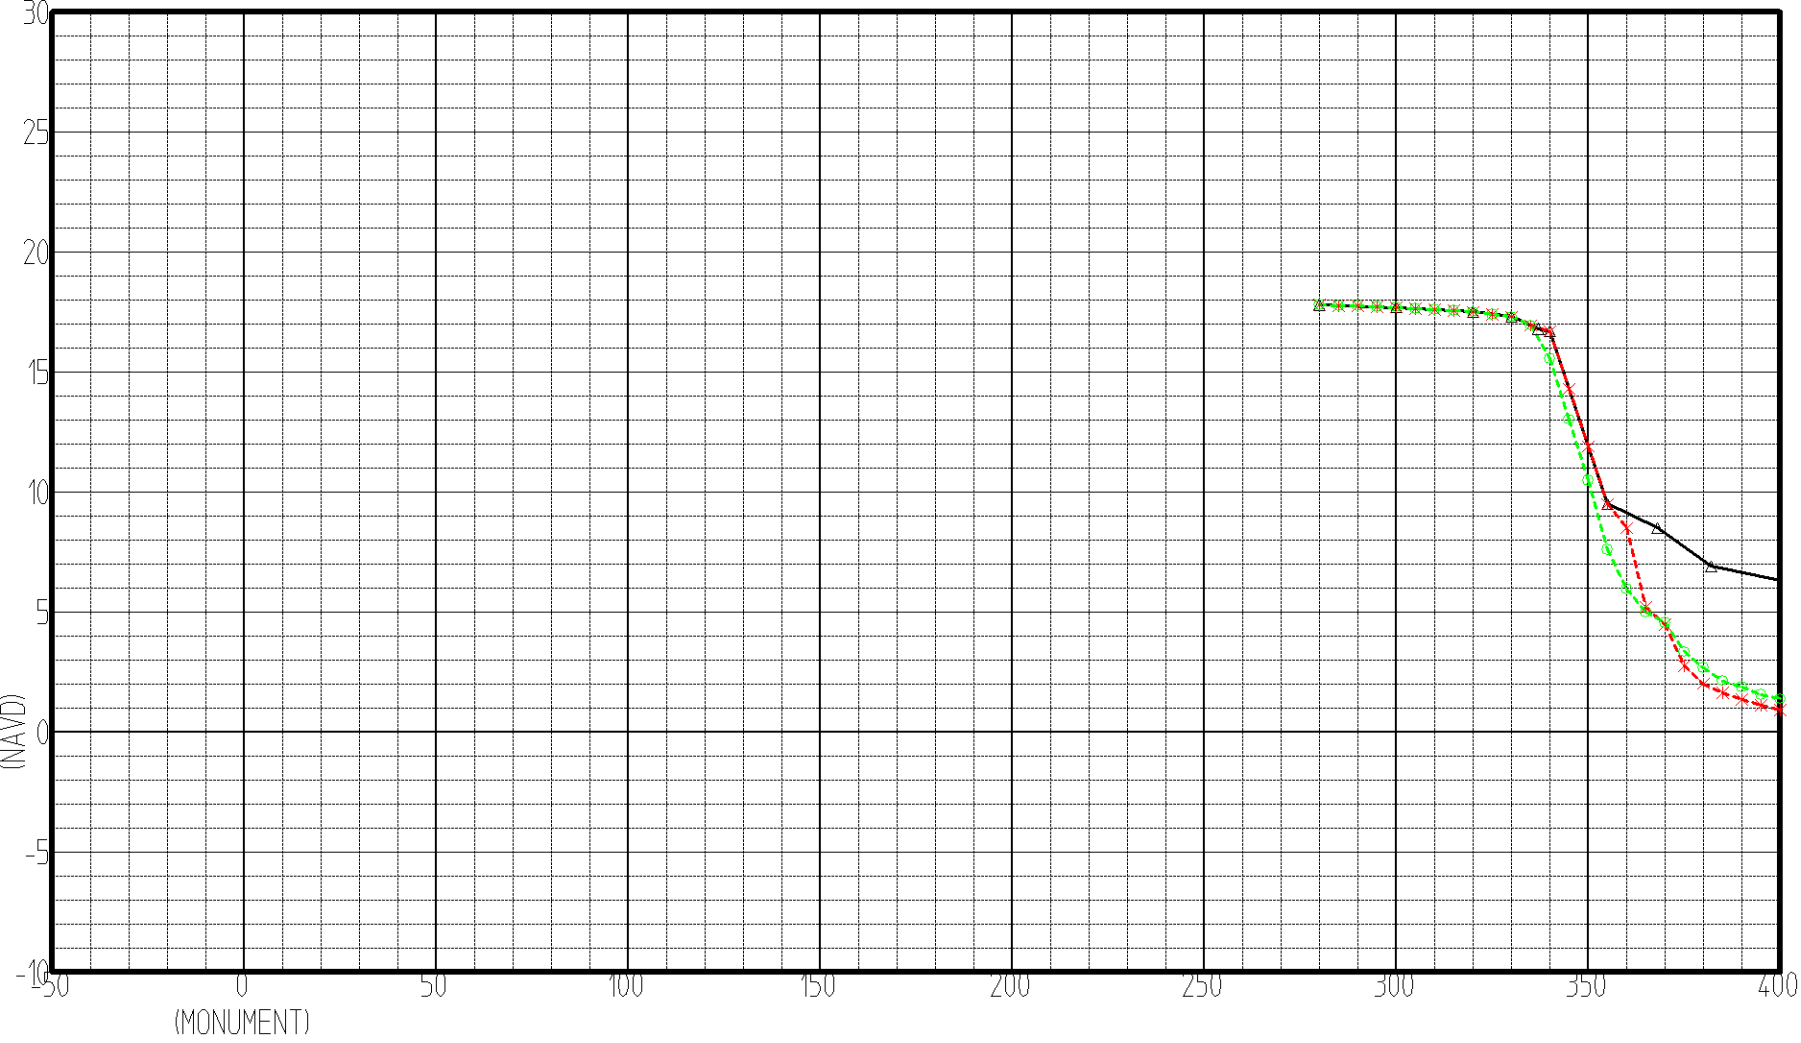
Range: R-177
 BEARING: 63.00
 1/2

BEACH PROFILE
 —△—△— 2005-2008 INPUT PRF
 - - * - - * - - 15-YR SBEACH ERODED PRF
 - - ○ - - ○ - - 25-YR SBEACH ERODED PRF

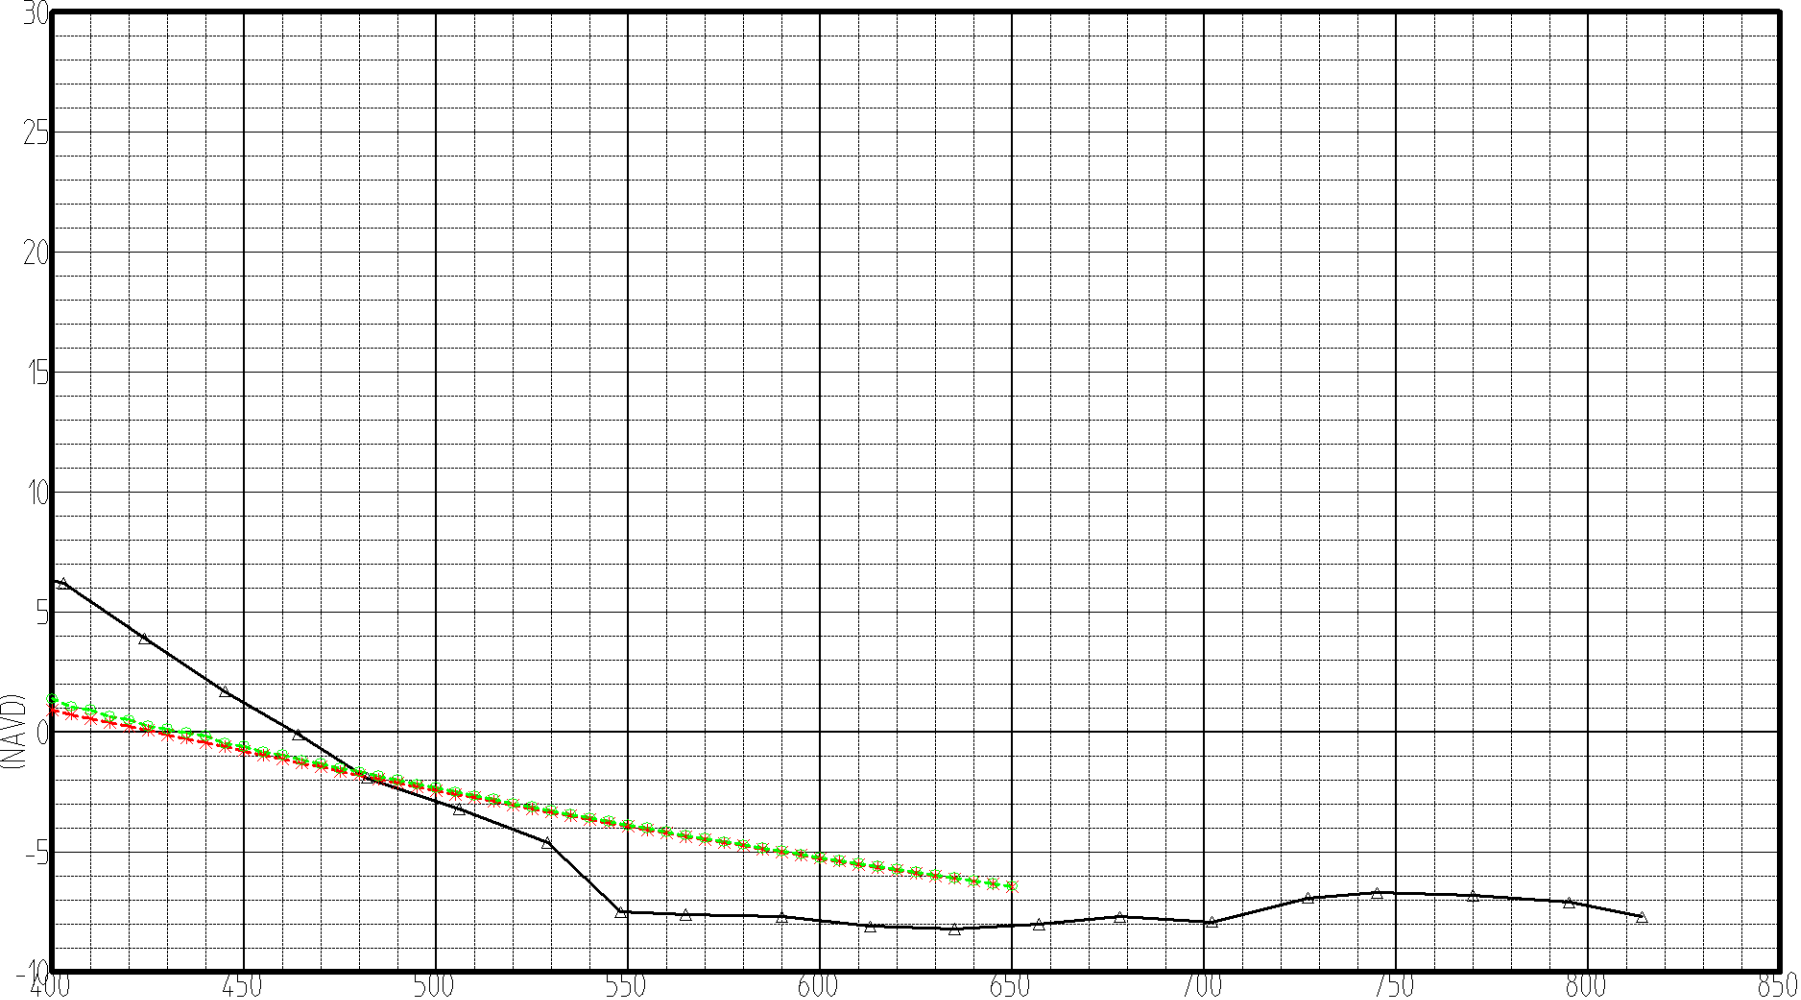
Range: R-177
 BEARING: 63.00
 2/2

BEACH PROFILE
 —△—△— 2005-2008 INPUT PRF
 - - * - - 15-YR SBEACH ERODED PRF
 - - o - - 25-YR SBEACH ERODED PRF
