Appendix XI

SBEACH 15 and 25 yr. Storm Erosion Profiles

Brevard County

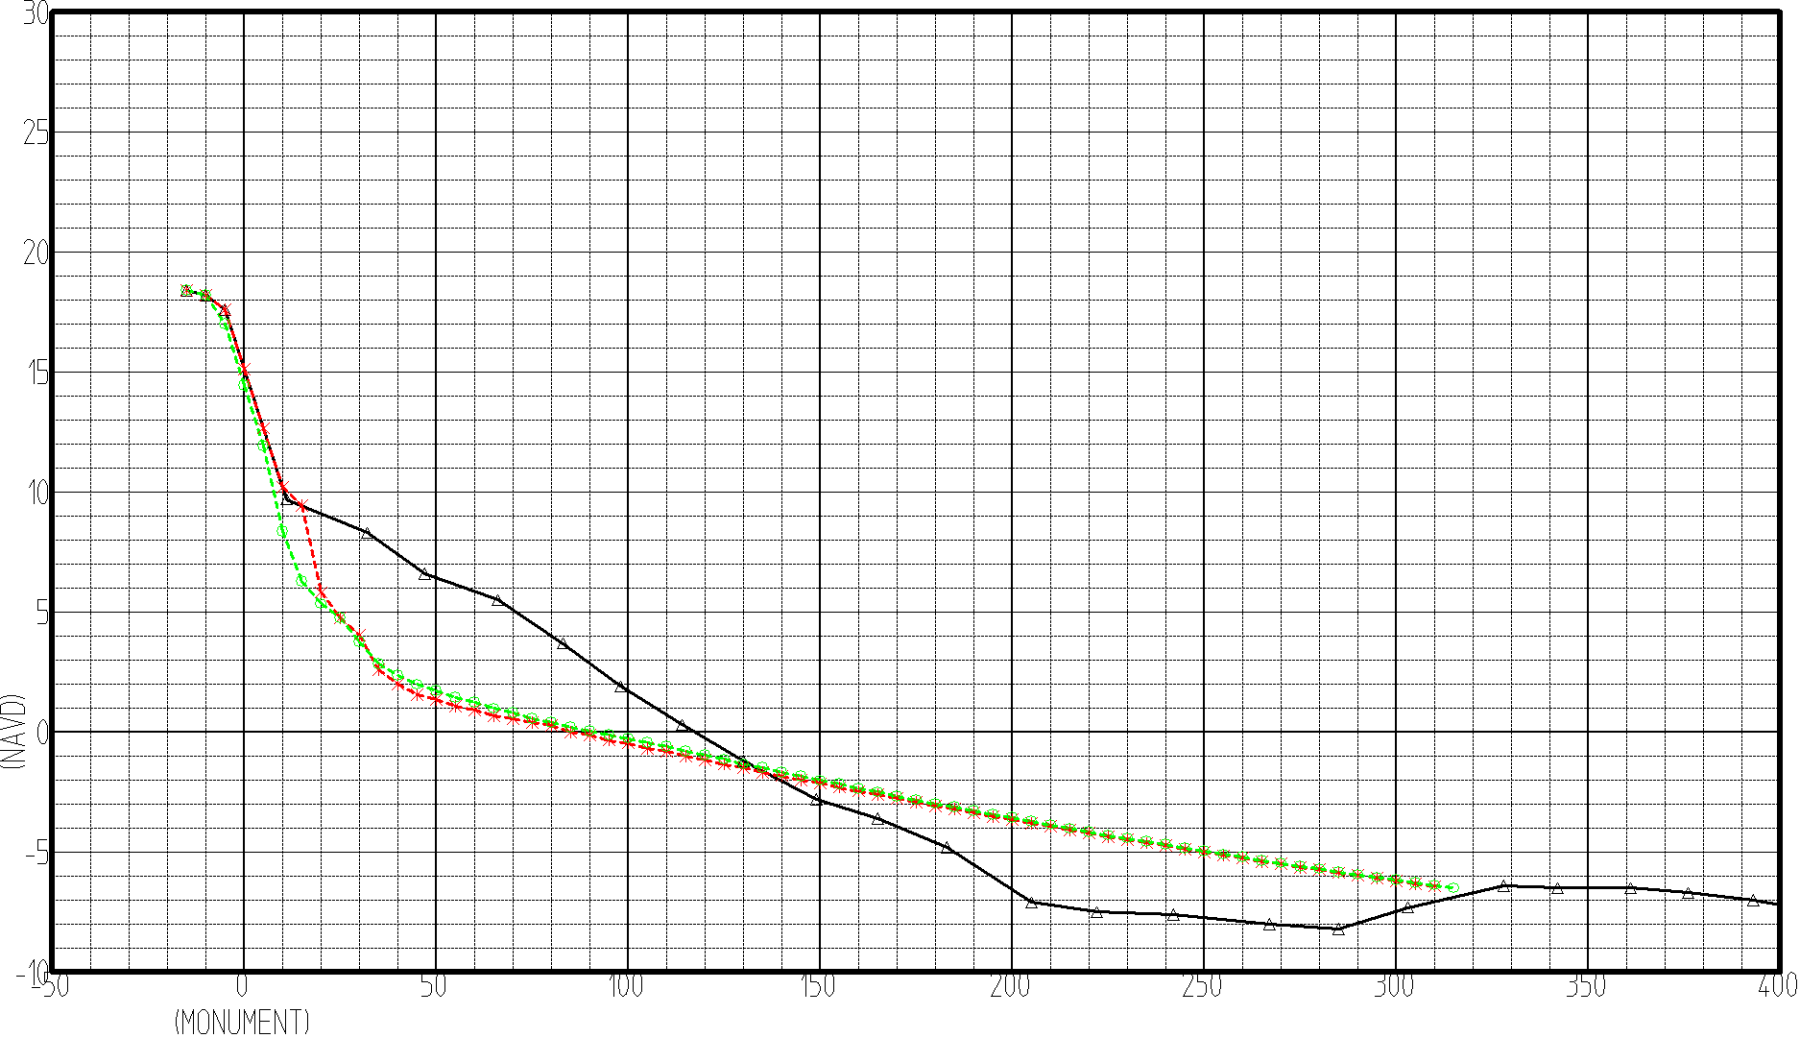
Range: R-178

BEACH PROFILE

—△—△— 2005-2008 INPUT PRF

- - - * - - - 15-YR SBEACH ERODED PRF

- - - o - - - 25-YR SBEACH ERODED PRF

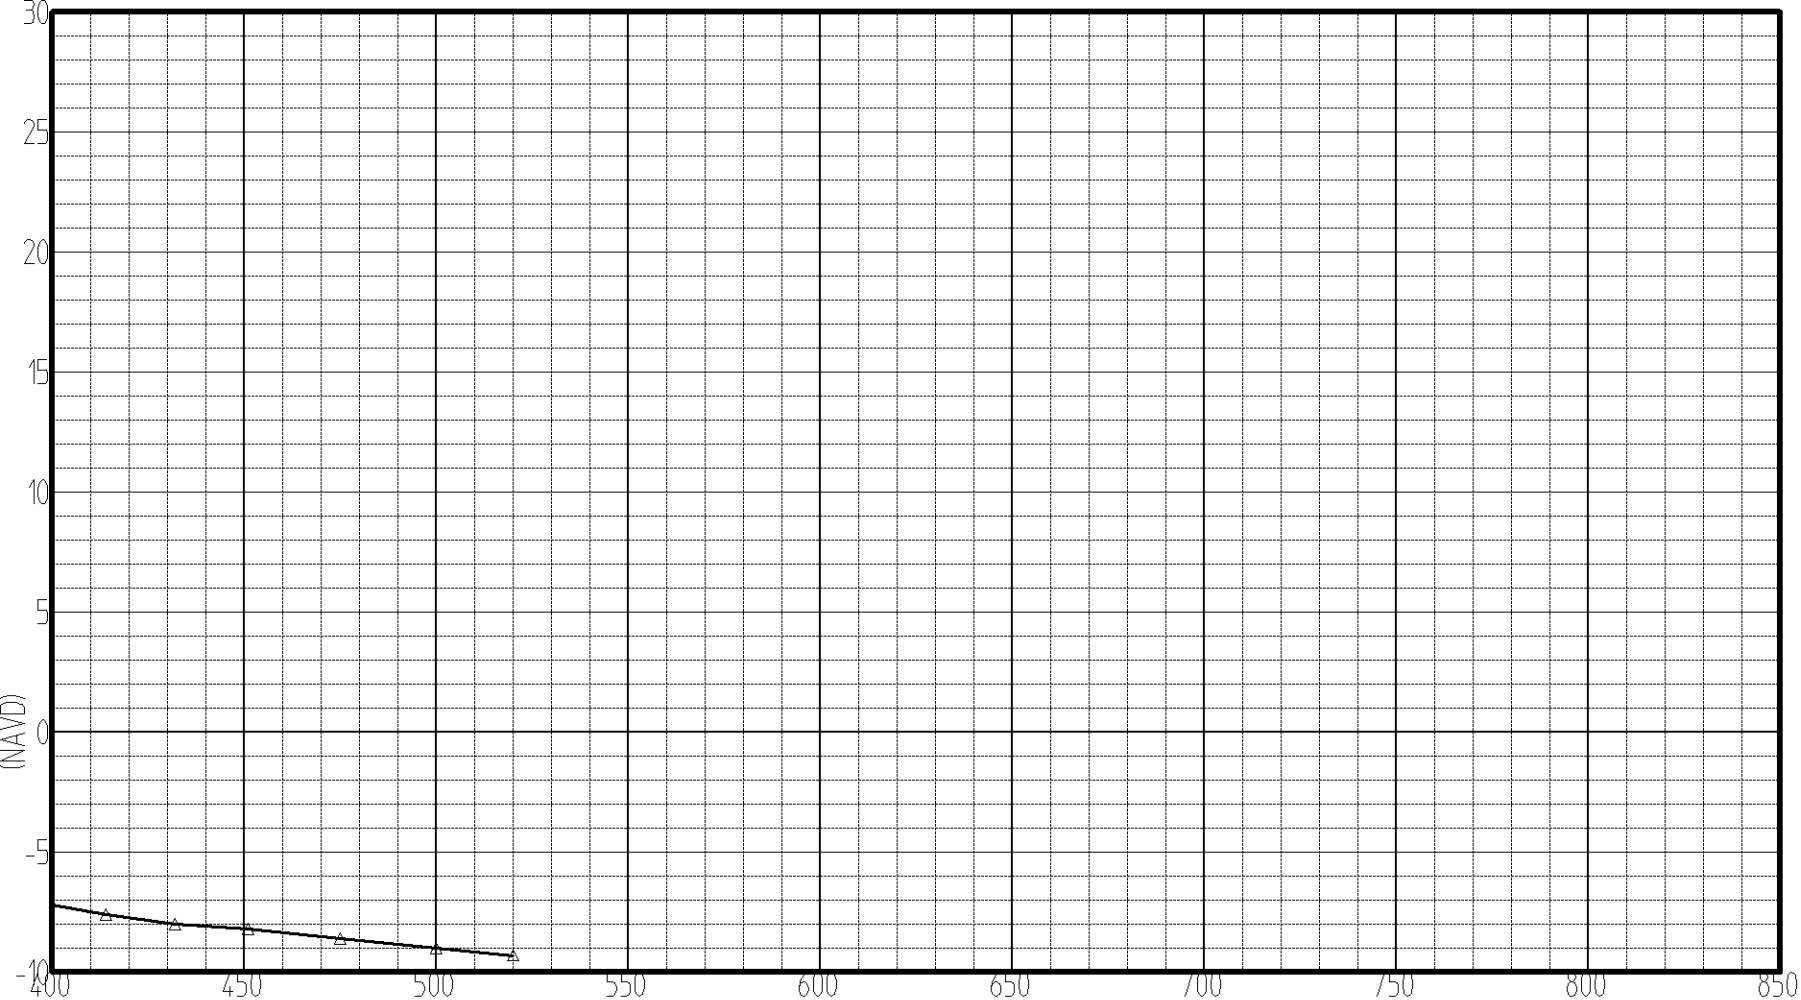
Range: R-178 2/2

BEACH PROFILE

- △—△— 2005-2008 INPUT PRF
- - - * - - - 15-YR SBEACH ERODED PRF
- - - o - - - 25-YR SBEACH ERODED PRF

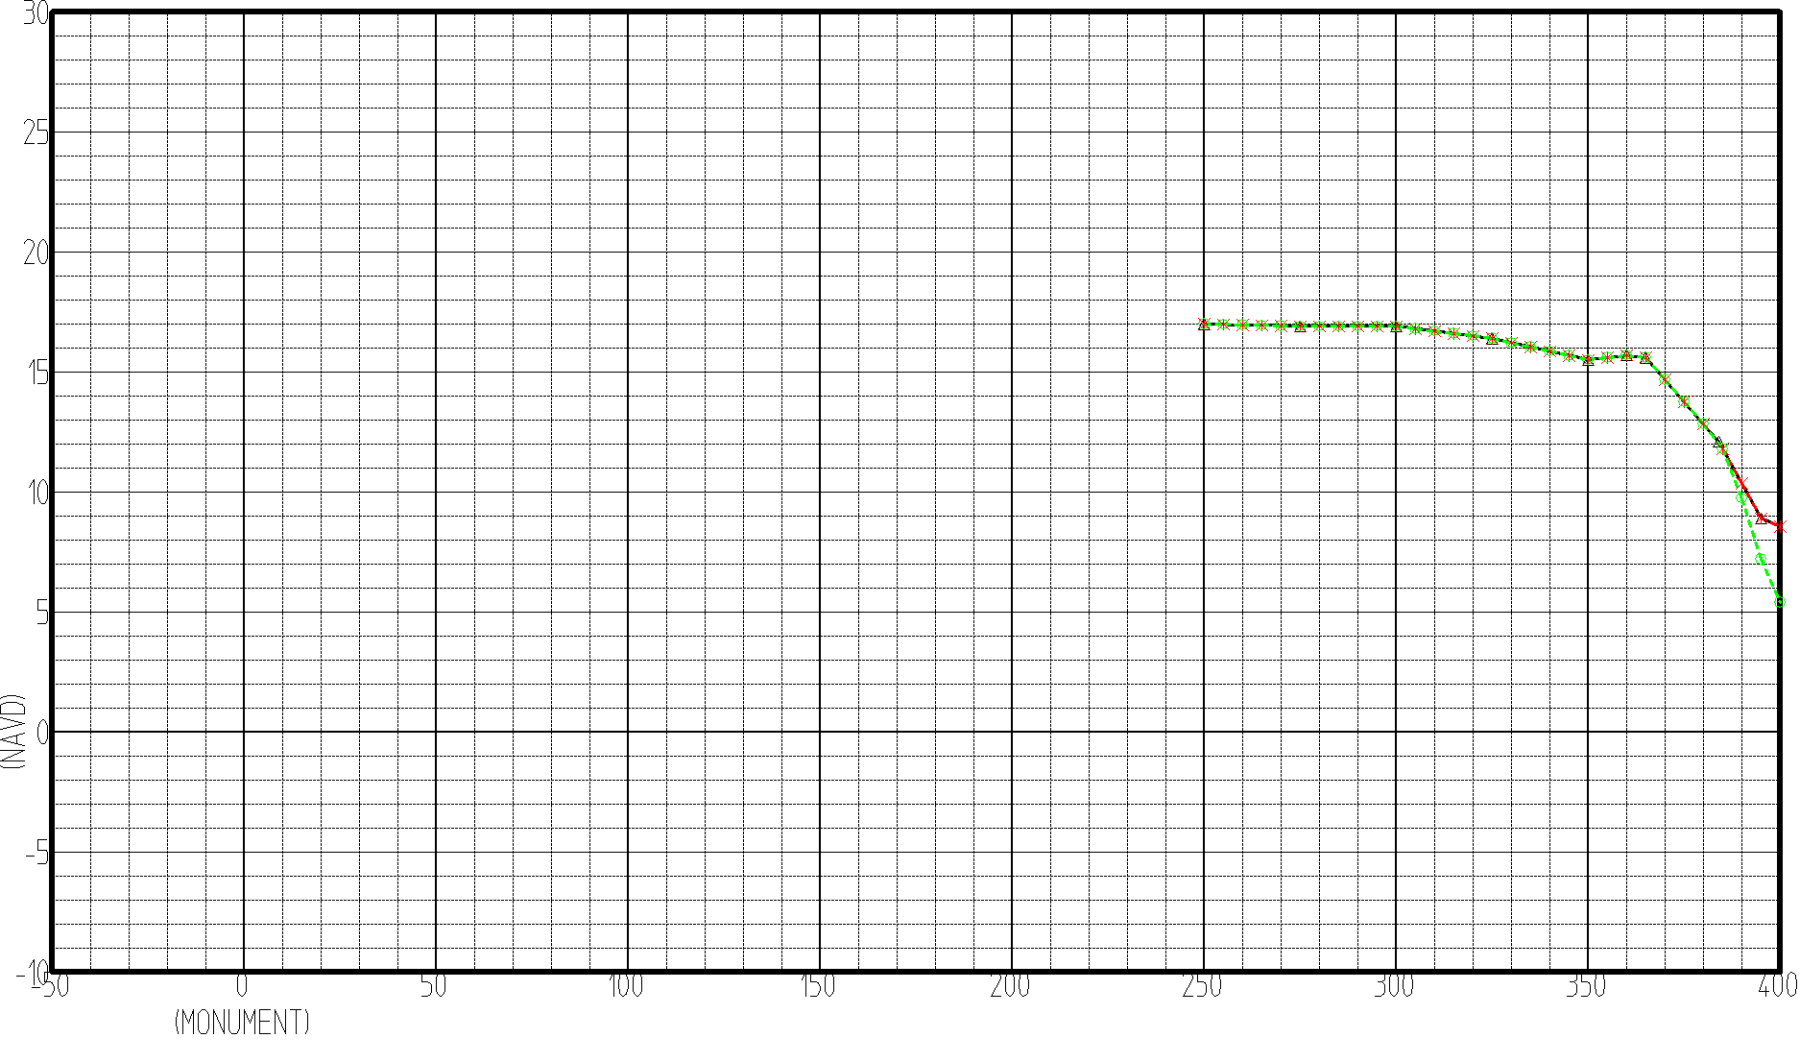
Range: R-179
 BEARING: 80.00
 1/2

BEACH PROFILE
 —△—△— 2005-2008 INPUT PRF
 - - * - - * - - 15-YR SBEACH ERODED PRF
 - - o - - o - - 25-YR SBEACH ERODED PRF

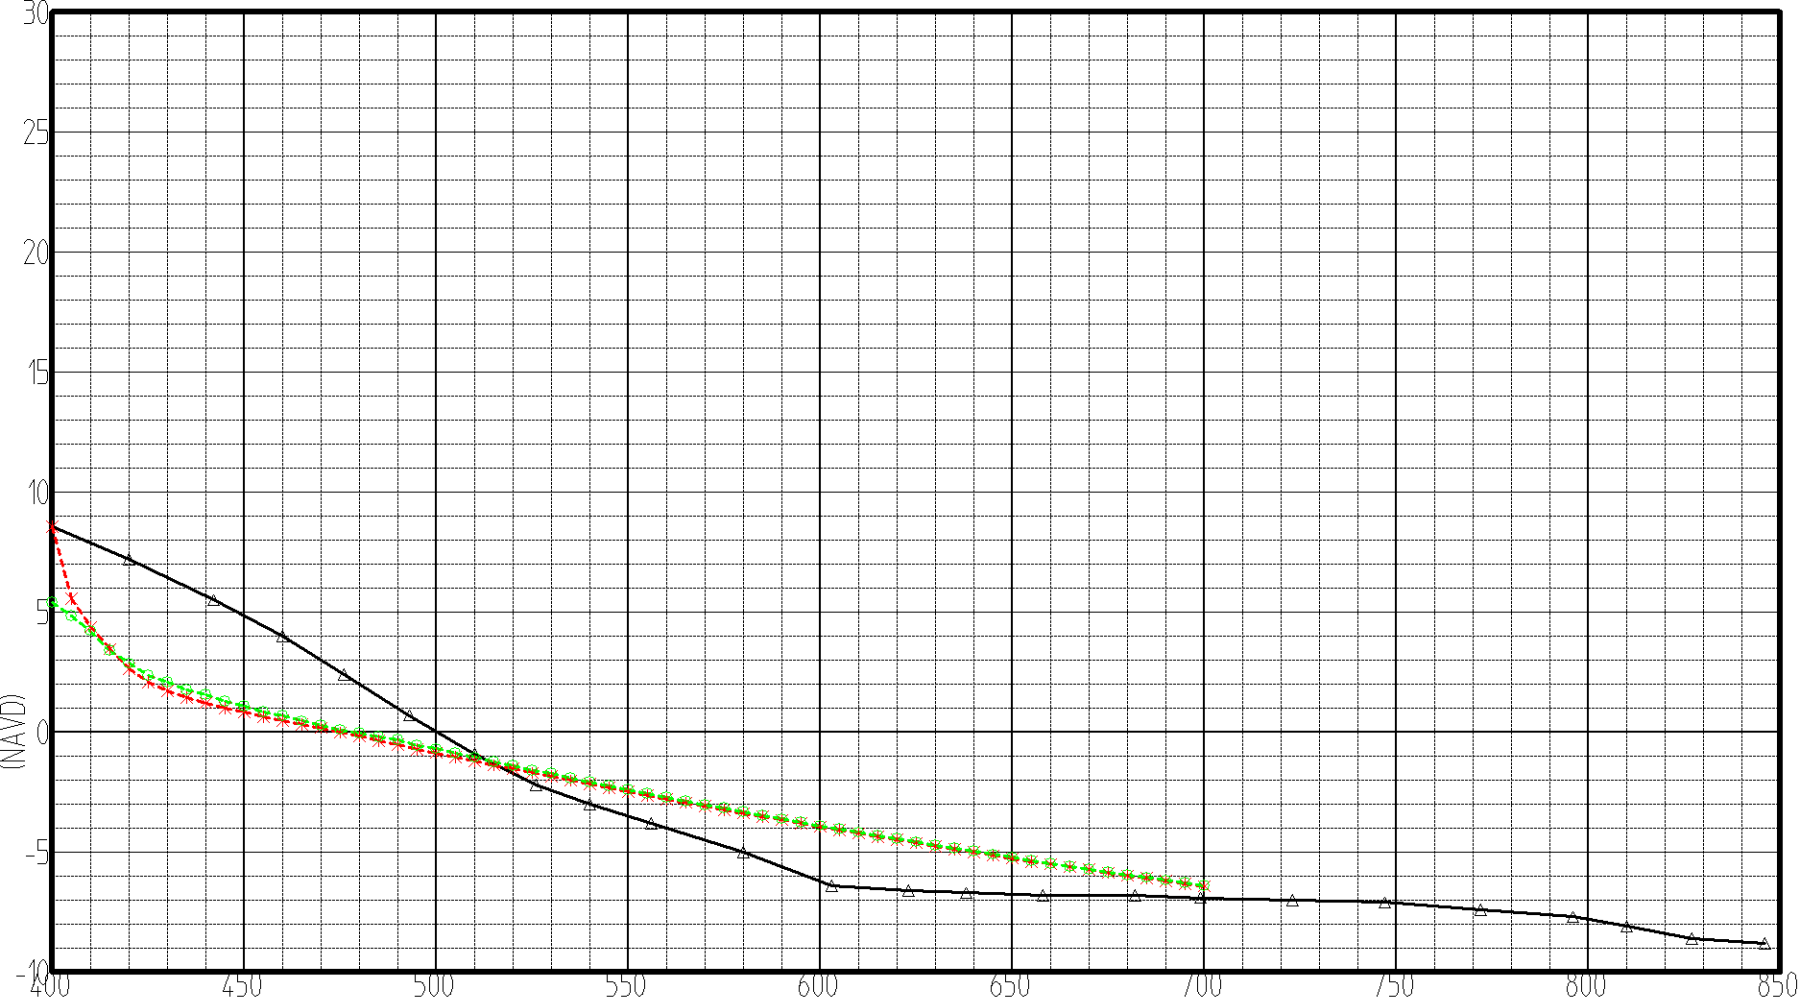
Range: R-179

BEACH PROFILE

—△—△— 2005-2008 INPUT PRF

- - - * - - - 15-YR SBEACH ERODED PRF

- - - o - - - 25-YR SBEACH ERODED PRF

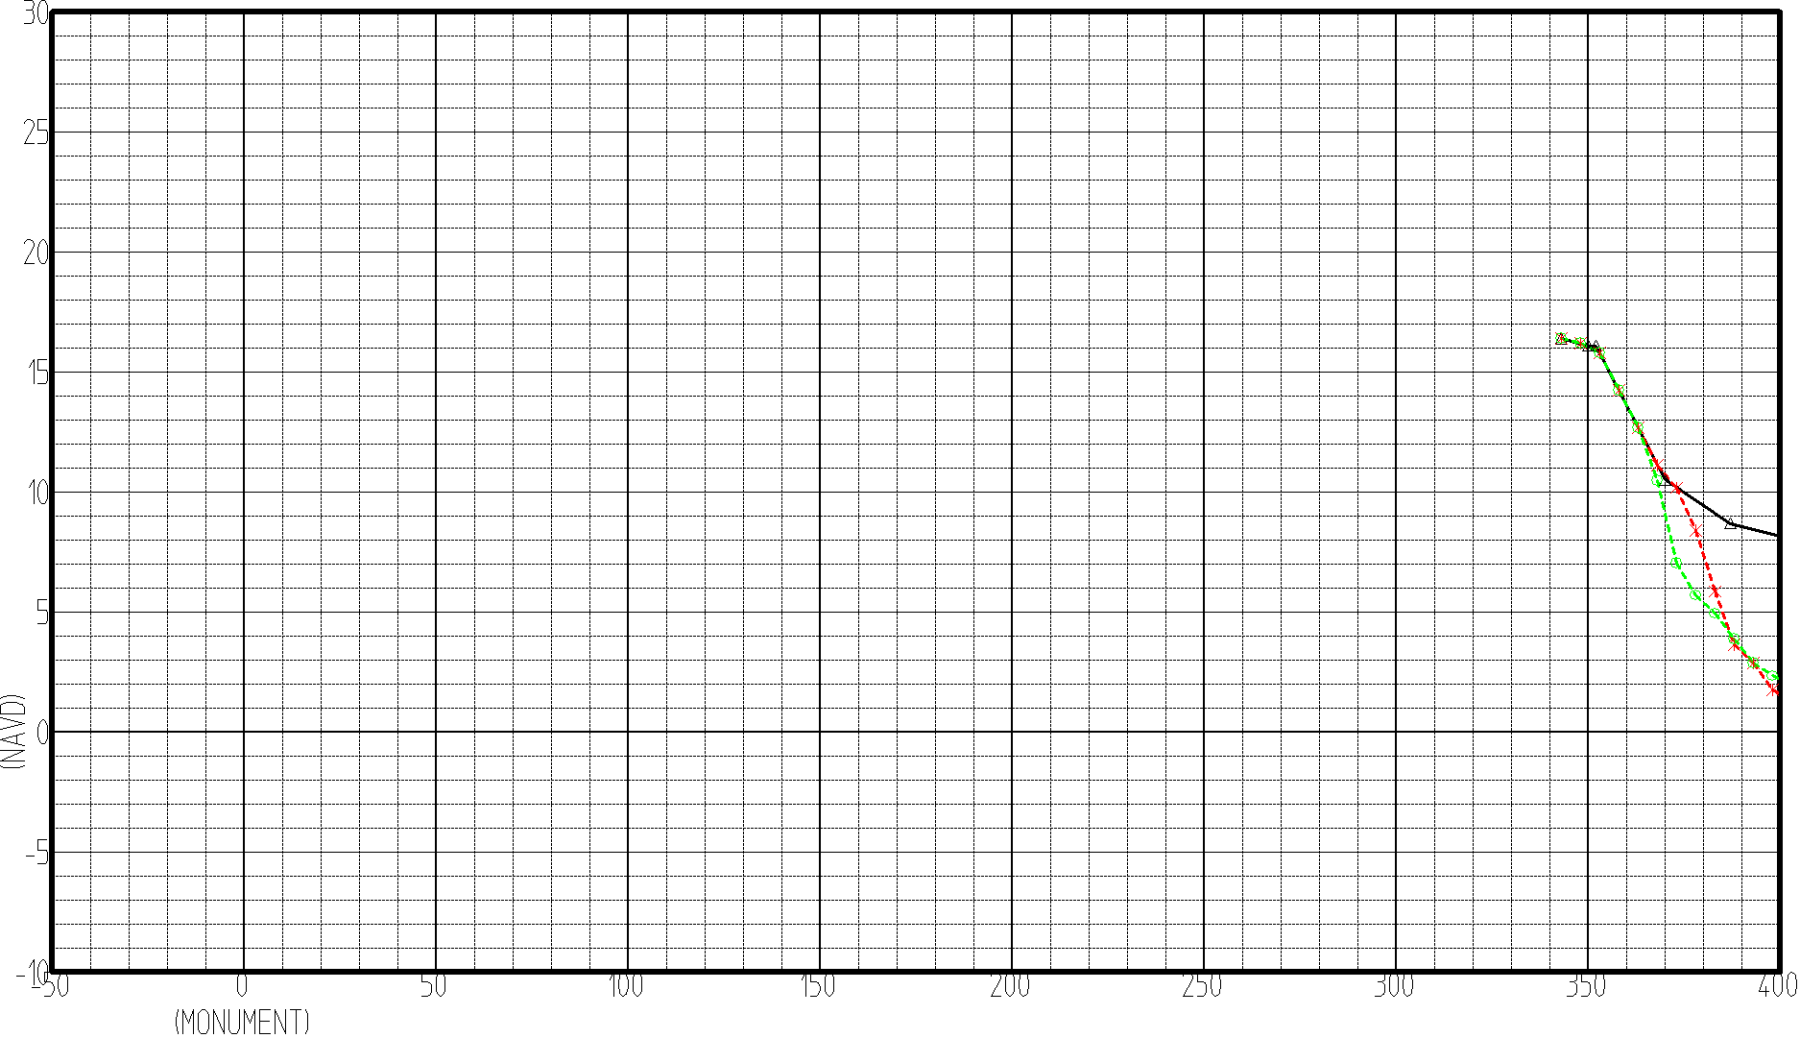
Range: R-180

BEACH PROFILE

—△—△— 2005-2008 INPUT PRF

- - - * - - - 15-YR SBEACH ERODED PRF

- - - o - - - 25-YR SBEACH ERODED PRF

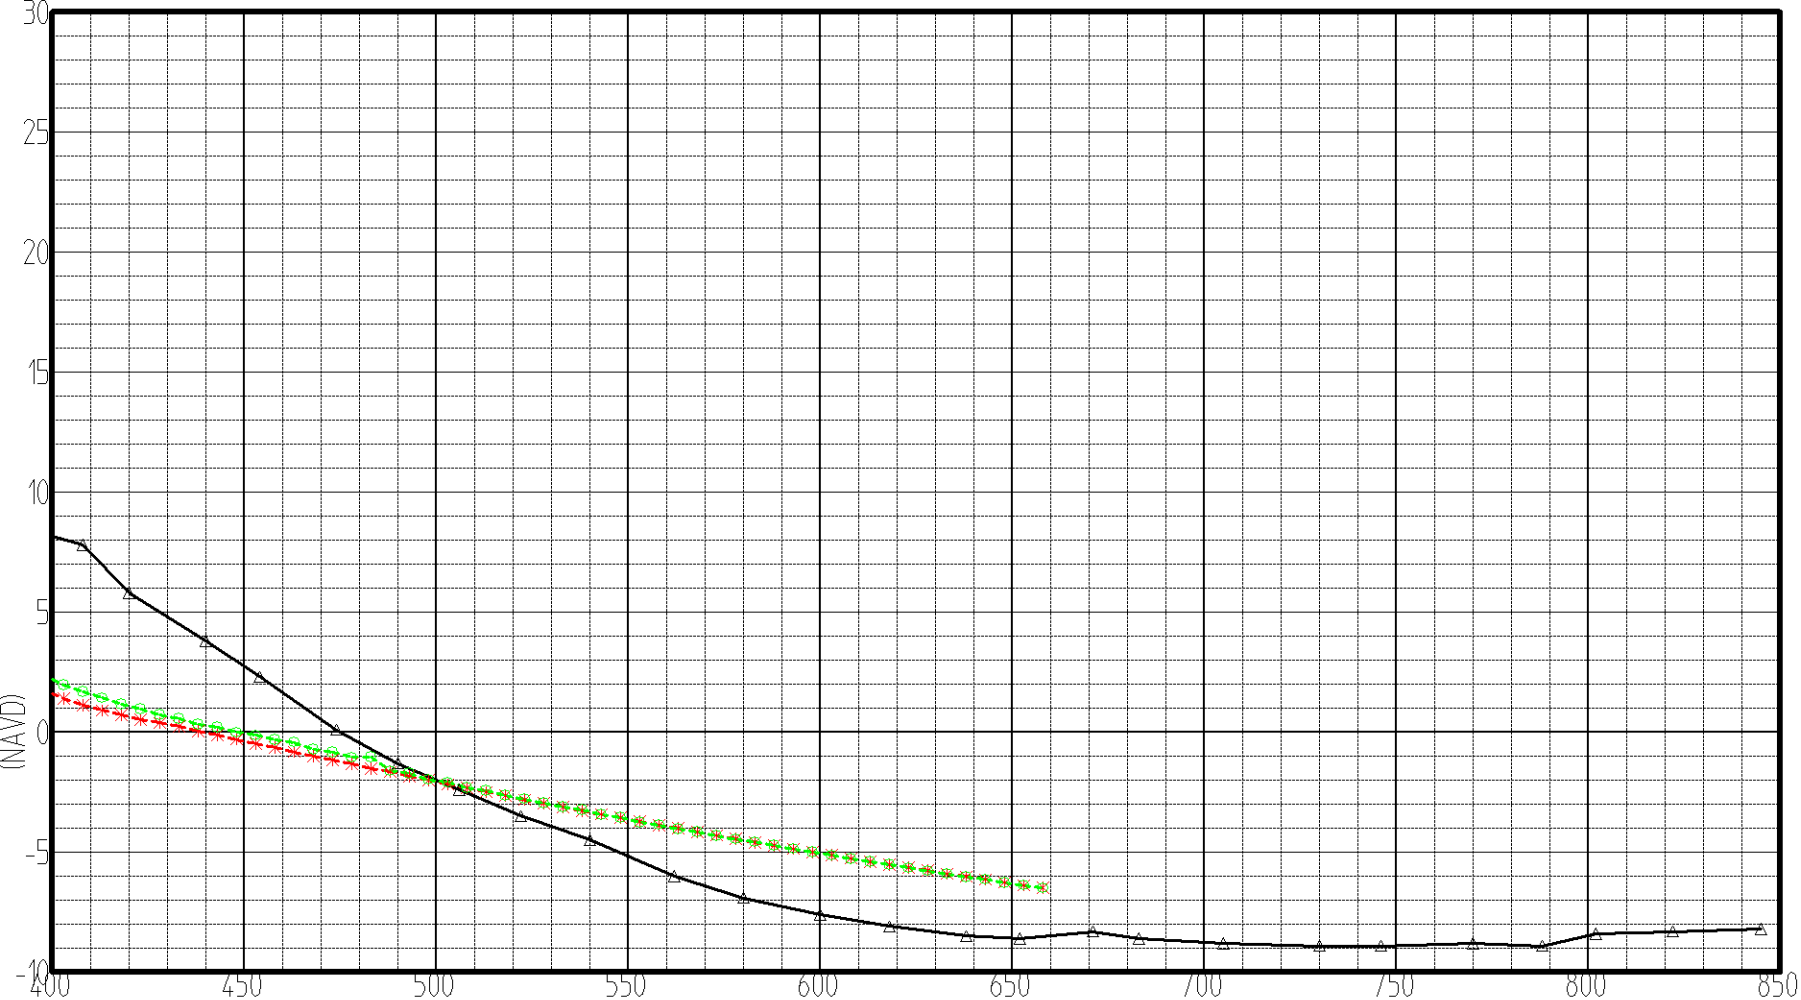
Range: R-180
 BEARING: 80.00
 2/2

BEACH PROFILE
 —△—△— 2005-2008 INPUT PRF
 - - * - - * - - 15-YR SBEACH ERODED PRF
 - - o - - o - - 25-YR SBEACH ERODED PRF

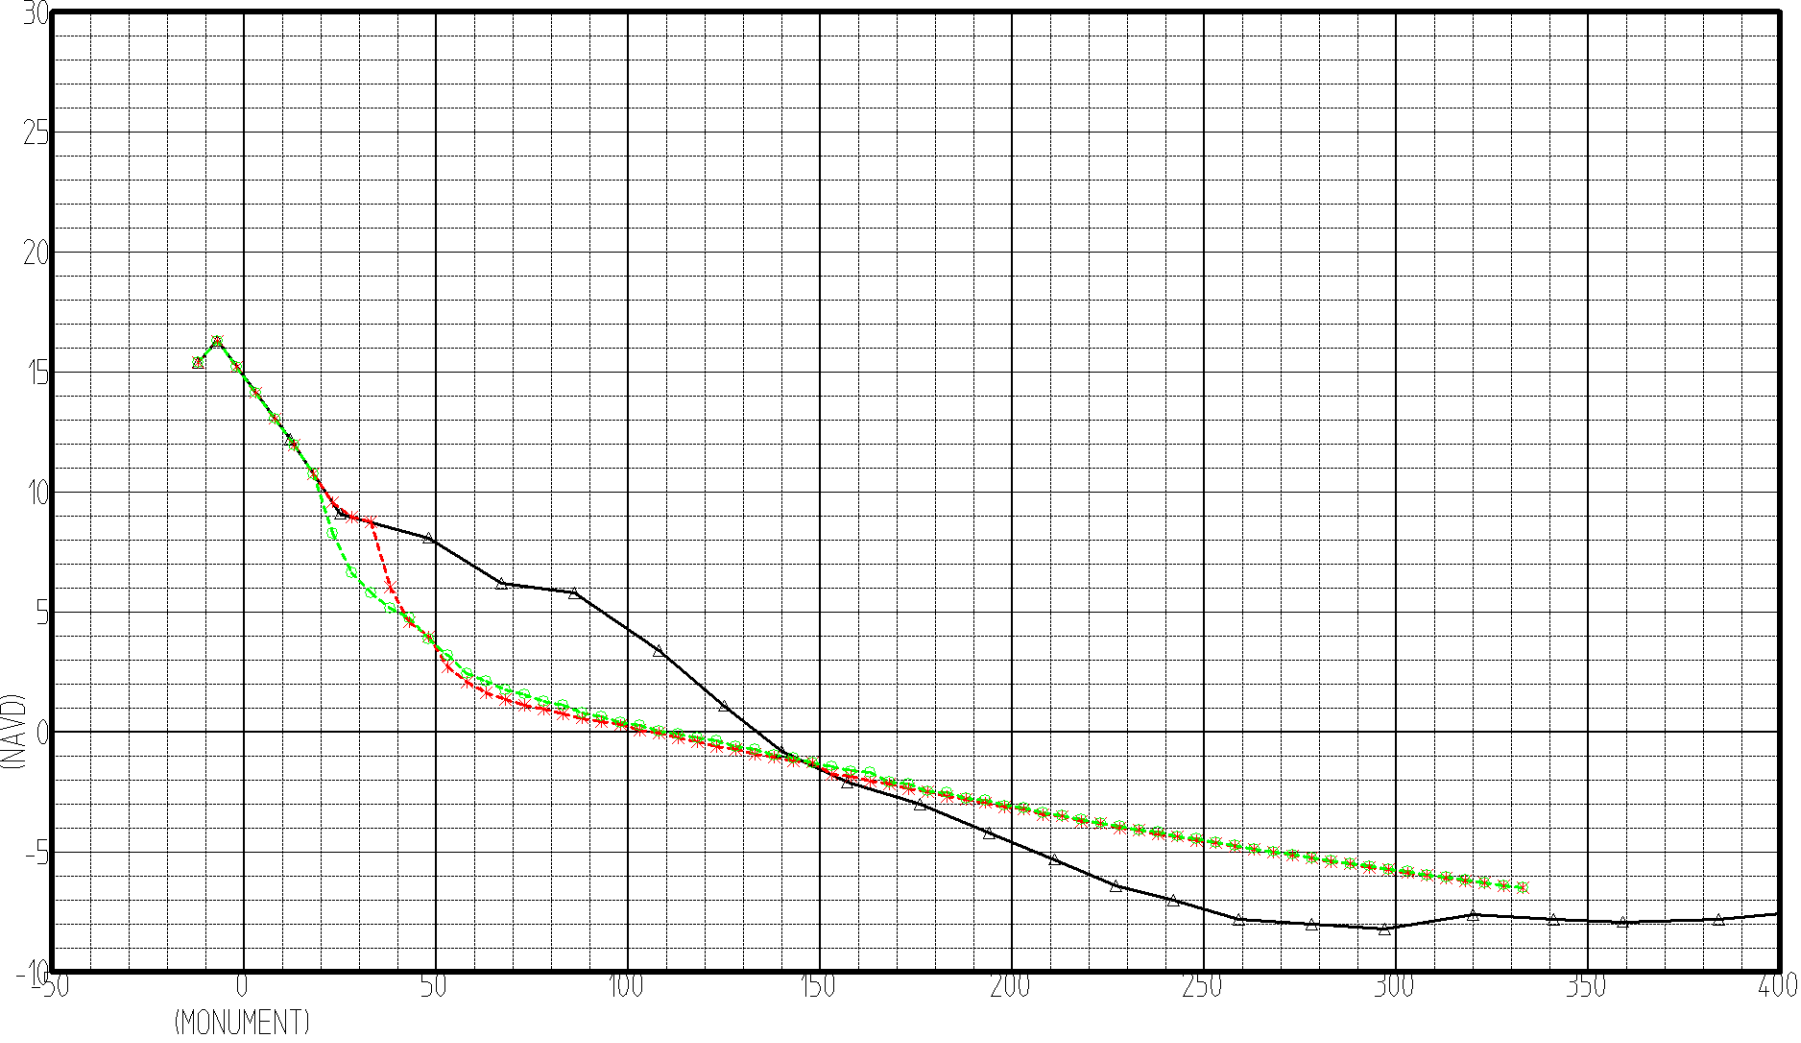
Range: R-181

BEACH PROFILE

—△—△— 2005-2008 INPUT PRF

- - - * - - - 15-YR SBEACH ERODED PRF

- - - o - - - 25-YR SBEACH ERODED PRF

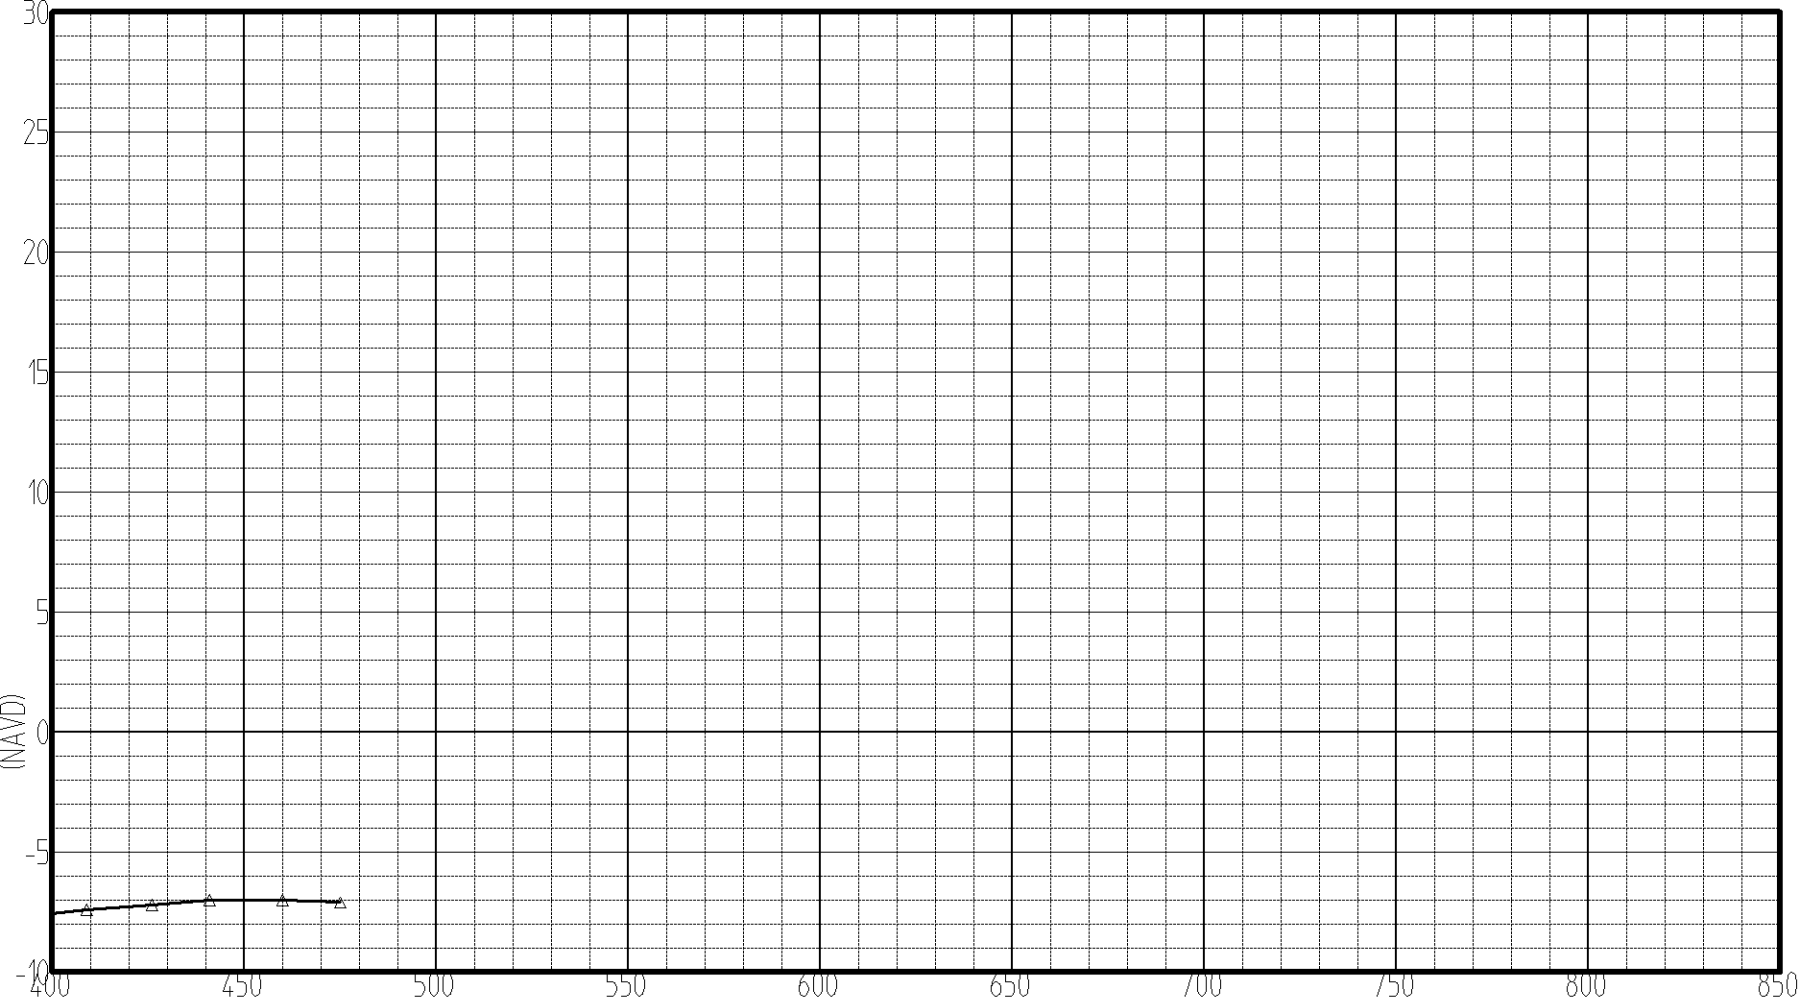
Range: R-181

BEACH PROFILE

—△—△— 2005-2008 INPUT PRF

- - - * - - - 15-YR SBEACH ERODED PRF

- - - o - - - 25-YR SBEACH ERODED PRF

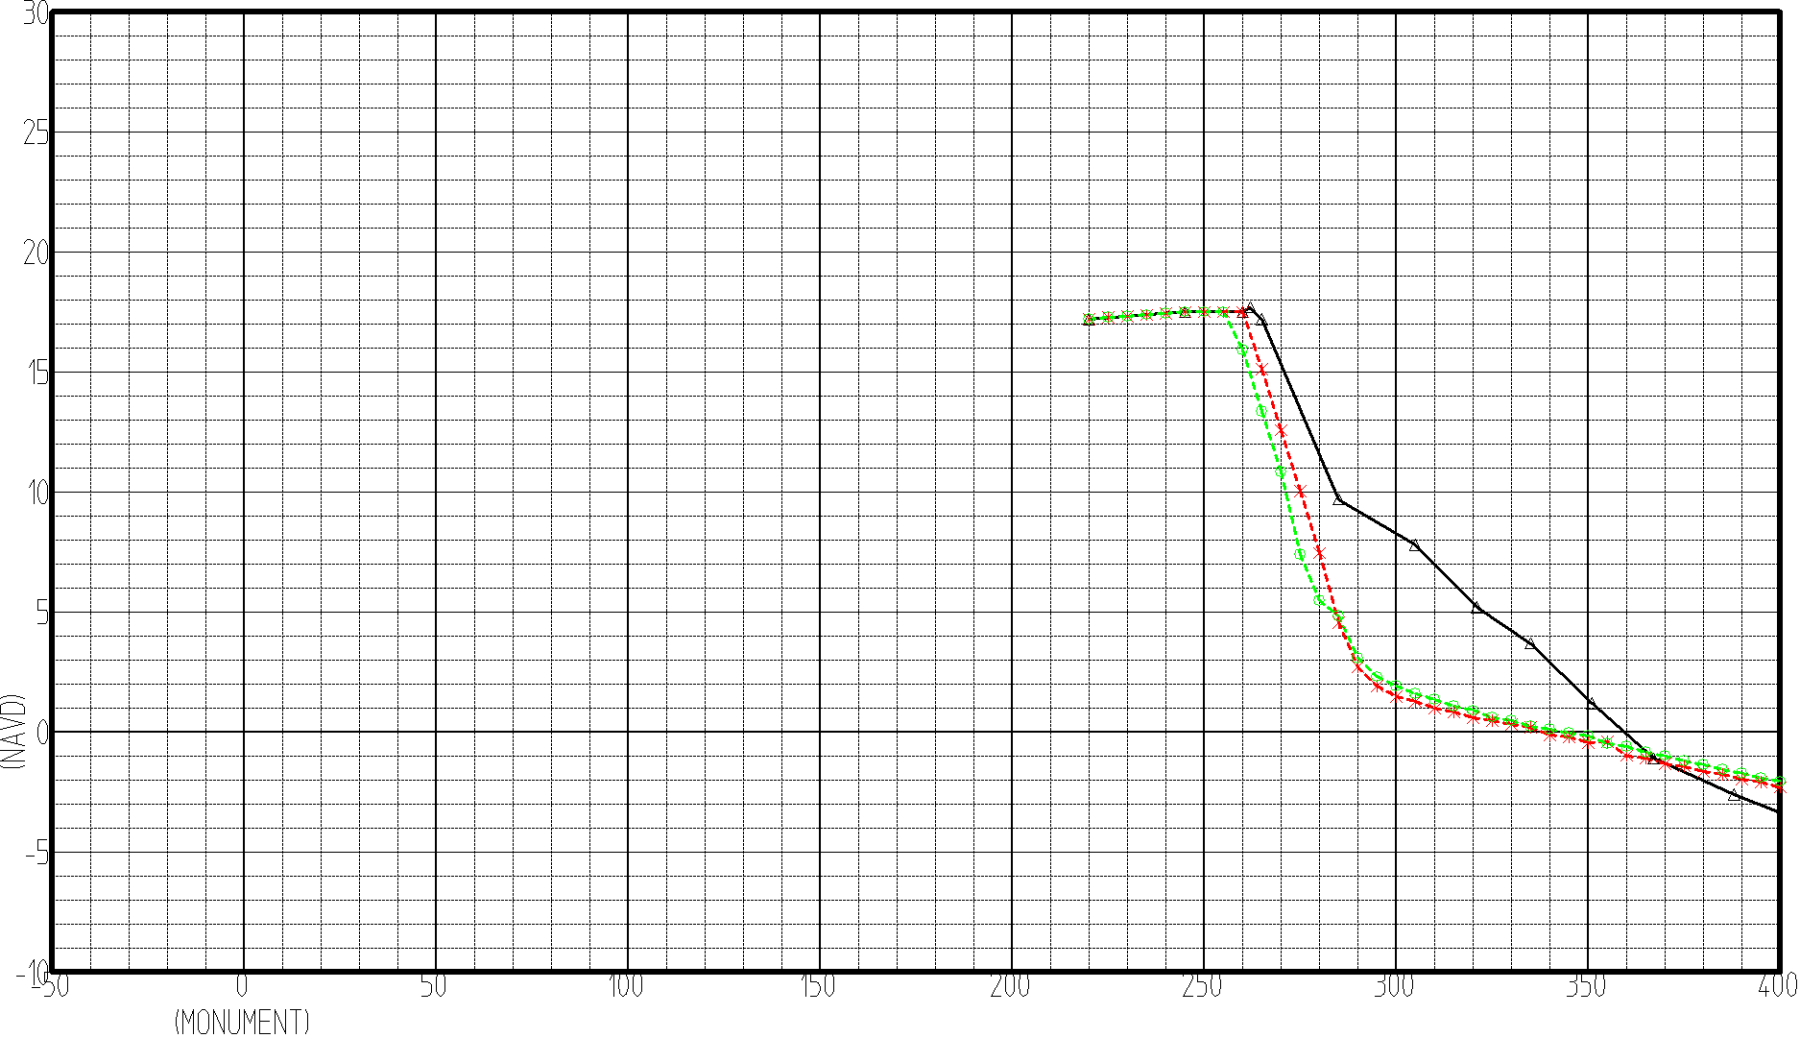
Range: R-182
 BEARING: 65.00
 1/2

BEACH PROFILE
 —△—△— 2005-2008 INPUT PRF
 - - * - - * - - 15-YR SBEACH ERODED PRF
 - - o - - o - - 25-YR SBEACH ERODED PRF

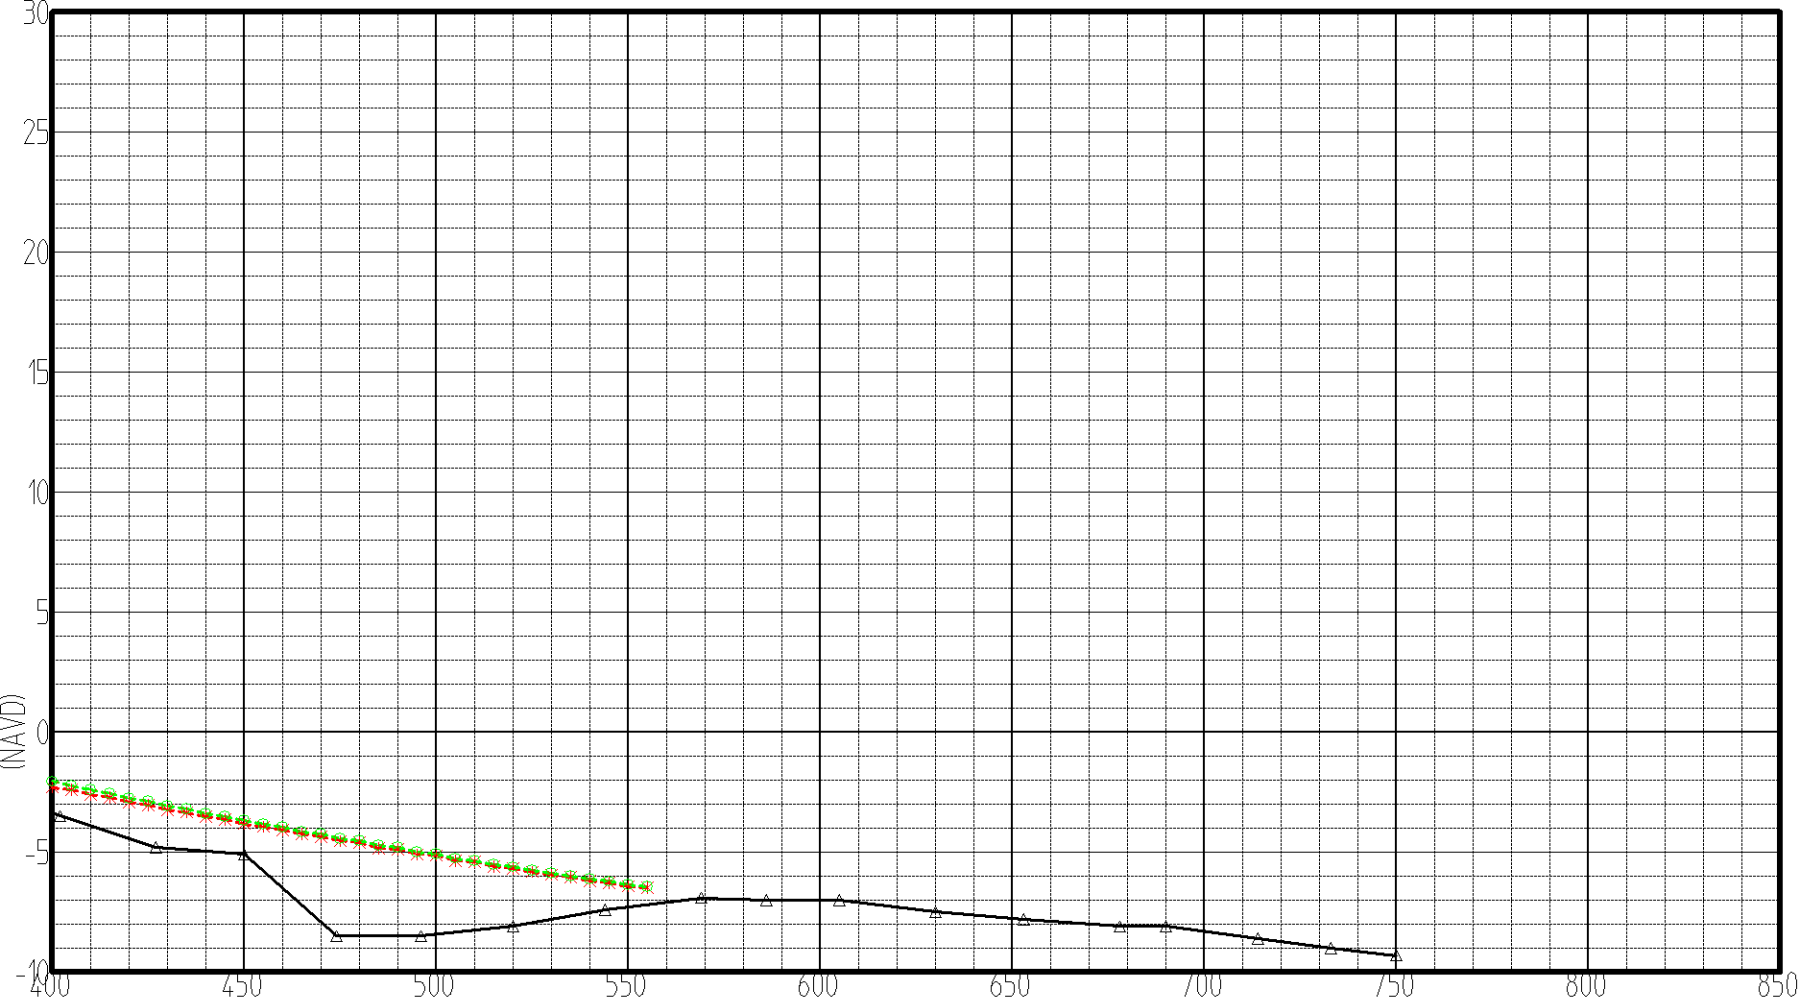
Range: R-182

BEACH PROFILE

—△—△— 2005-2008 INPUT PRF

- - - * - - - 15-YR SBEACH ERODED PRF

- - - o - - - 25-YR SBEACH ERODED PRF

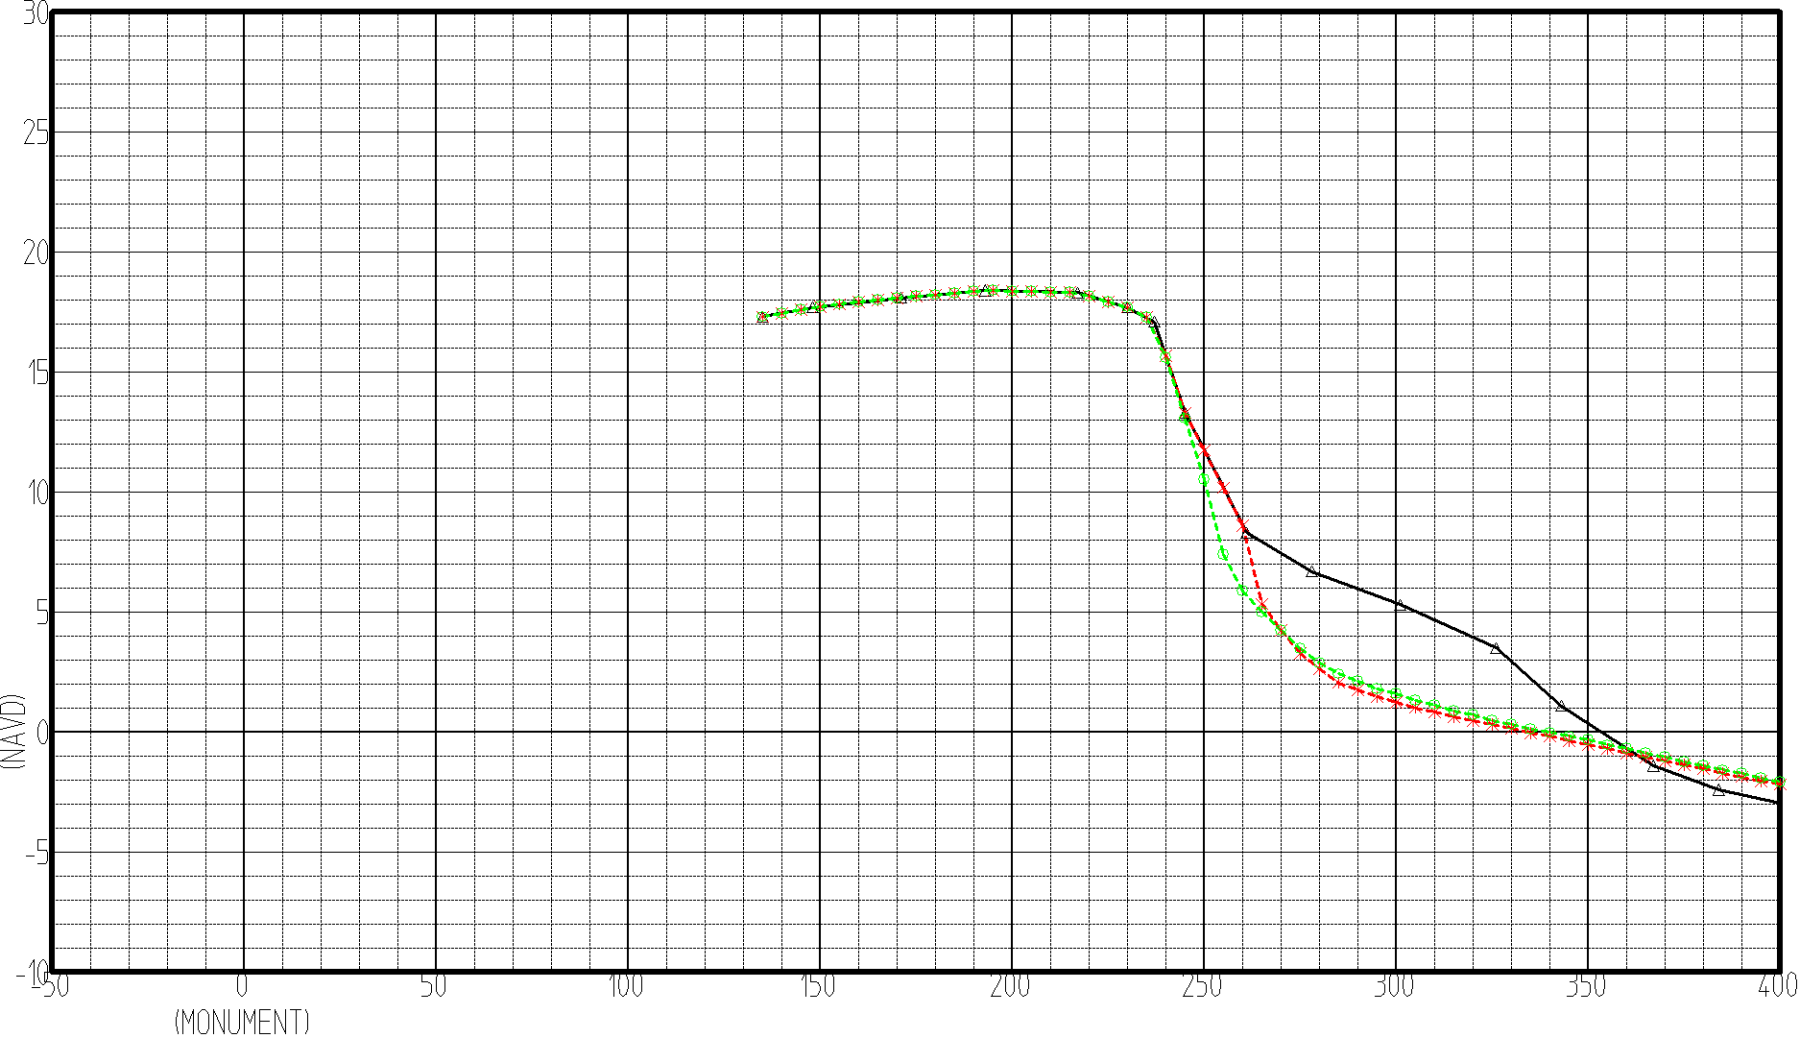
Range: R-183
 BEARING: 70.00
 1/2

BEACH PROFILE
 —△—△— 2005-2008 INPUT PRF
 - - * - - 15-YR SBEACH ERODED PRF
 - - o - - 25-YR SBEACH ERODED PRF

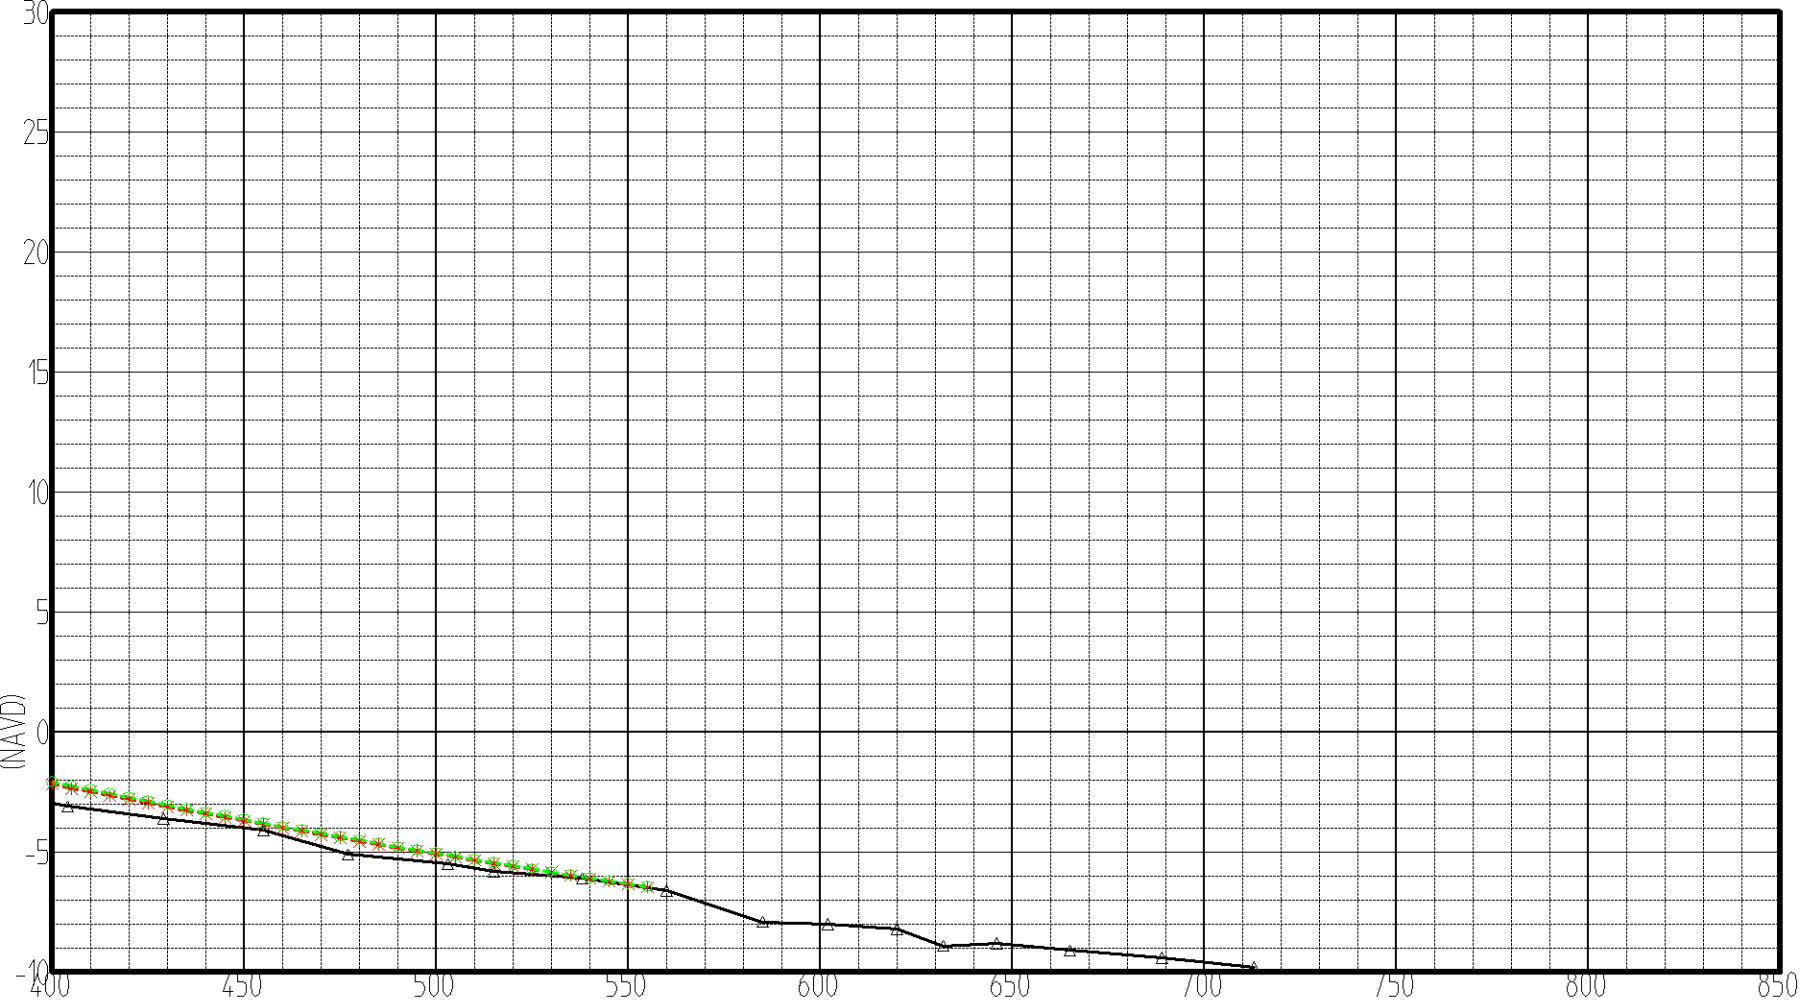
Range: R-183

BEACH PROFILE

—△—△— 2005-2008 INPUT PRF

- - - * - - - 15-YR SBEACH ERODED PRF

- - - o - - - 25-YR SBEACH ERODED PRF
