Appendix XI

SBEACH 15 and 25 yr. Storm Erosion Profiles

Brevard County

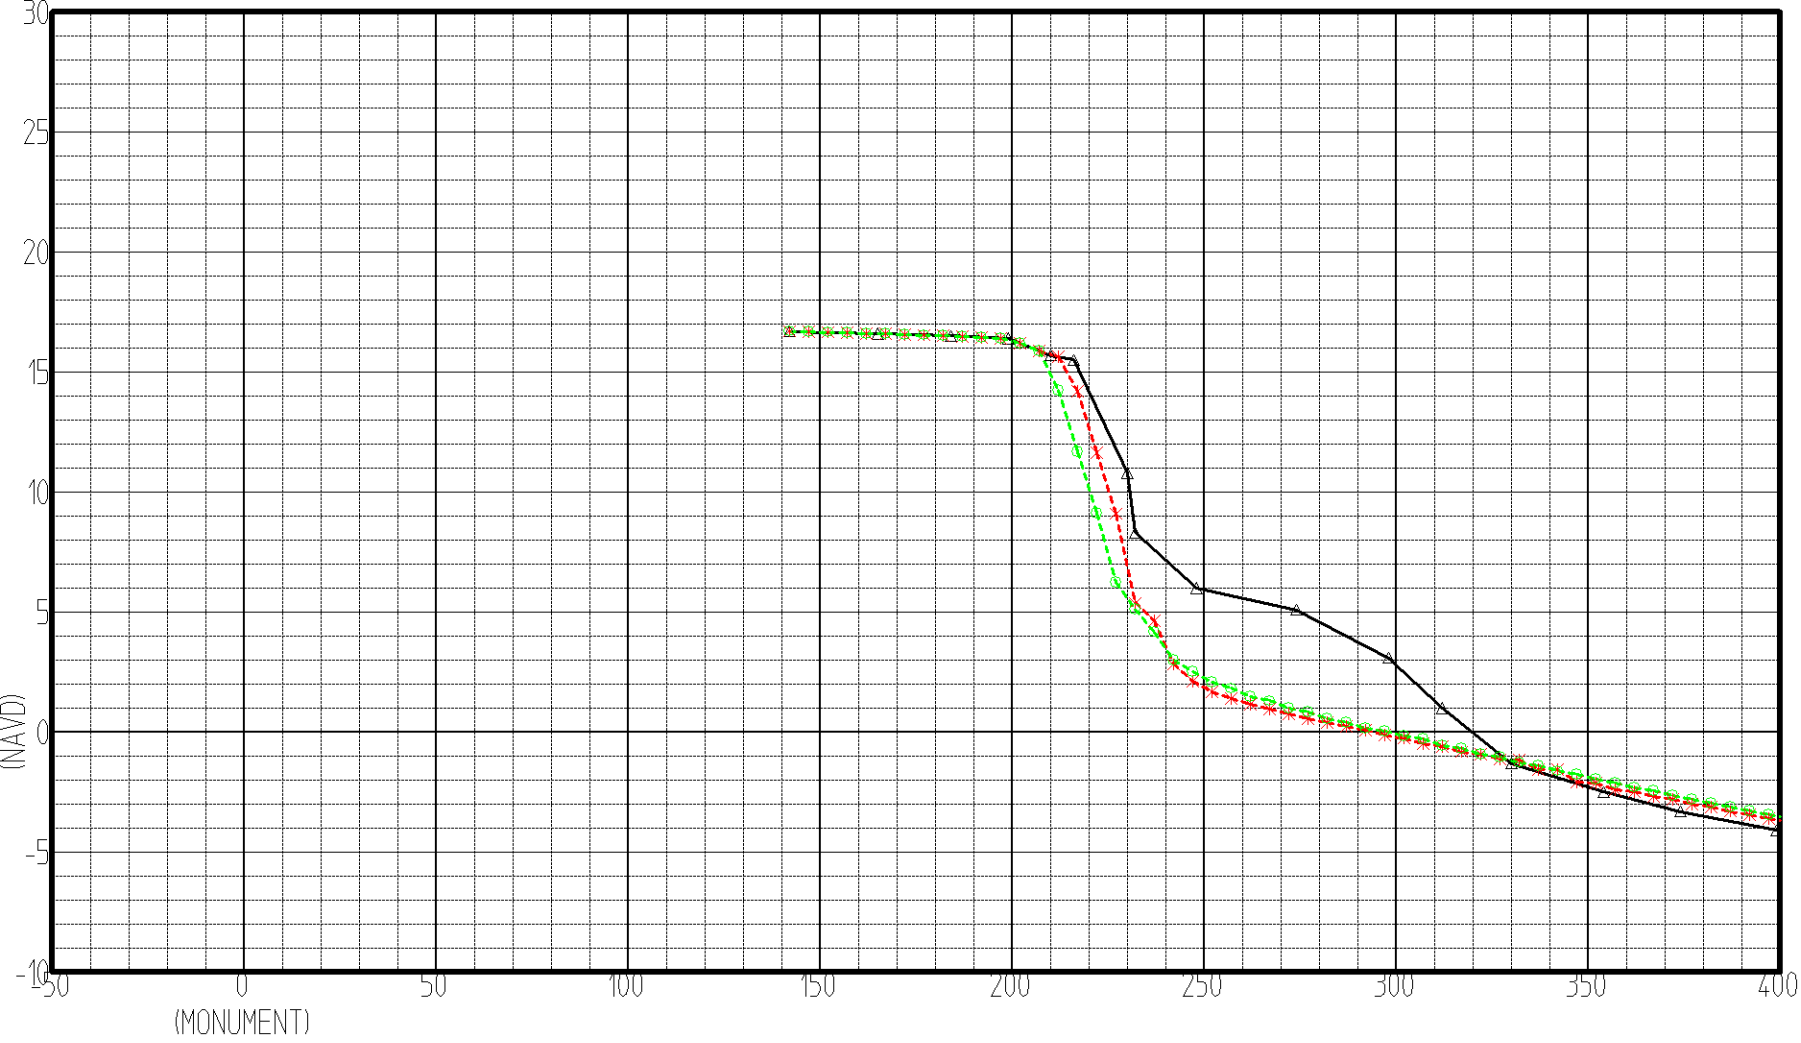
Range: R-184

BEACH PROFILE

—△—△— 2005-2008 INPUT PRF

- - - * - - - 15-YR SBEACH ERODED PRF

- - - o - - - 25-YR SBEACH ERODED PRF

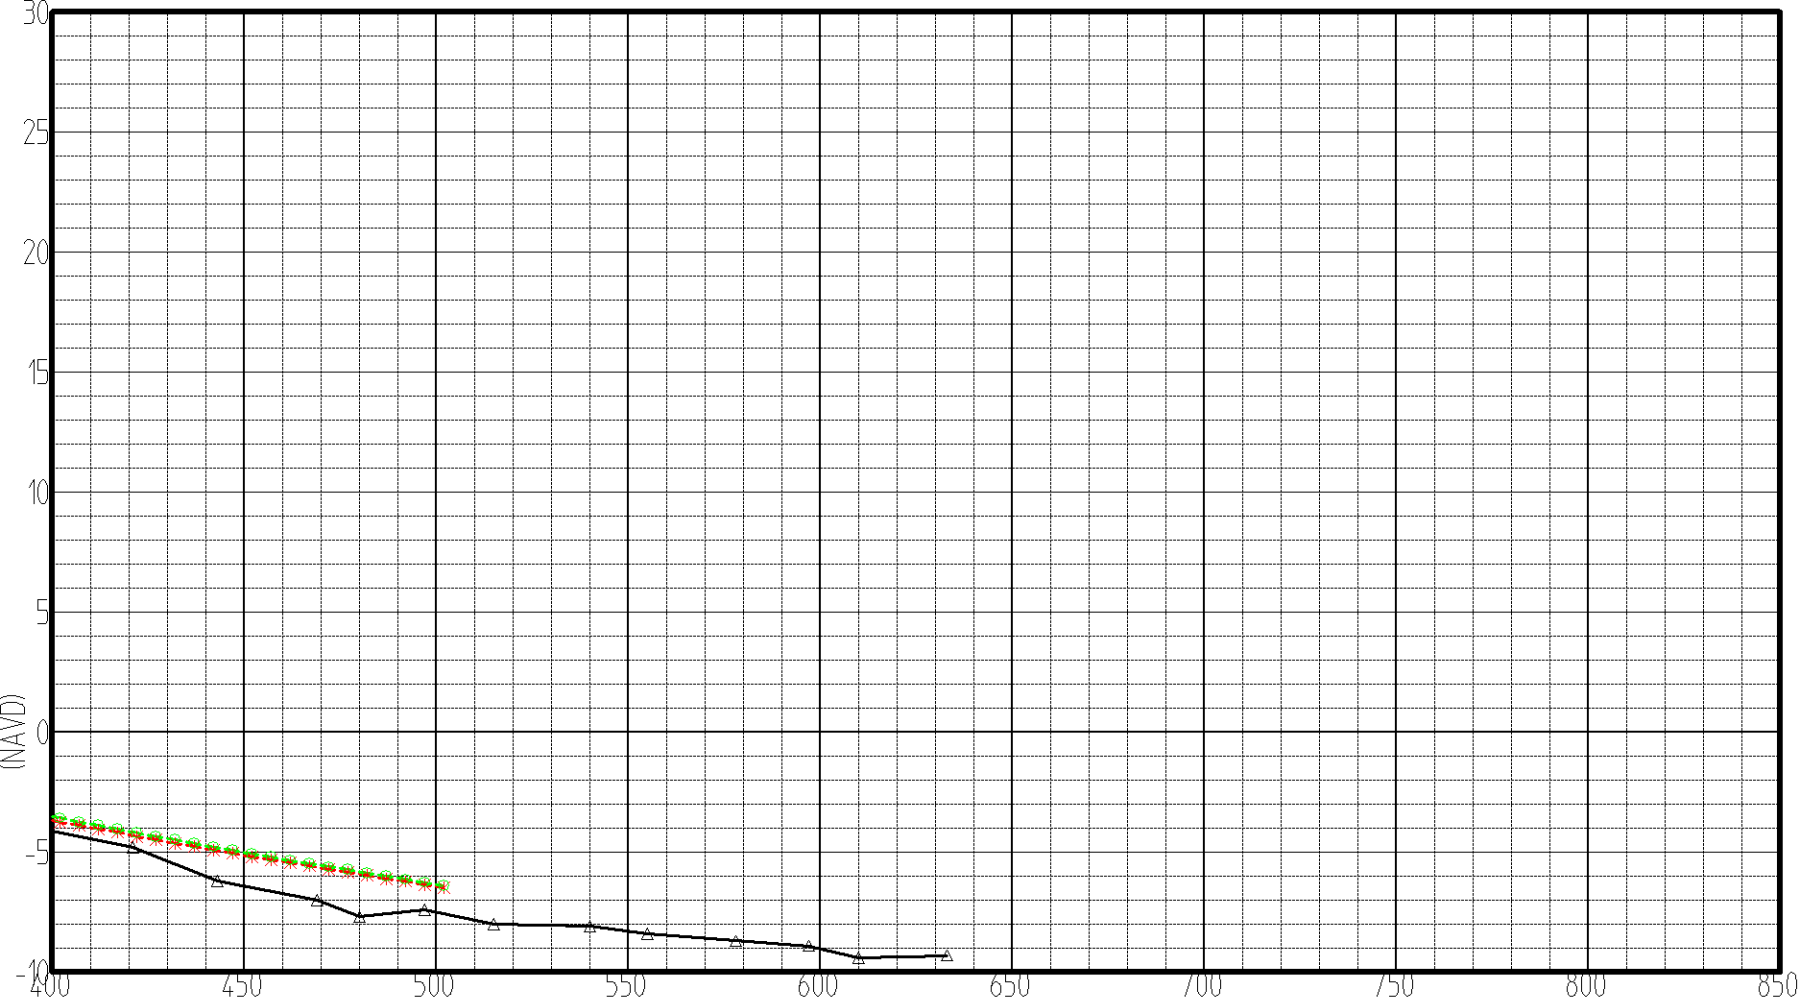
Range: R-184

BEACH PROFILE

—△—△— 2005-2008 INPUT PRF

- - - * - - - 15-YR SBEACH ERODED PRF

- - - o - - - 25-YR SBEACH ERODED PRF

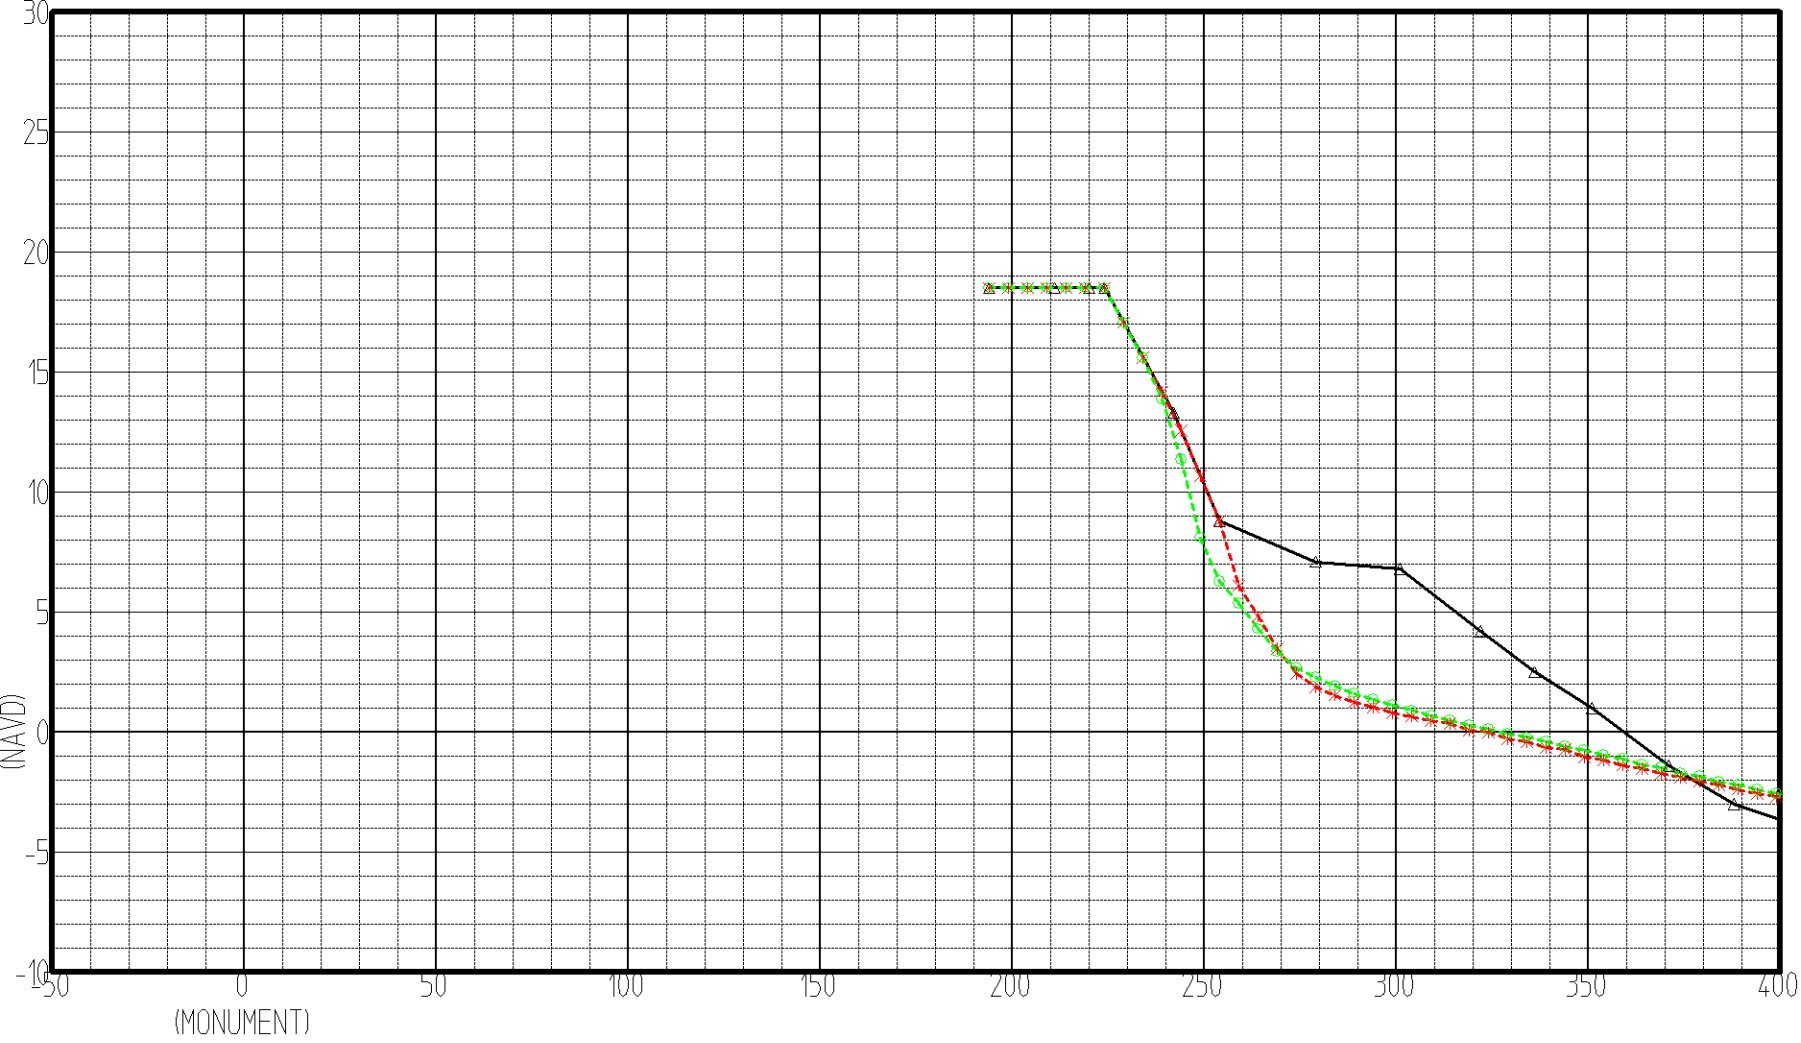
Range: R-185

BEACH PROFILE

—△—△— 2005-2008 INPUT PRF

- - - * - - - 15-YR SBEACH ERODED PRF

- - - o - - - 25-YR SBEACH ERODED PRF

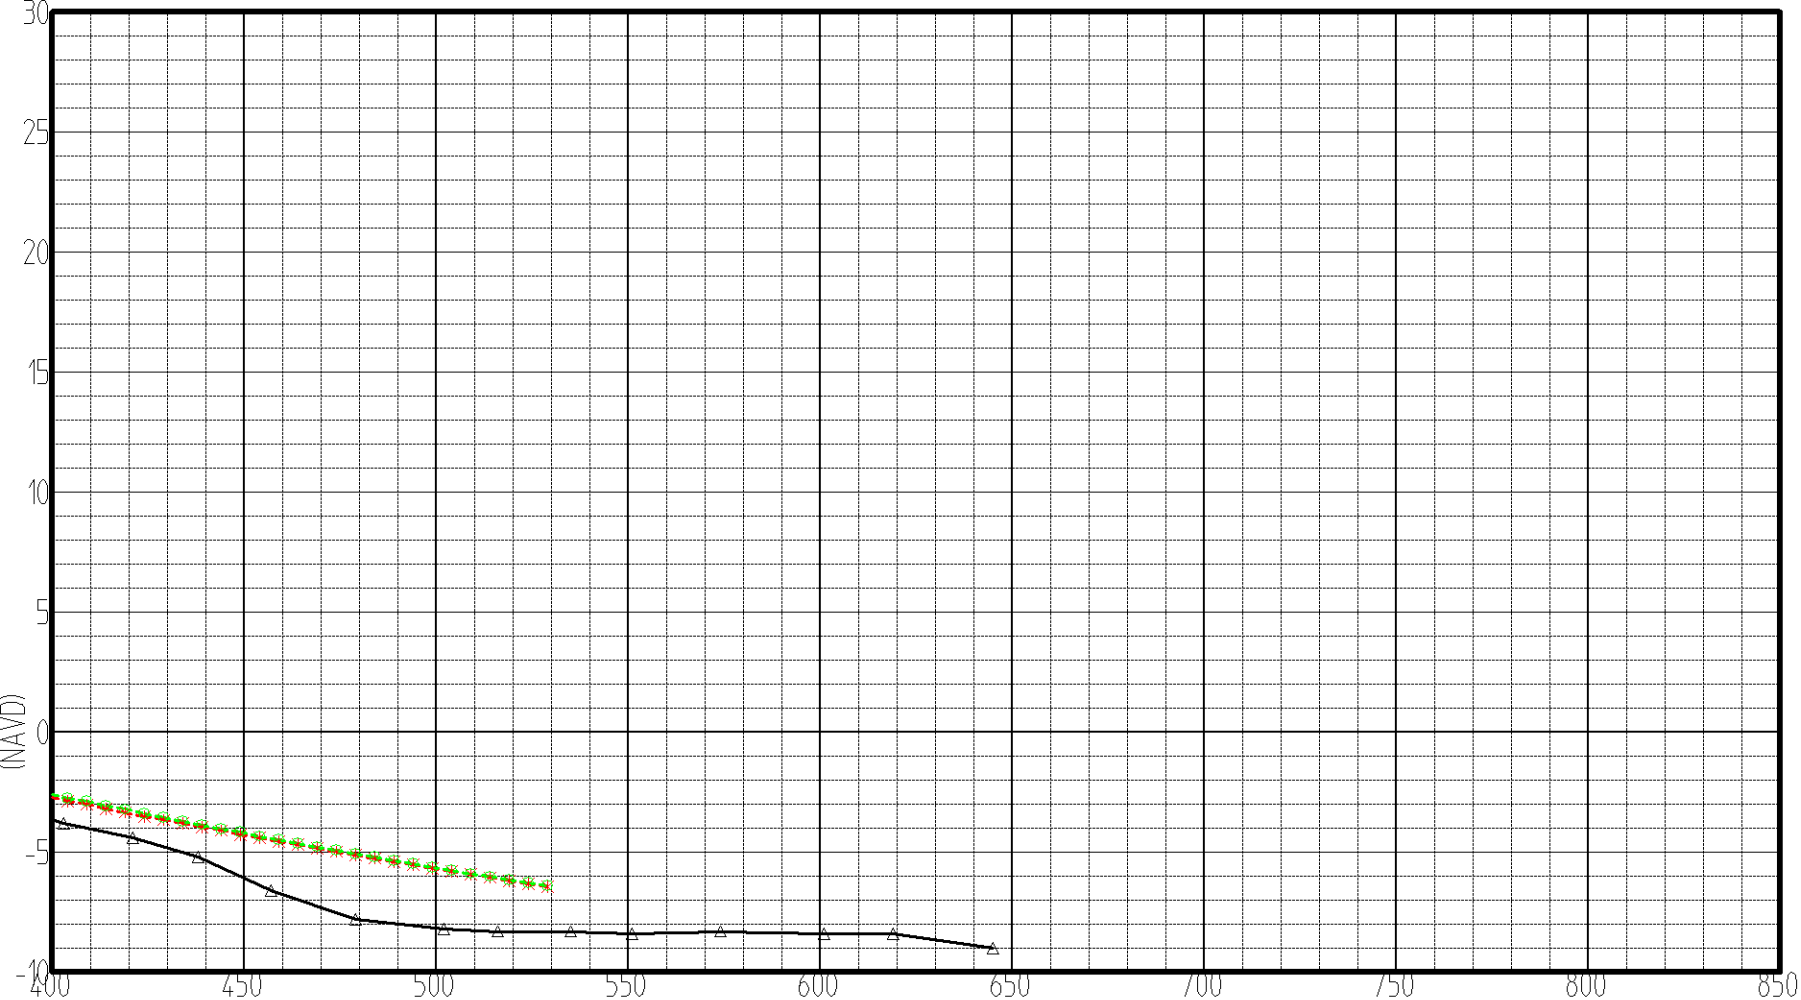
Range: R-185
 BEARING: 60.00
 2/2

BEACH PROFILE
 —△—△— 2005-2008 INPUT PRF
 - - * - - * - - 15-YR SBEACH ERODED PRF
 - - o - - o - - 25-YR SBEACH ERODED PRF

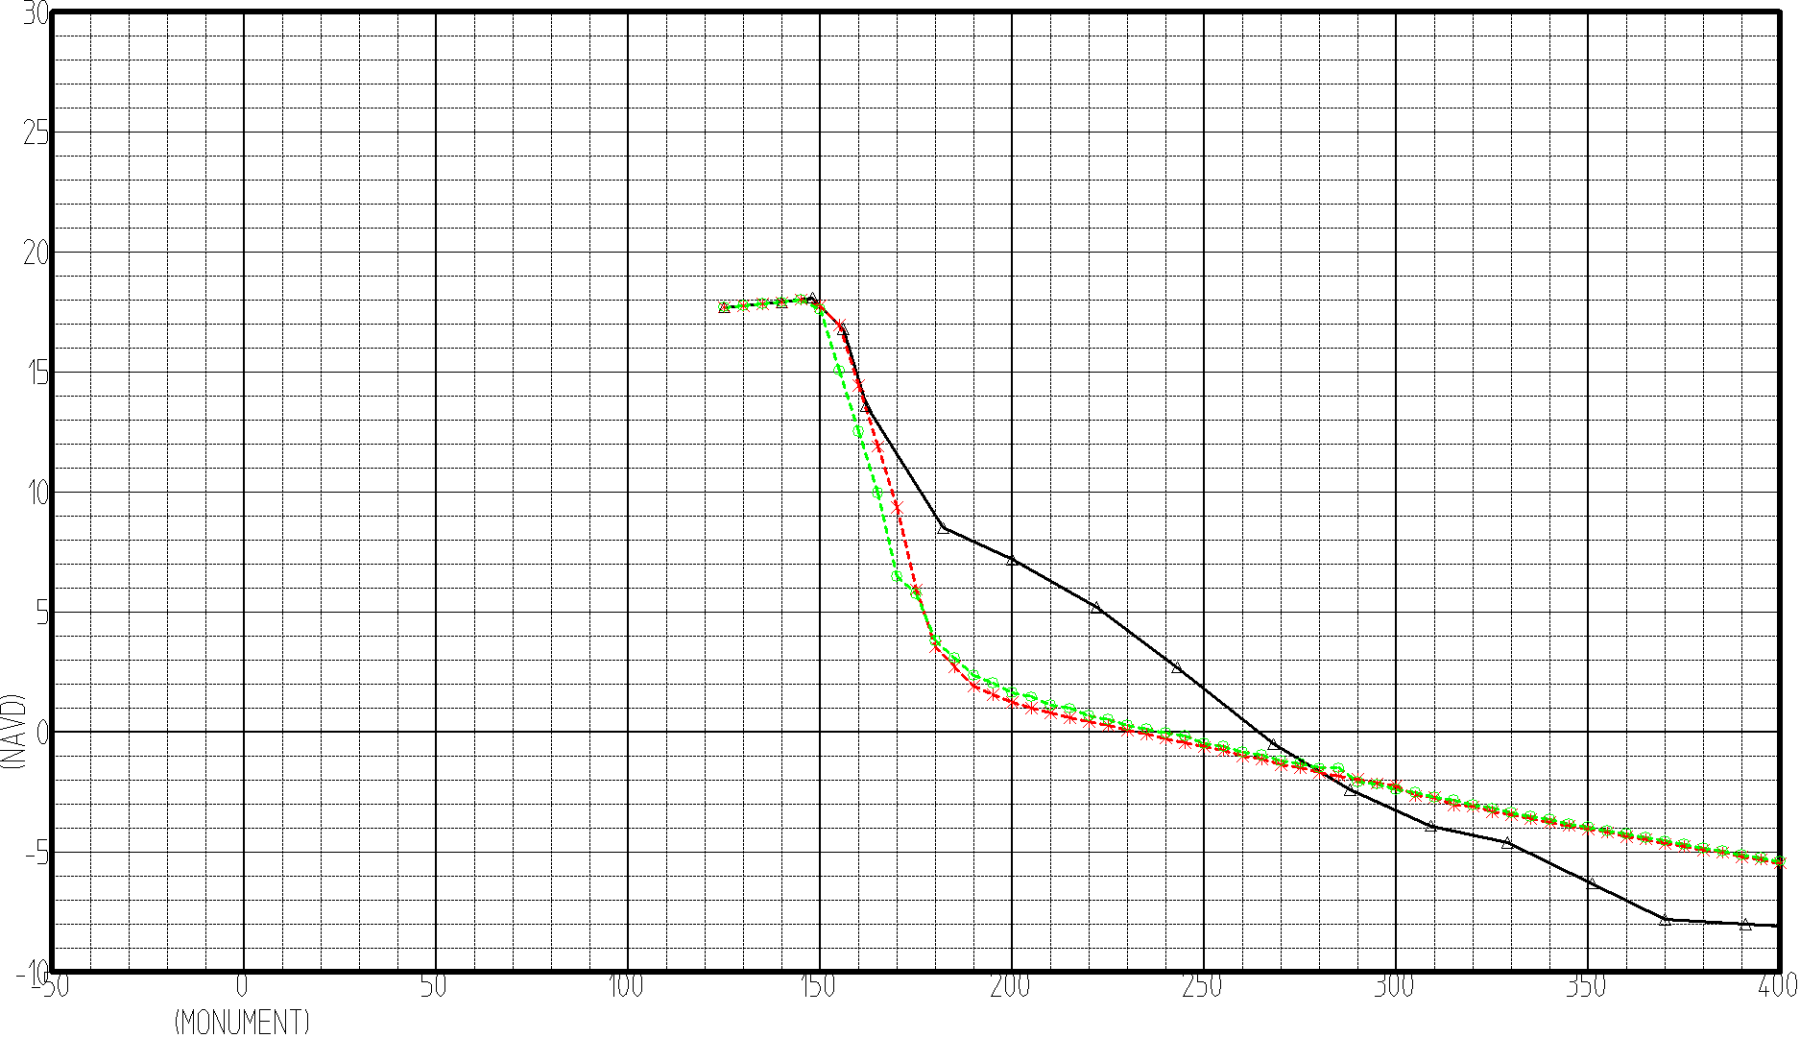
Range: R-186

BEACH PROFILE

—△—△— 2005-2008 INPUT PRF

- - * - - * - - 15-YR SBEACH ERODED PRF

- - o - - o - - 25-YR SBEACH ERODED PRF

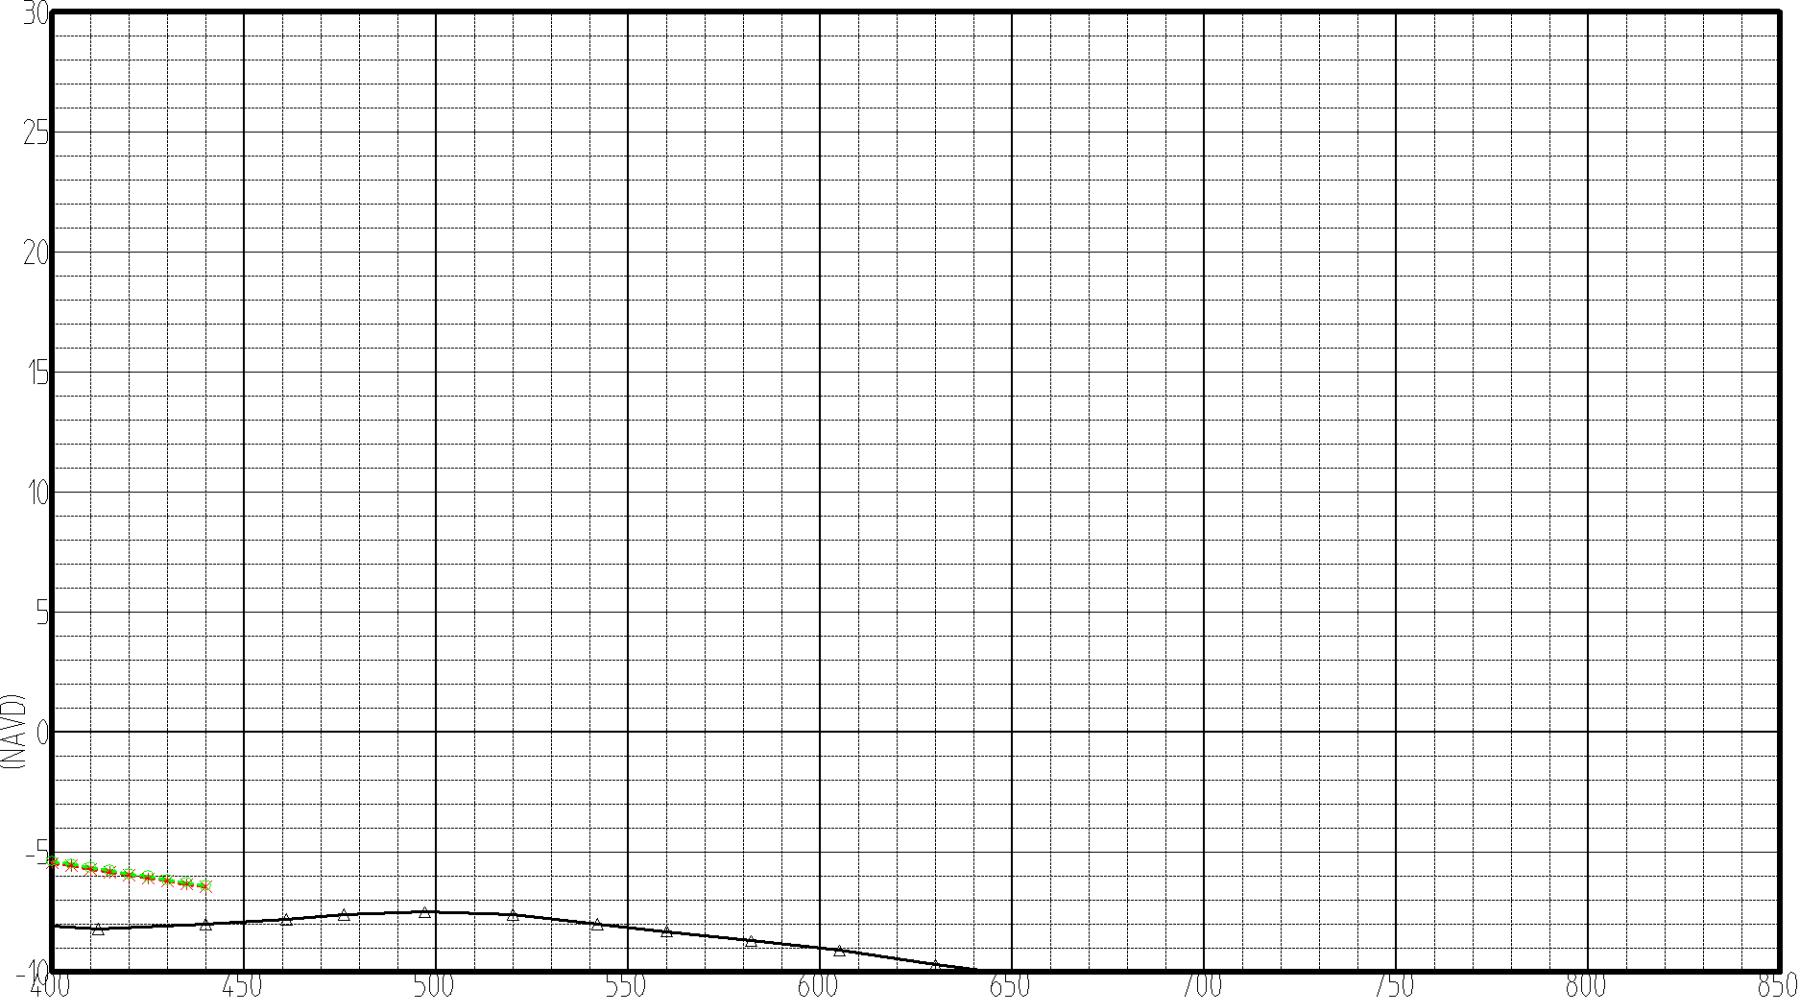
Range: R-186

BEACH PROFILE

—△—△— 2005-2008 INPUT PRF

- - - * - - - 15-YR SBEACH ERODED PRF

- - - o - - - 25-YR SBEACH ERODED PRF

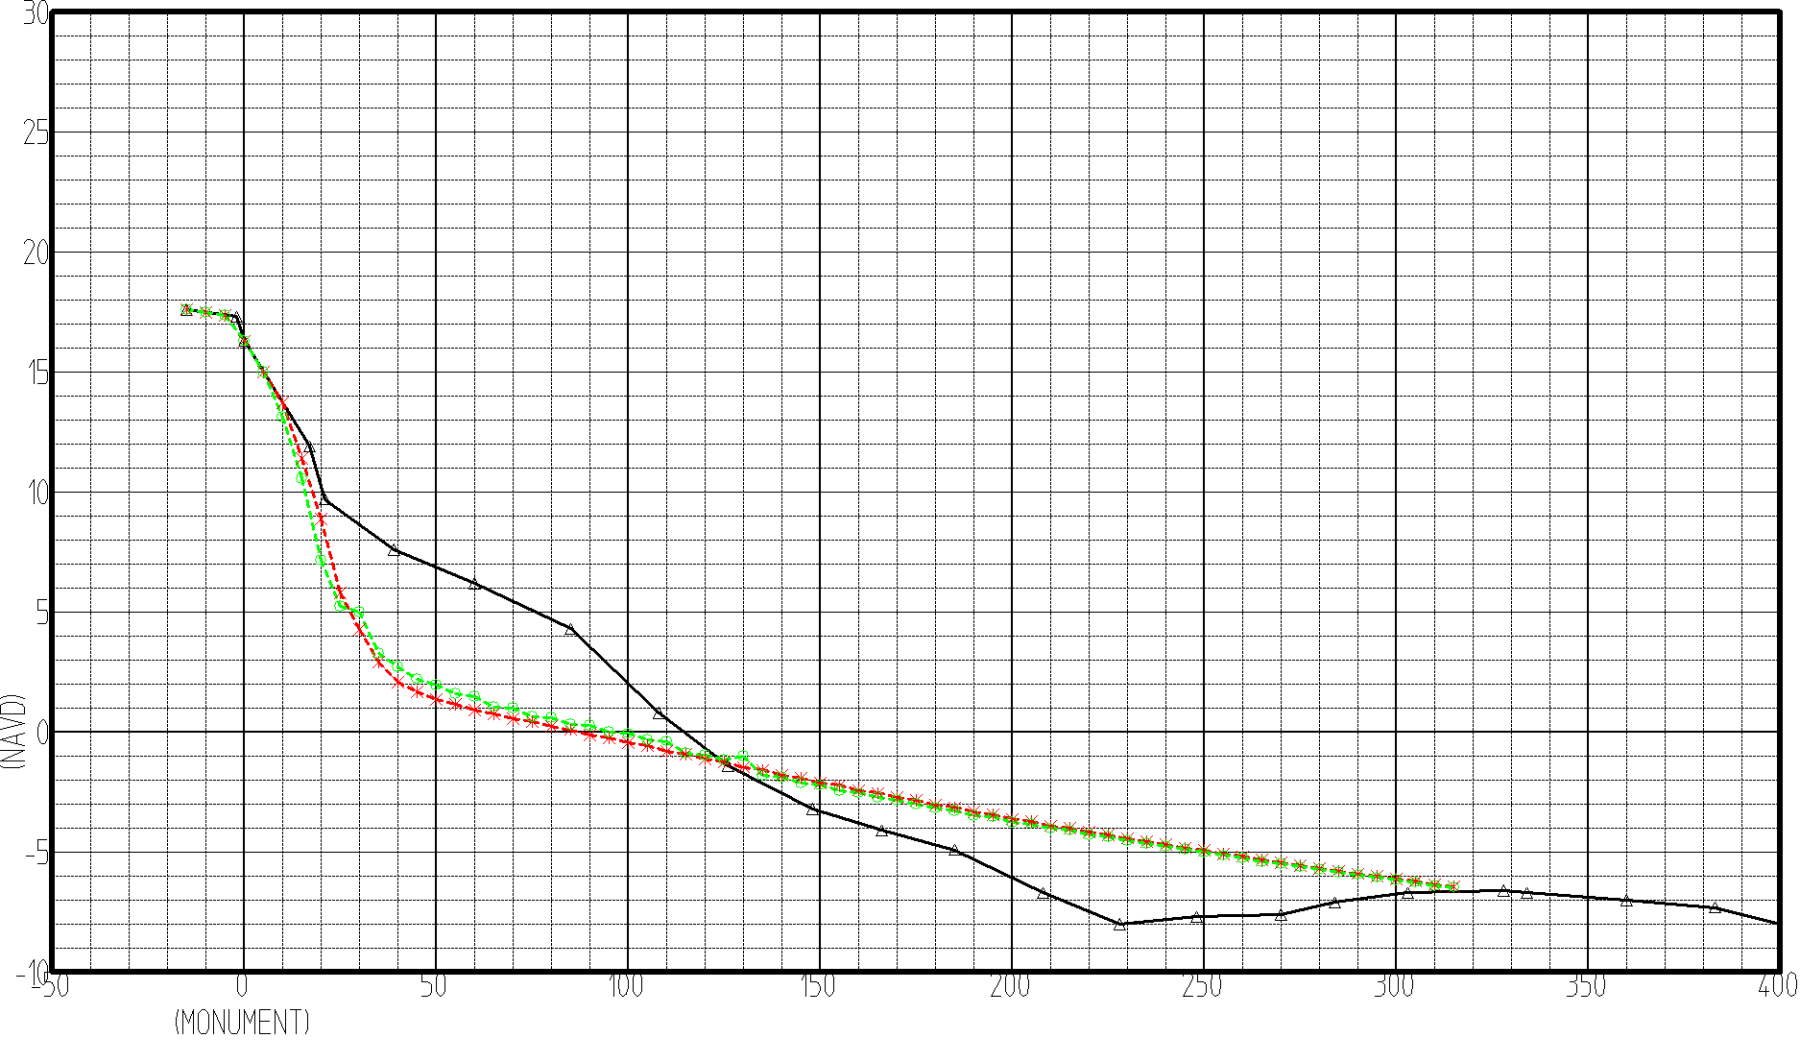
Range: R-187

BEACH PROFILE

—△—△— 2005-2008 INPUT PRF

- - - * - - - 15-YR SBEACH ERODED PRF

- - - o - - - 25-YR SBEACH ERODED PRF

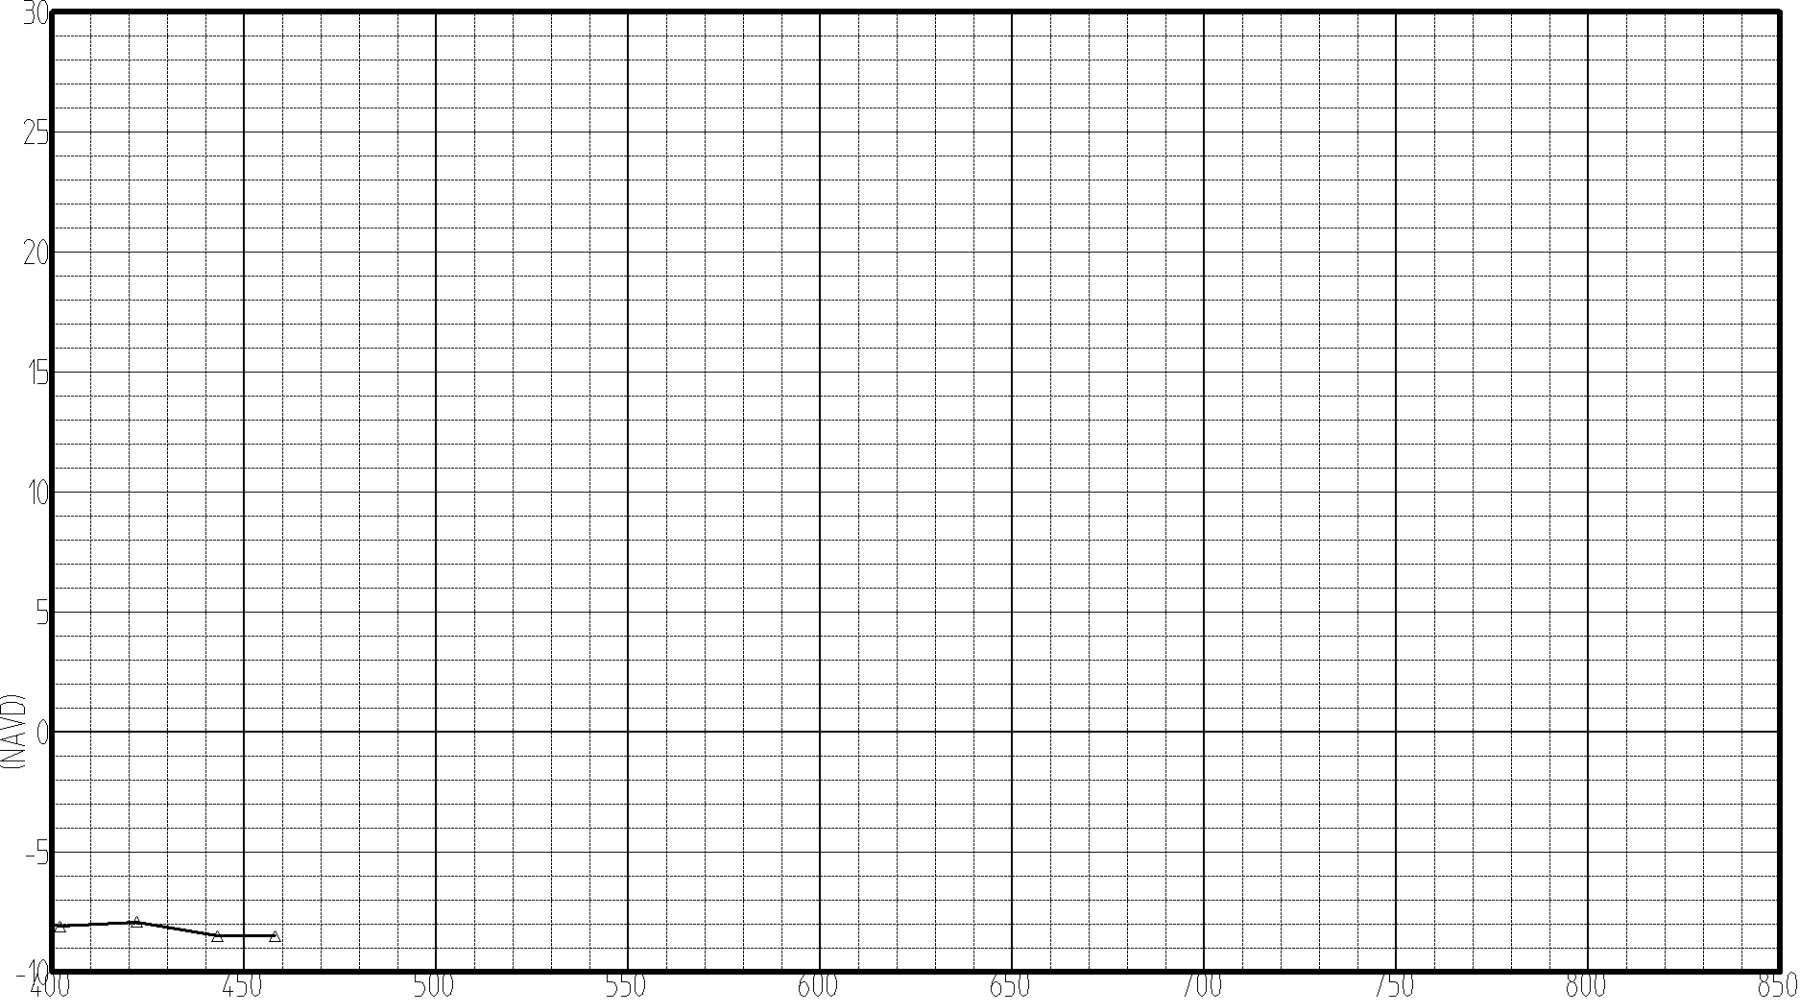
Range: R-187 2/2

BEACH PROFILE

- △—△— 2005-2008 INPUT PRF
- - - * - - - 15-YR SBEACH ERODED PRF
- - - o - - - 25-YR SBEACH ERODED PRF

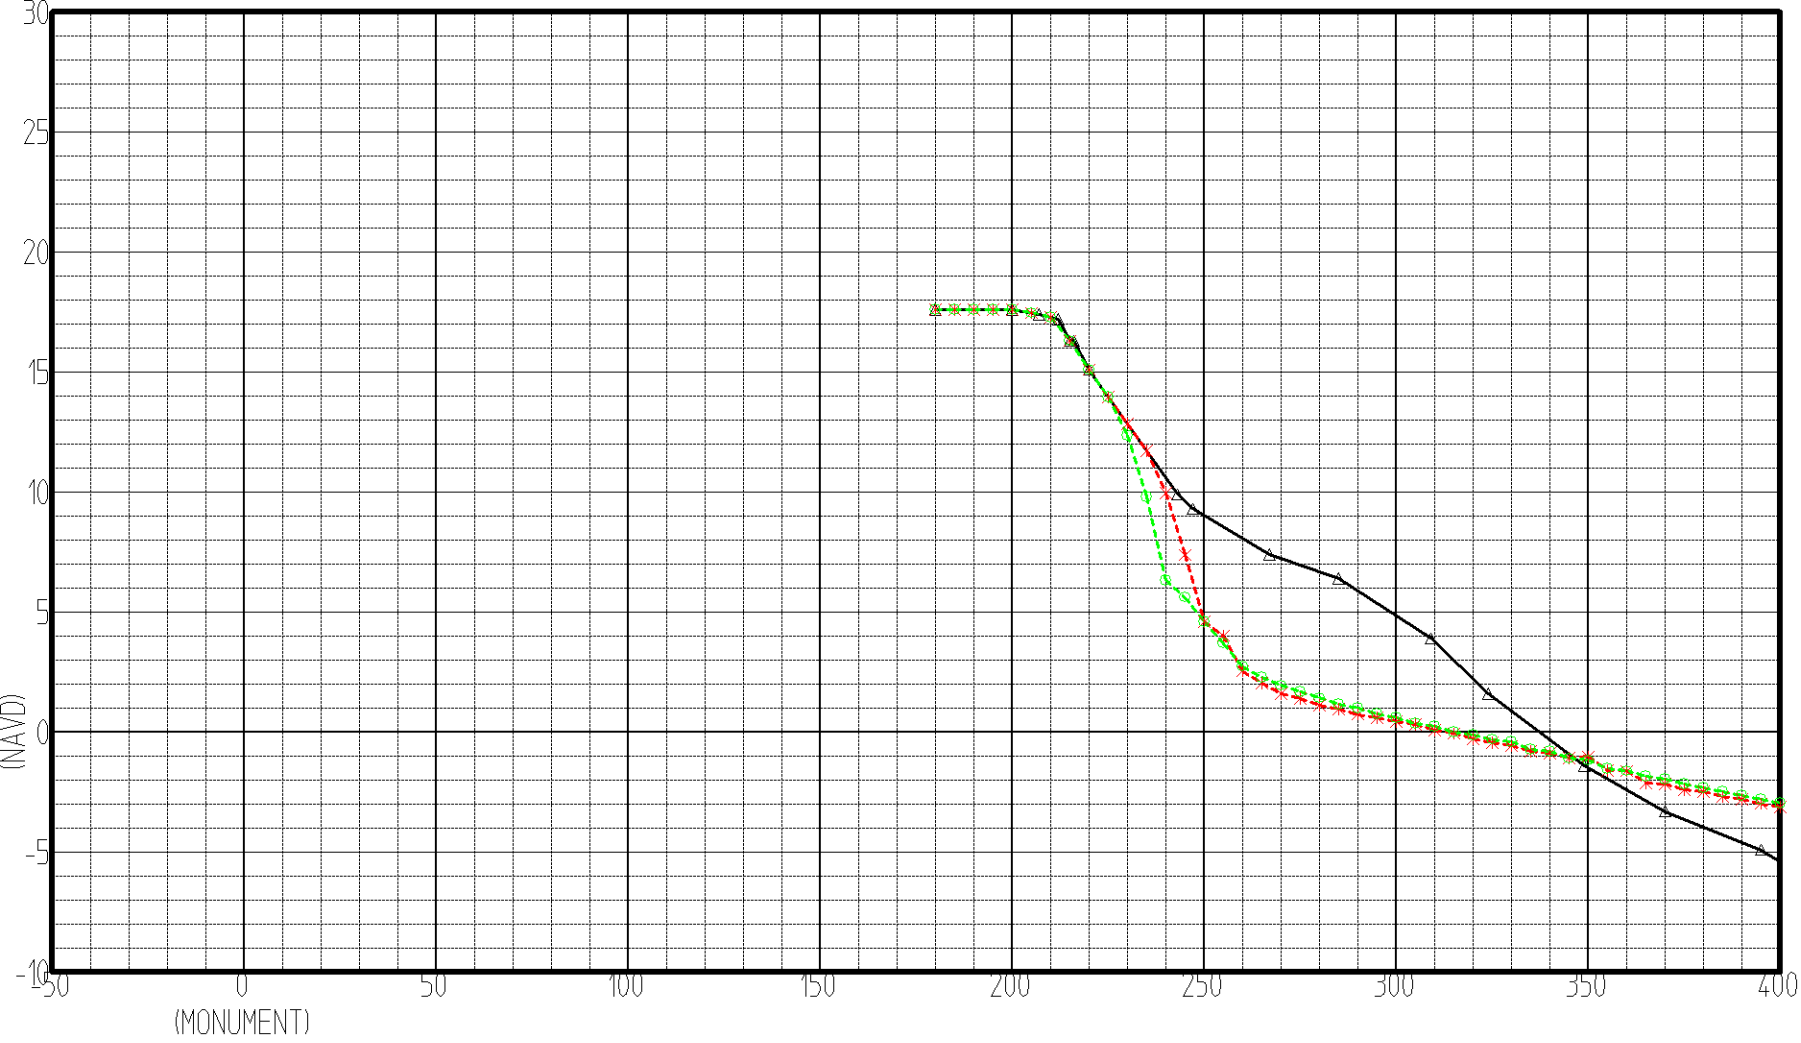
Range: R-188
 BEARING: 70.00
 1/2

BEACH PROFILE
 —△—△— 2005-2008 INPUT PRF
 - - * - - * - - 15-YR SBEACH ERODED PRF
 - - o - - o - - 25-YR SBEACH ERODED PRF

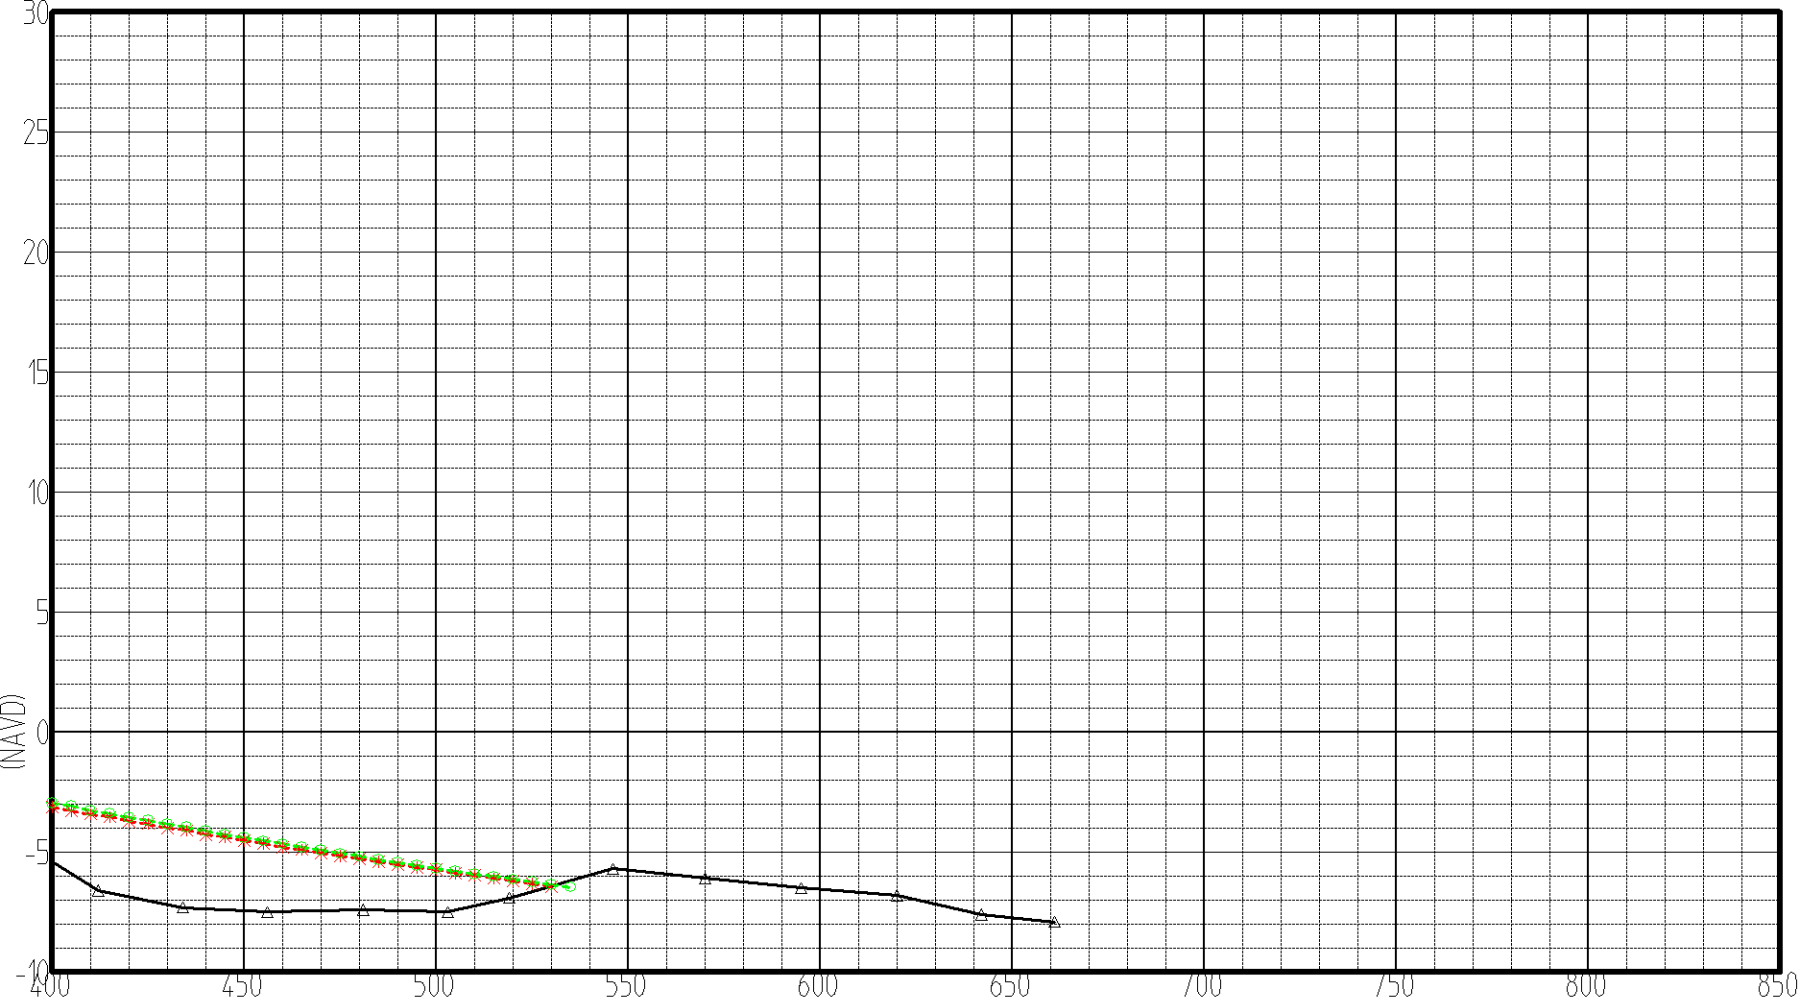
Range: R-188

BEACH PROFILE

—△—△— 2005-2008 INPUT PRF

- - - * - - - 15-YR SBEACH ERODED PRF

- - - o - - - 25-YR SBEACH ERODED PRF

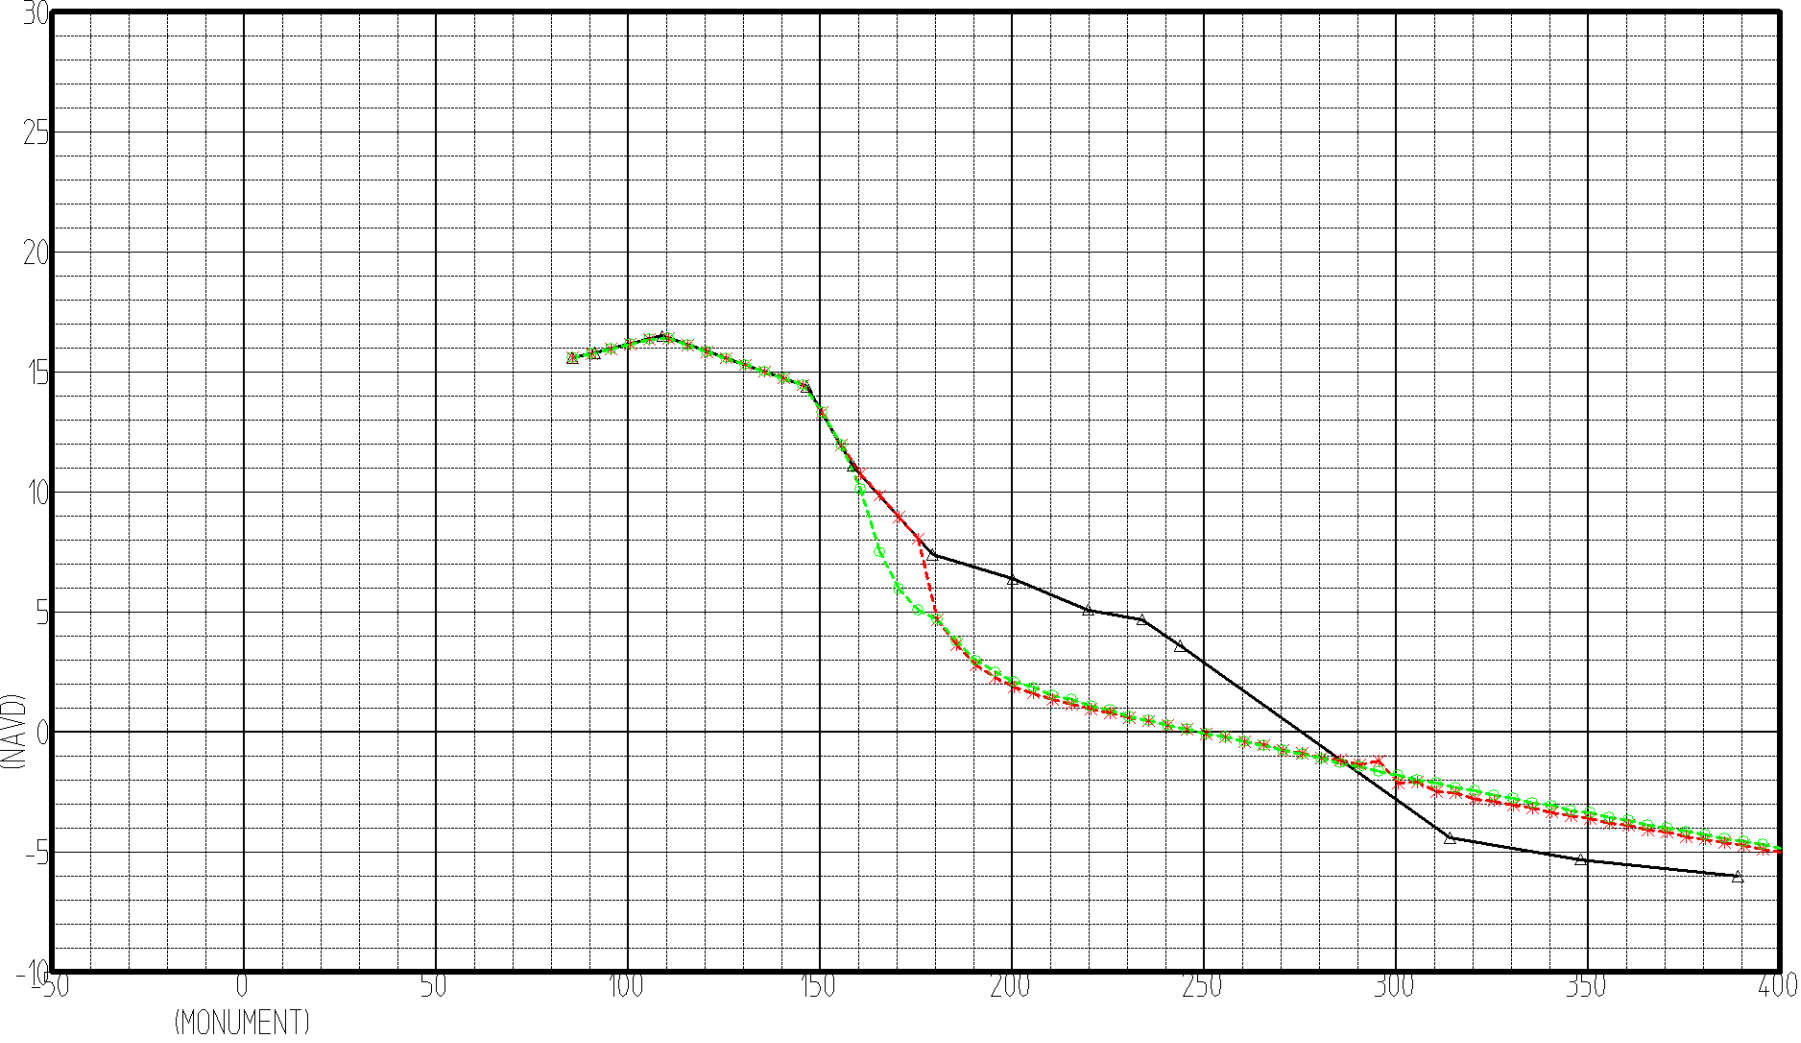
Range: R-189

BEACH PROFILE

—△—△— 2005-2008 INPUT PRF

- - - * - - - 15-YR SBEACH ERODED PRF

- - - o - - - 25-YR SBEACH ERODED PRF

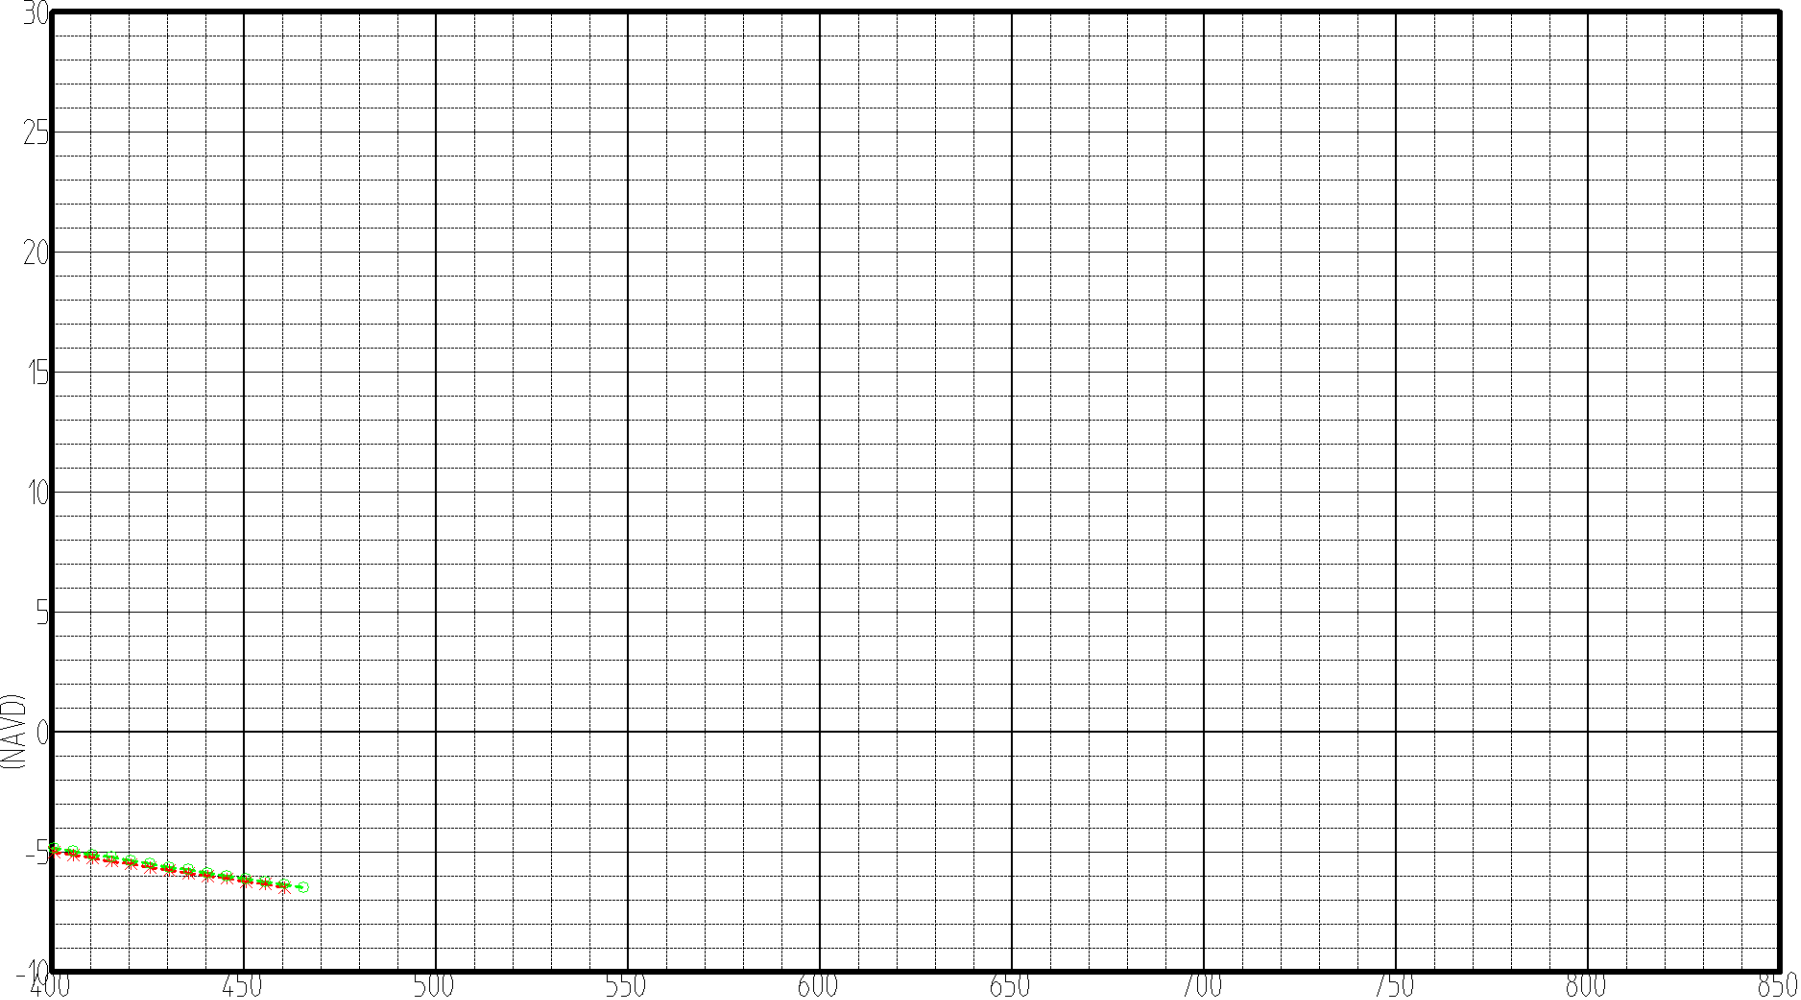
Range: R-189 2/2

BEACH PROFILE

- △—△— 2005-2008 INPUT PRF
- - - * - - - 15-YR SBEACH ERODED PRF
- - - o - - - 25-YR SBEACH ERODED PRF
