Appendix XI

SBEACH 15 and 25 yr. Storm Erosion Profiles

Brevard County

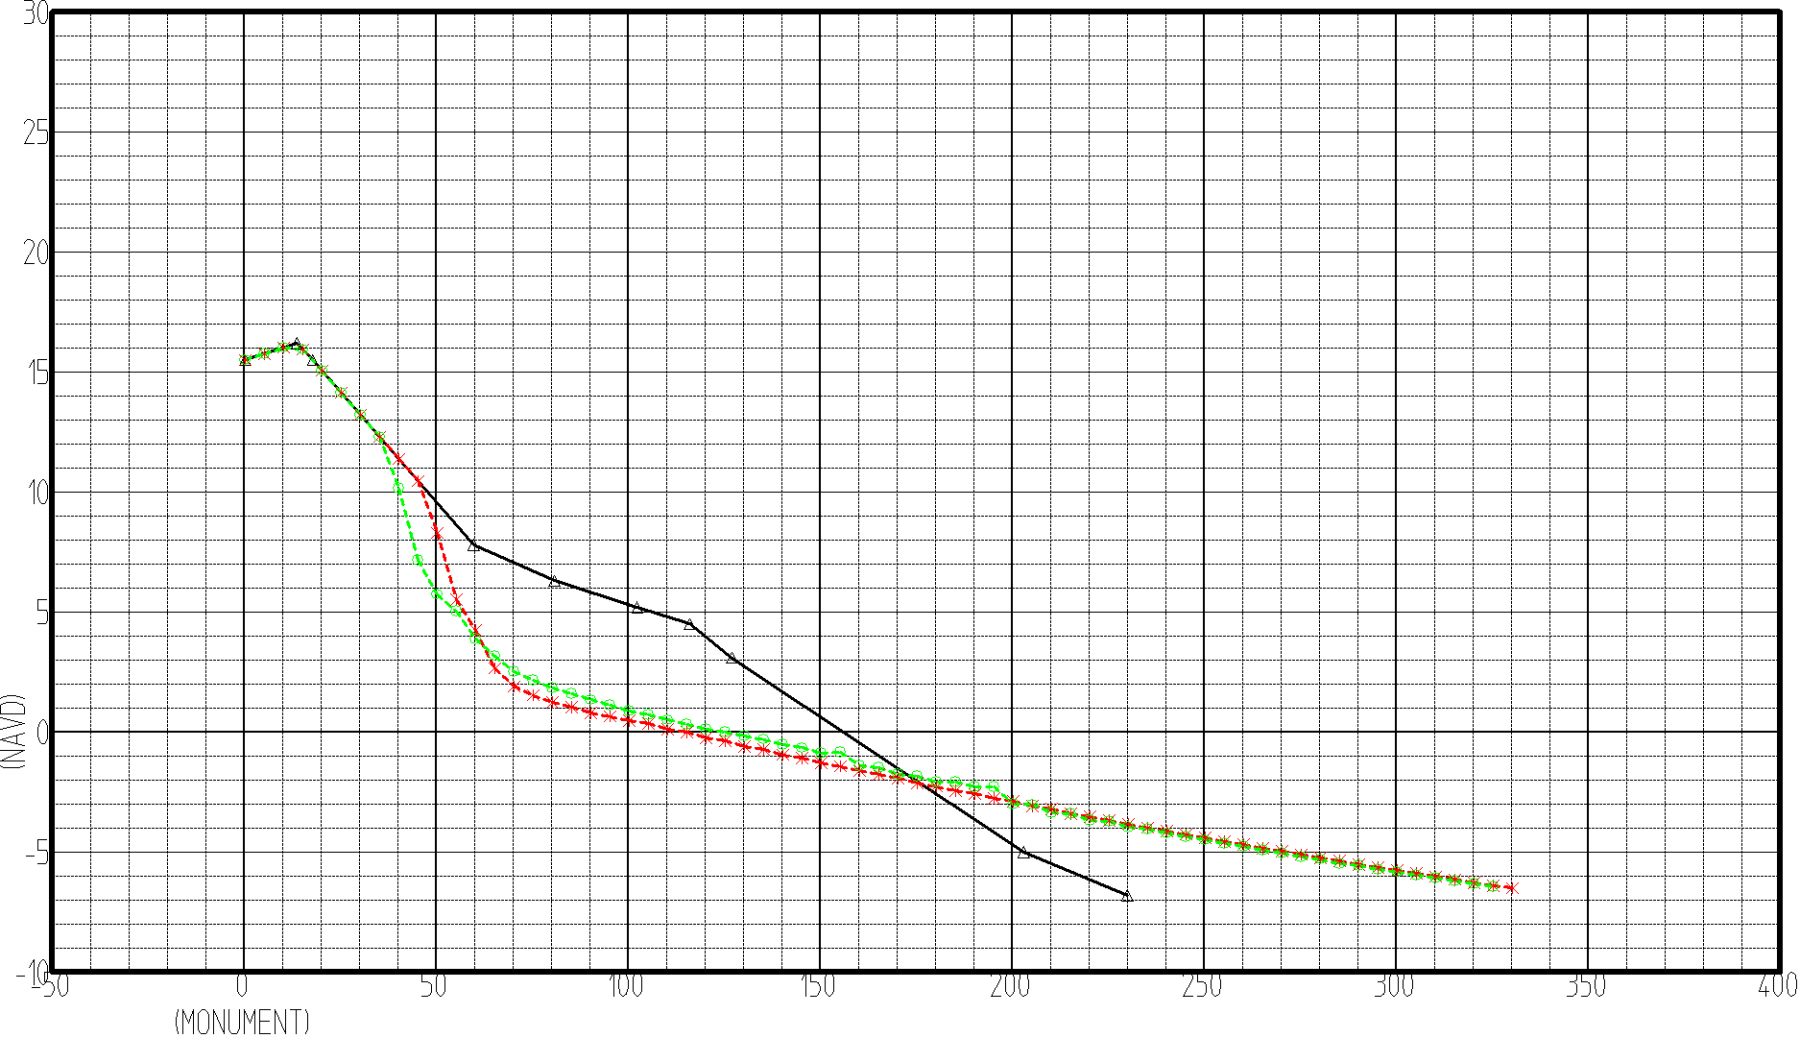
Range: R-190

BEACH PROFILE

—△—△— 2005-2008 INPUT PRF

- - - * - - - 15-YR SBEBACH ERODED PRF

- - - o - - - 25-YR SBEBACH ERODED PRF

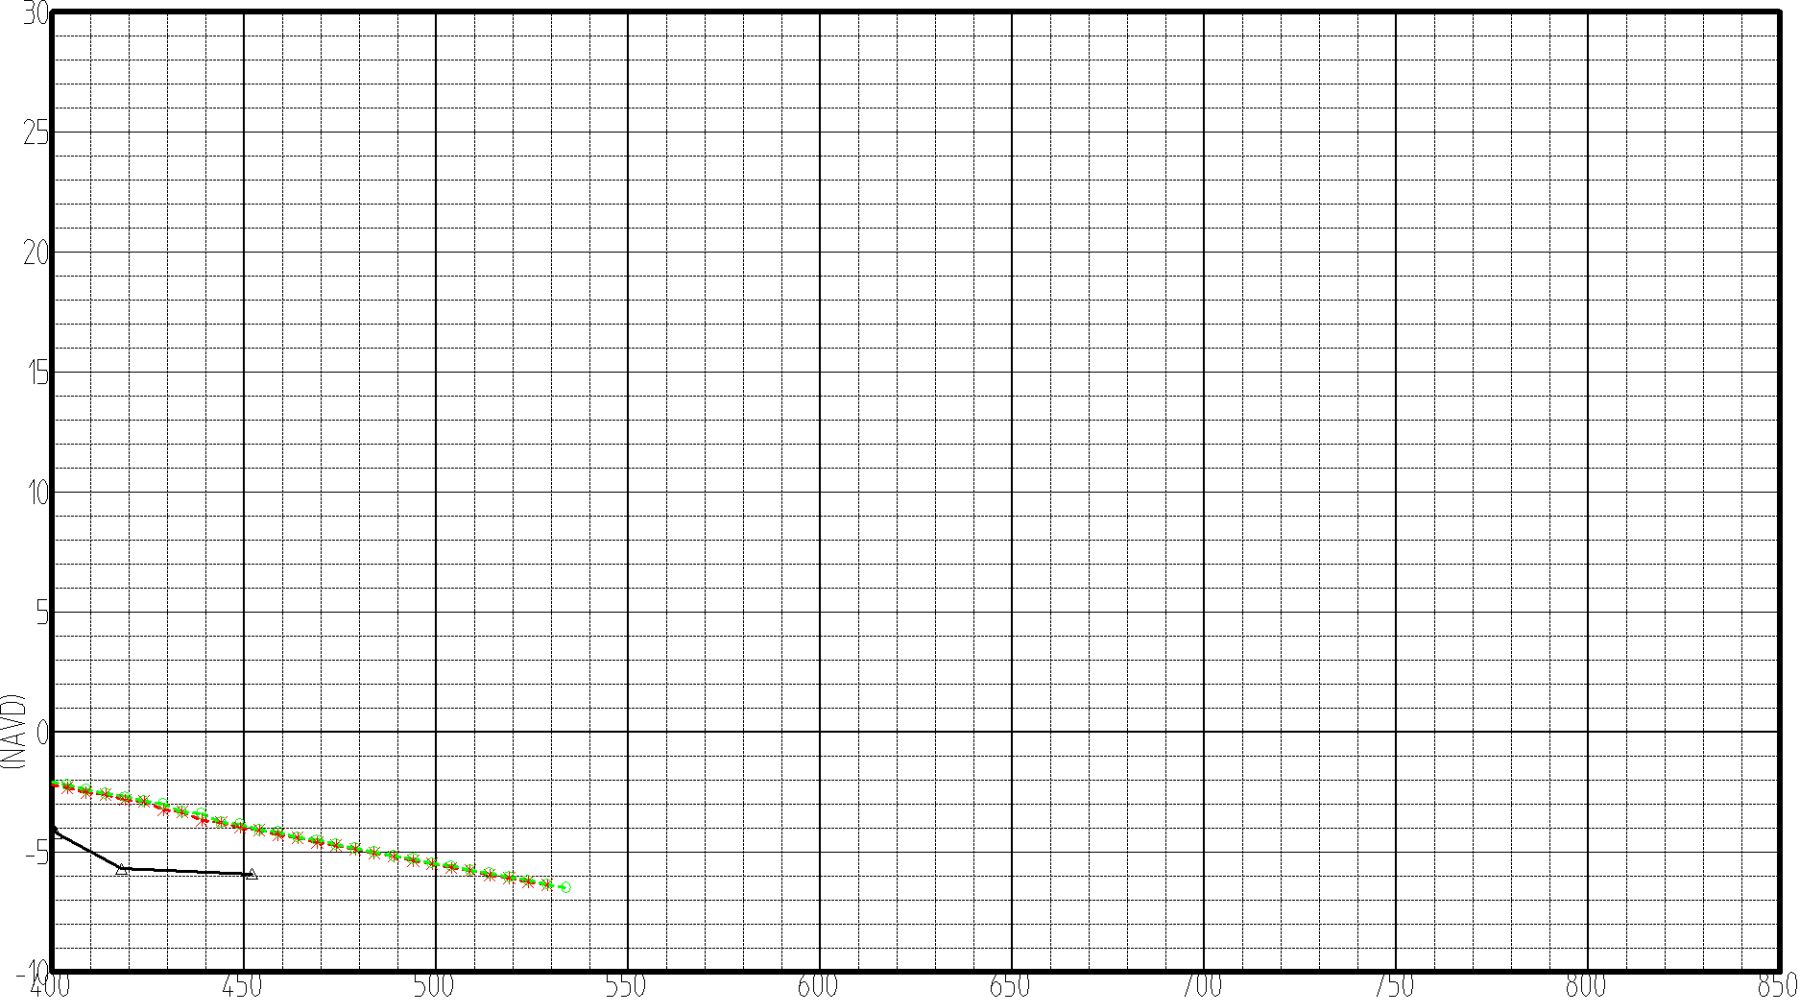
Range: R-212-T

BEACH PROFILE

—△—△— 2005-2008 INPUT PRF

- - - * - - - 15-YR SBEACH ERODED PRF

- - - ○ - - - 25-YR SBEACH ERODED PRF

BEARING: 70.00

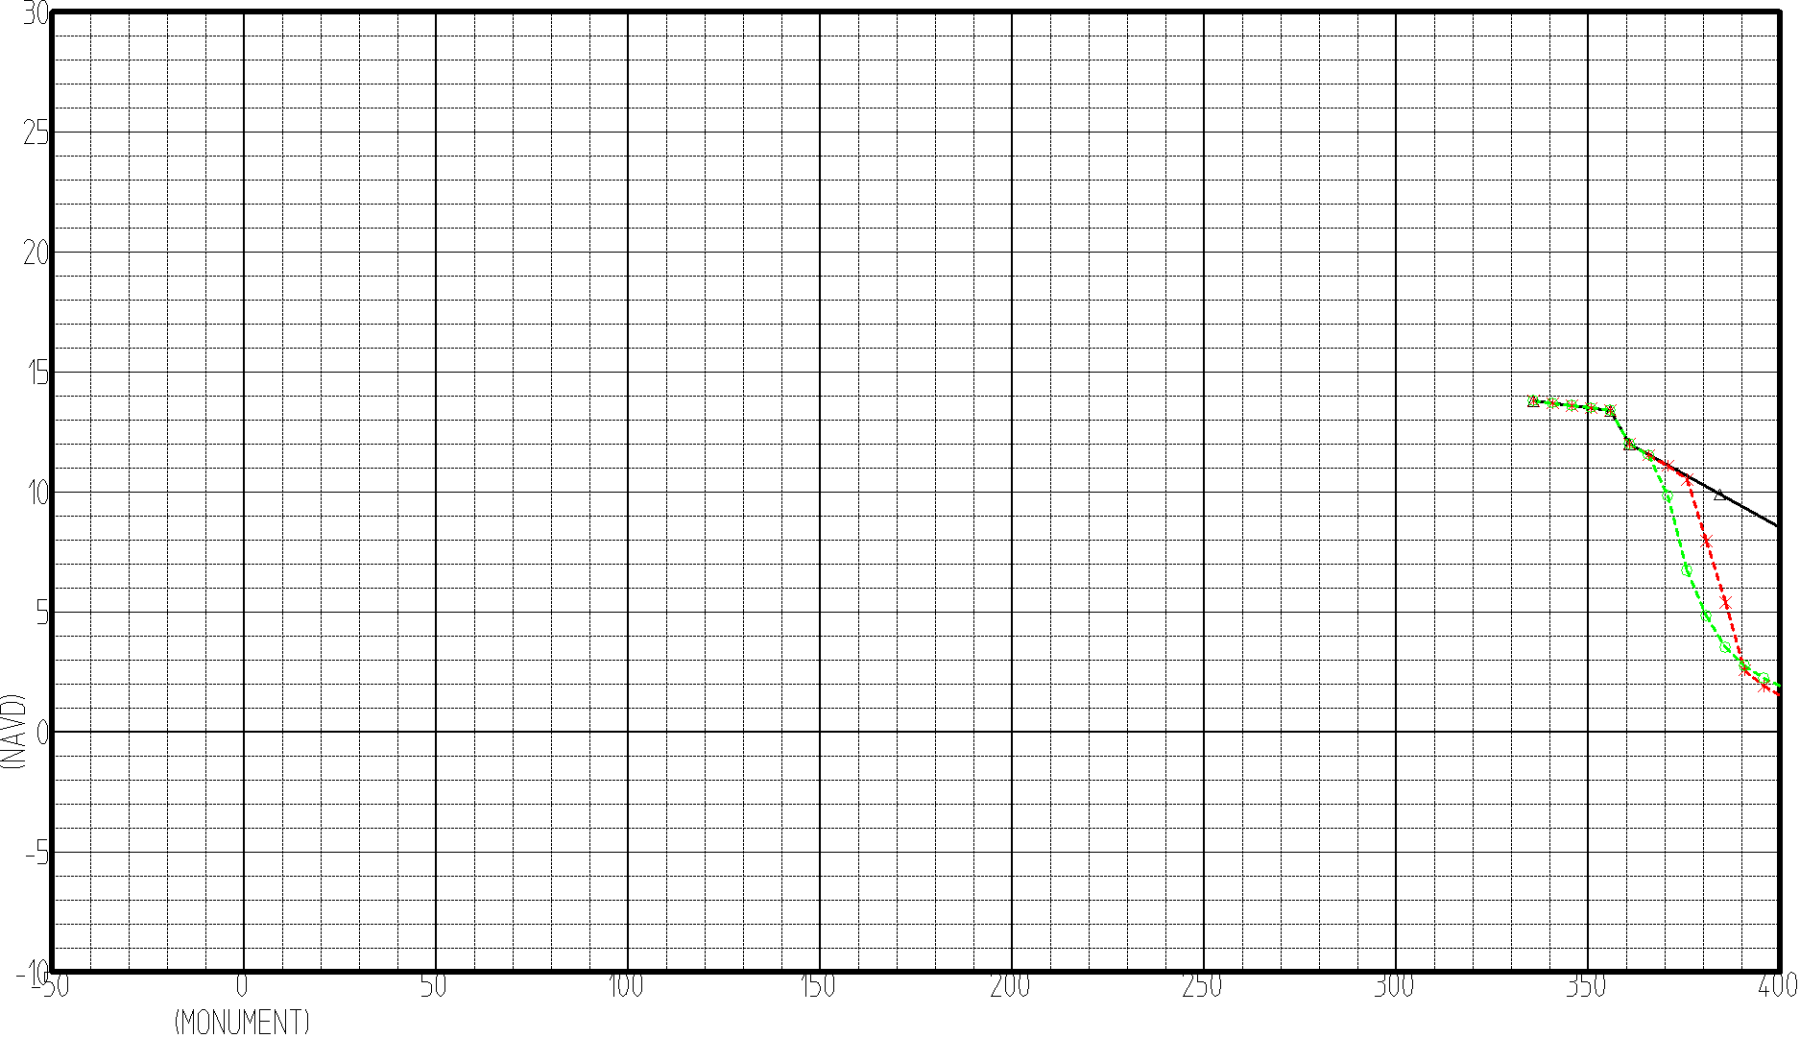
Range: R-213 1/2

BEACH PROFILE

- △—△— 2005-2008 INPUT PRF
- - - * - - - 15-YR SBEACH ERODED PRF
- - - o - - - 25-YR SBEACH ERODED PRF

BEARING: 70.00

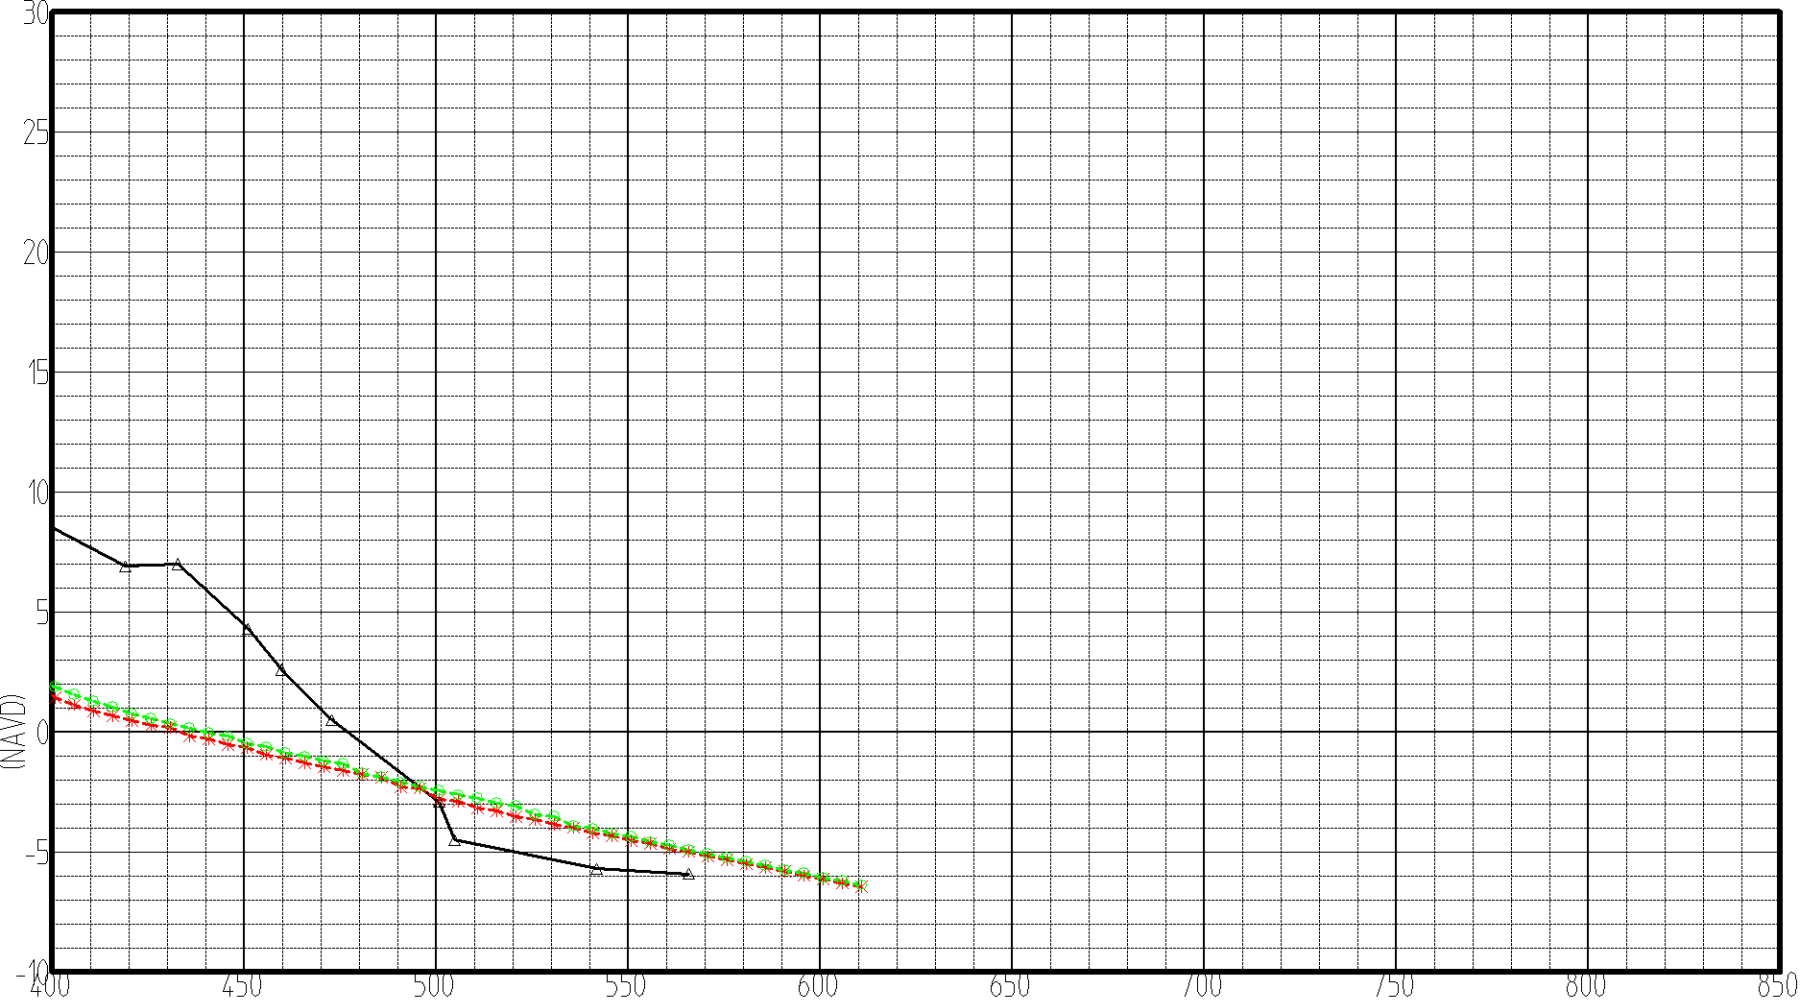
Range: R-213

BEACH PROFILE

—△—△— 2005-2008 INPUT PRF

- - - * - - - 15-YR SBEACH ERODED PRF

- - - o - - - 25-YR SBEACH ERODED PRF

BEARING: 70.00

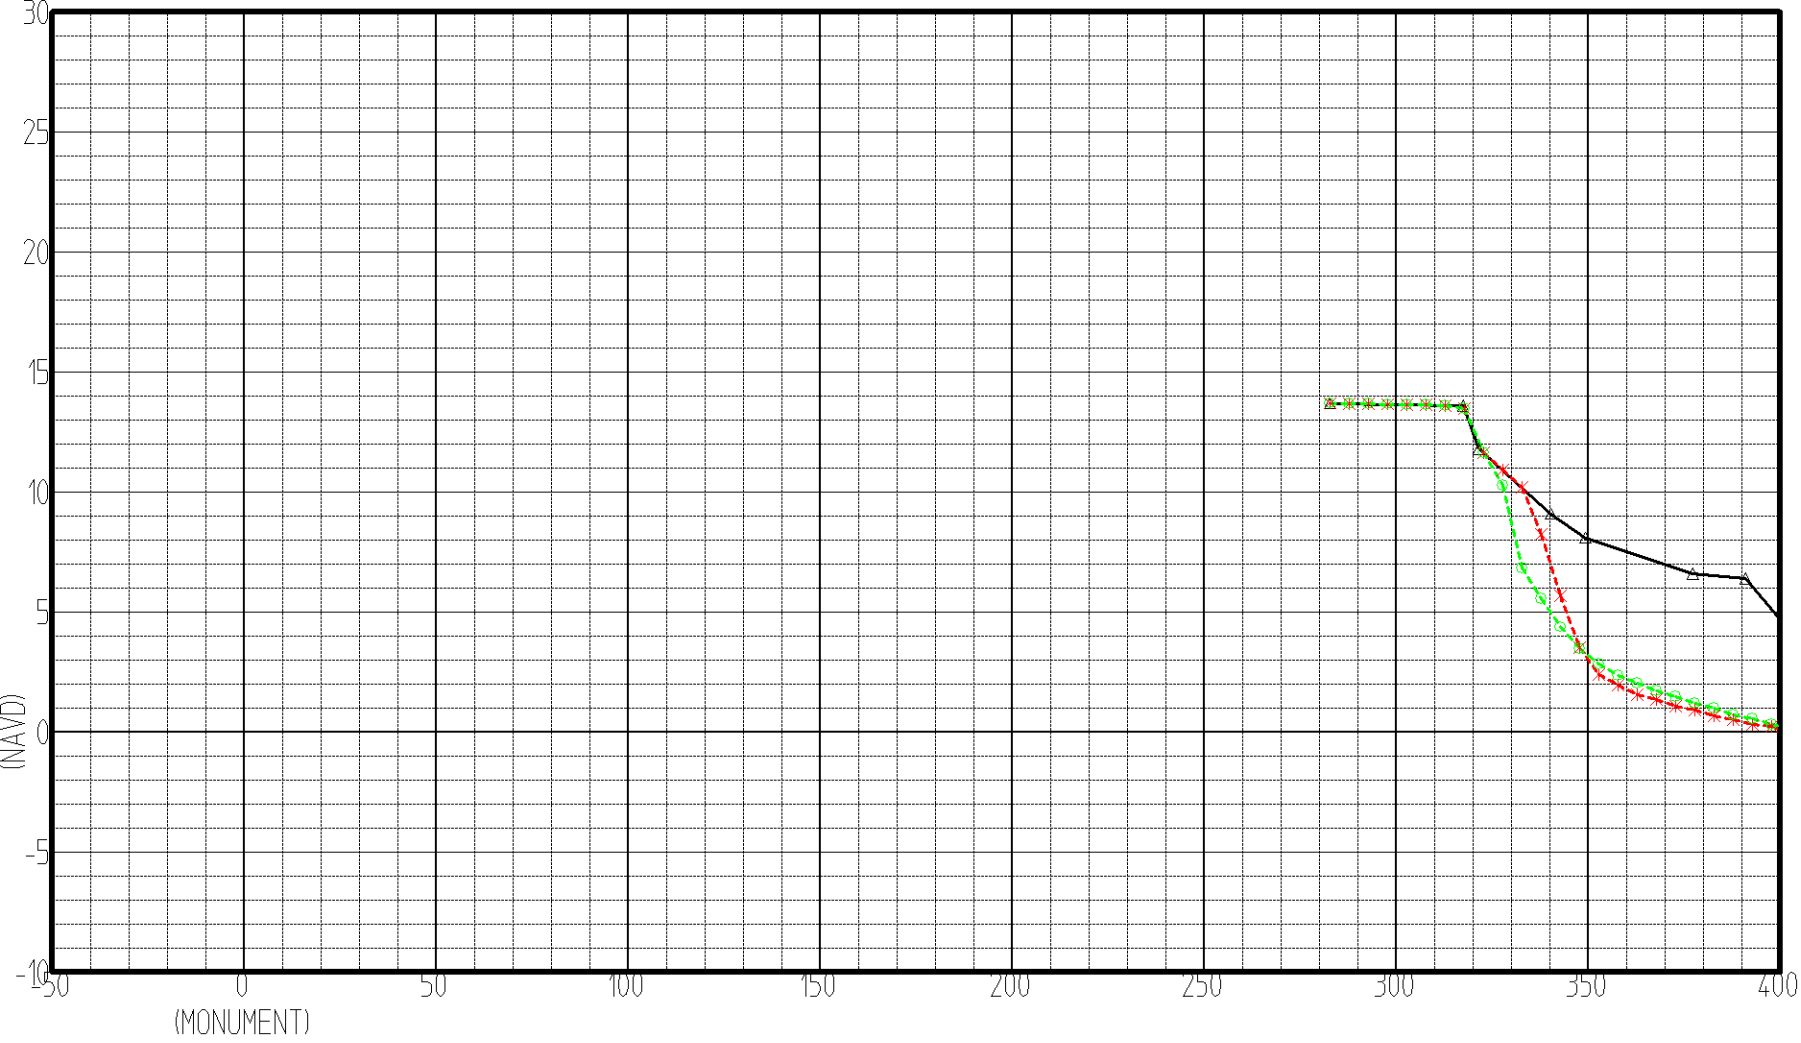
Range: R-214 1/2

BEACH PROFILE

- △—△— 2005-2008 INPUT PRF
- - - * - - - 15-YR SBEACH ERODED PRF
- - - o - - - 25-YR SBEACH ERODED PRF

Bearing: 70.00

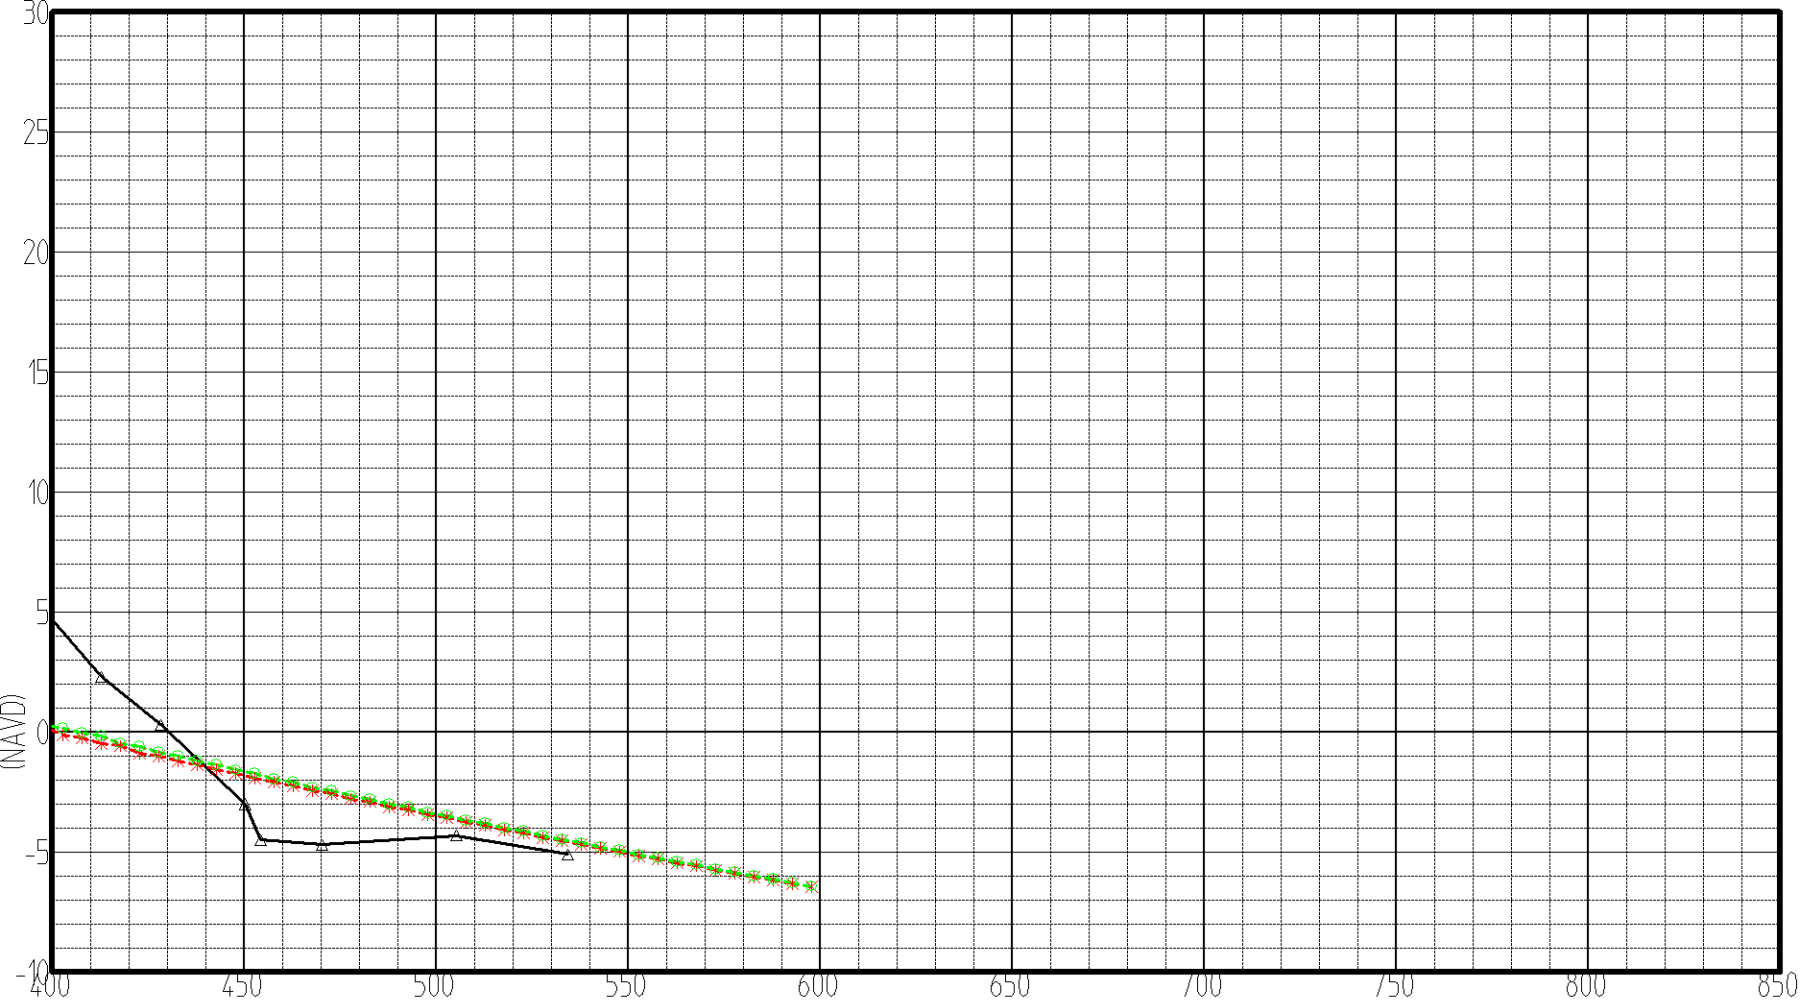
Range: R-214

BEACH PROFILE

—△—△— 2005-2008 INPUT PRF

- - - * - - - 15-YR SBEACH ERODED PRF

- - - o - - - 25-YR SBEACH ERODED PRF

BEARING: 70.00

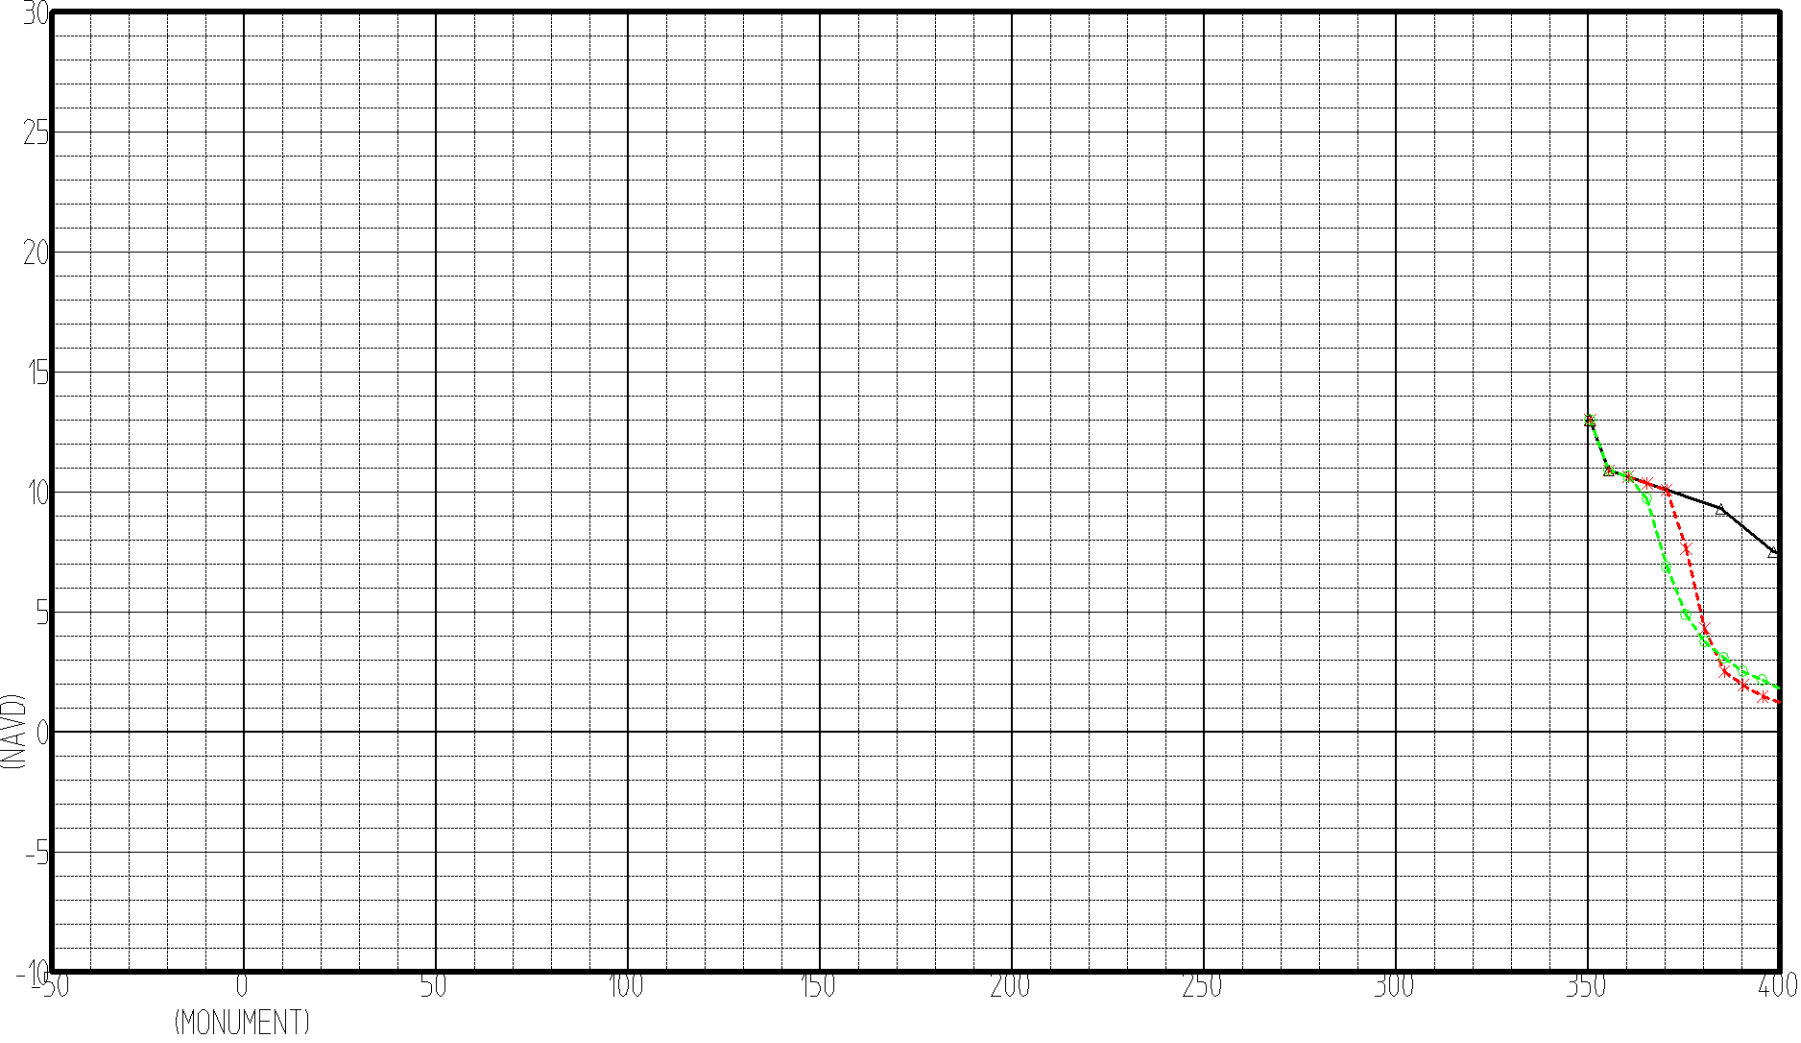
Range: R-215 1/2

BEACH PROFILE

- △—△— 2005-2008 INPUT PRF
- - - * - - - 15-YR SBEACH ERODED PRF
- - - o - - - 25-YR SBEACH ERODED PRF

Bearing: 70.00

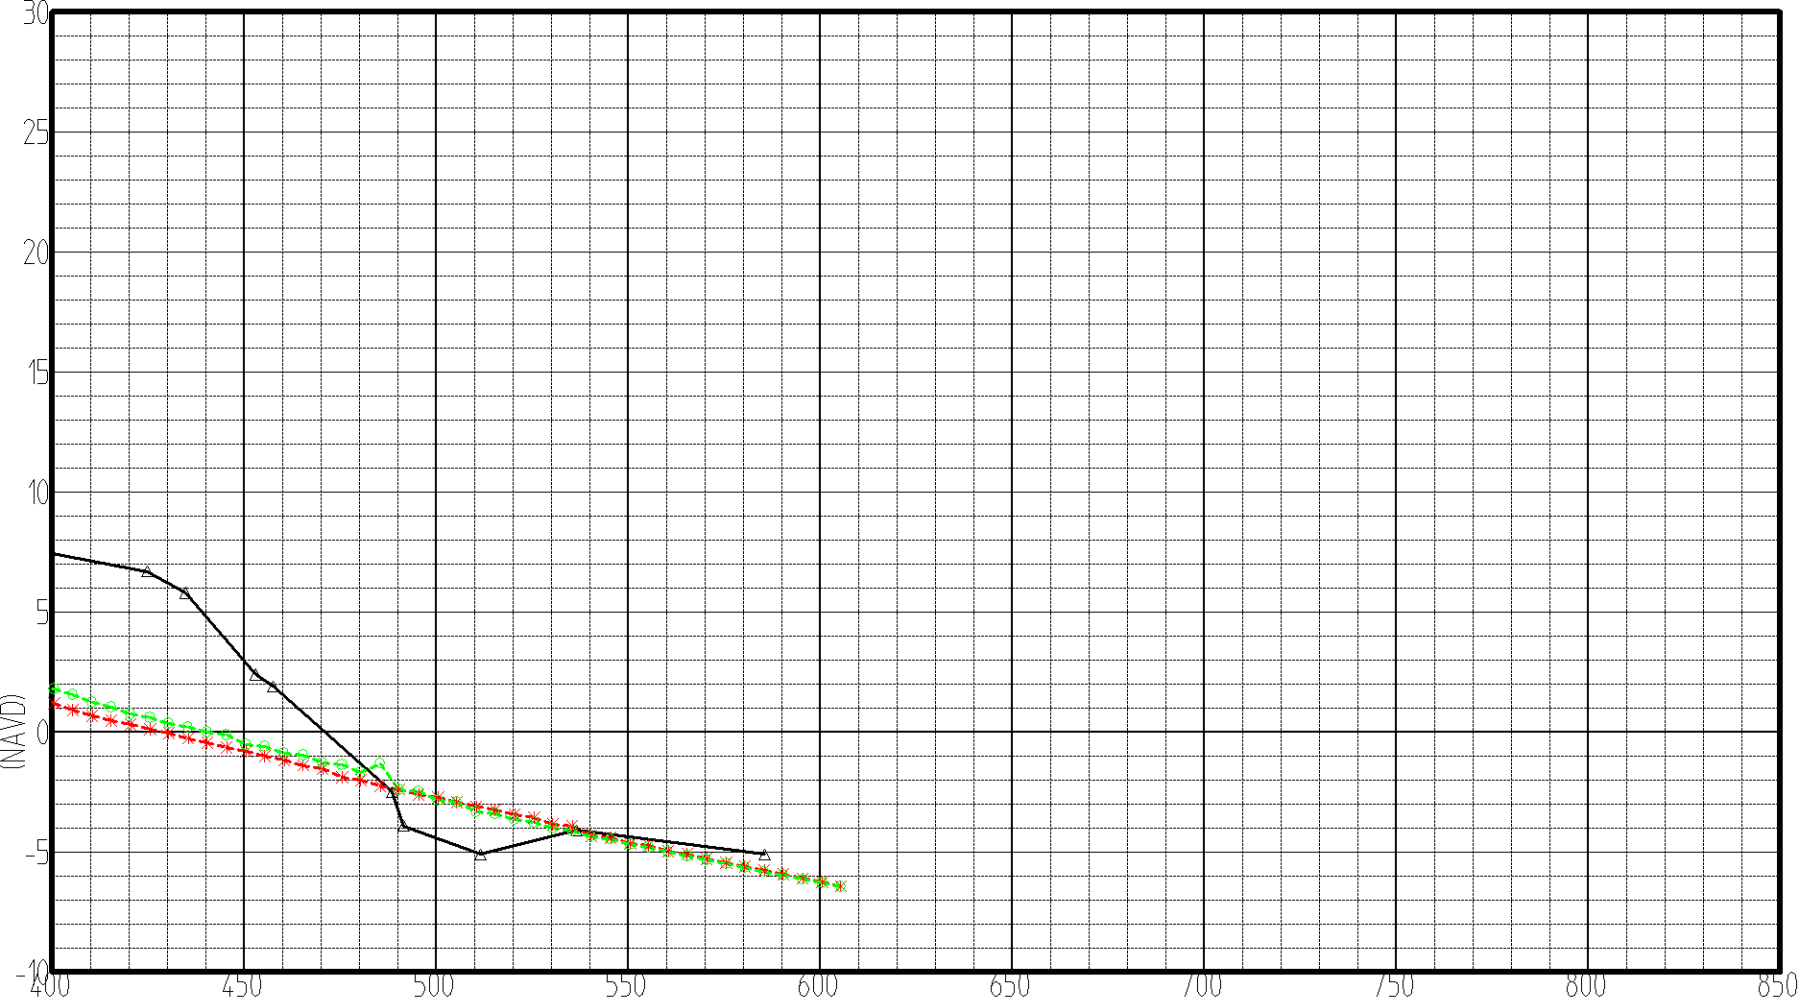
Range: R-215

BEACH PROFILE

—△—△— 2005-2008 INPUT PRF

- - - * - - - 15-YR SBEACH ERODED PRF

- - - o - - - 25-YR SBEACH ERODED PRF

BEARING: 70.00

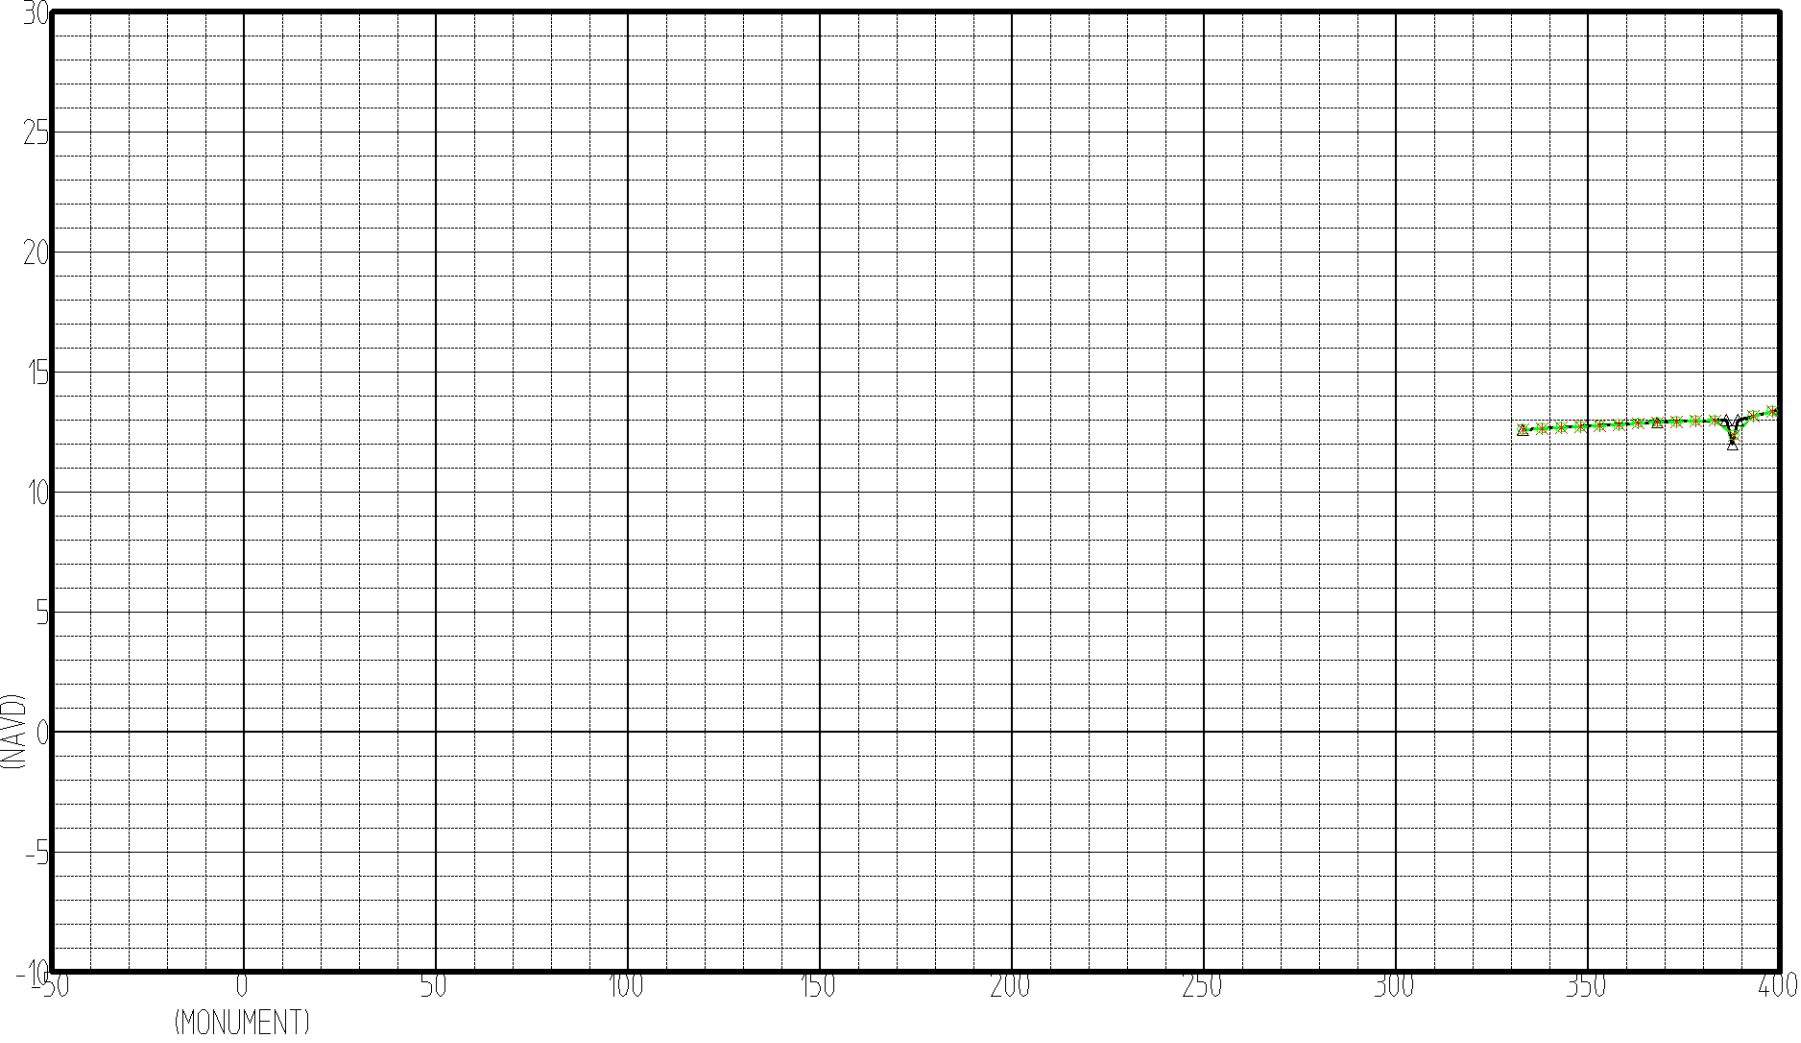
Range: R-216-T 1/2

BEACH PROFILE

- △—△— 2005-2008 INPUT PRF
- - * - - * - - 15-YR SBEACH ERODED PRF
- - o - - o - - 25-YR SBEACH ERODED PRF

BEARING: 70.00

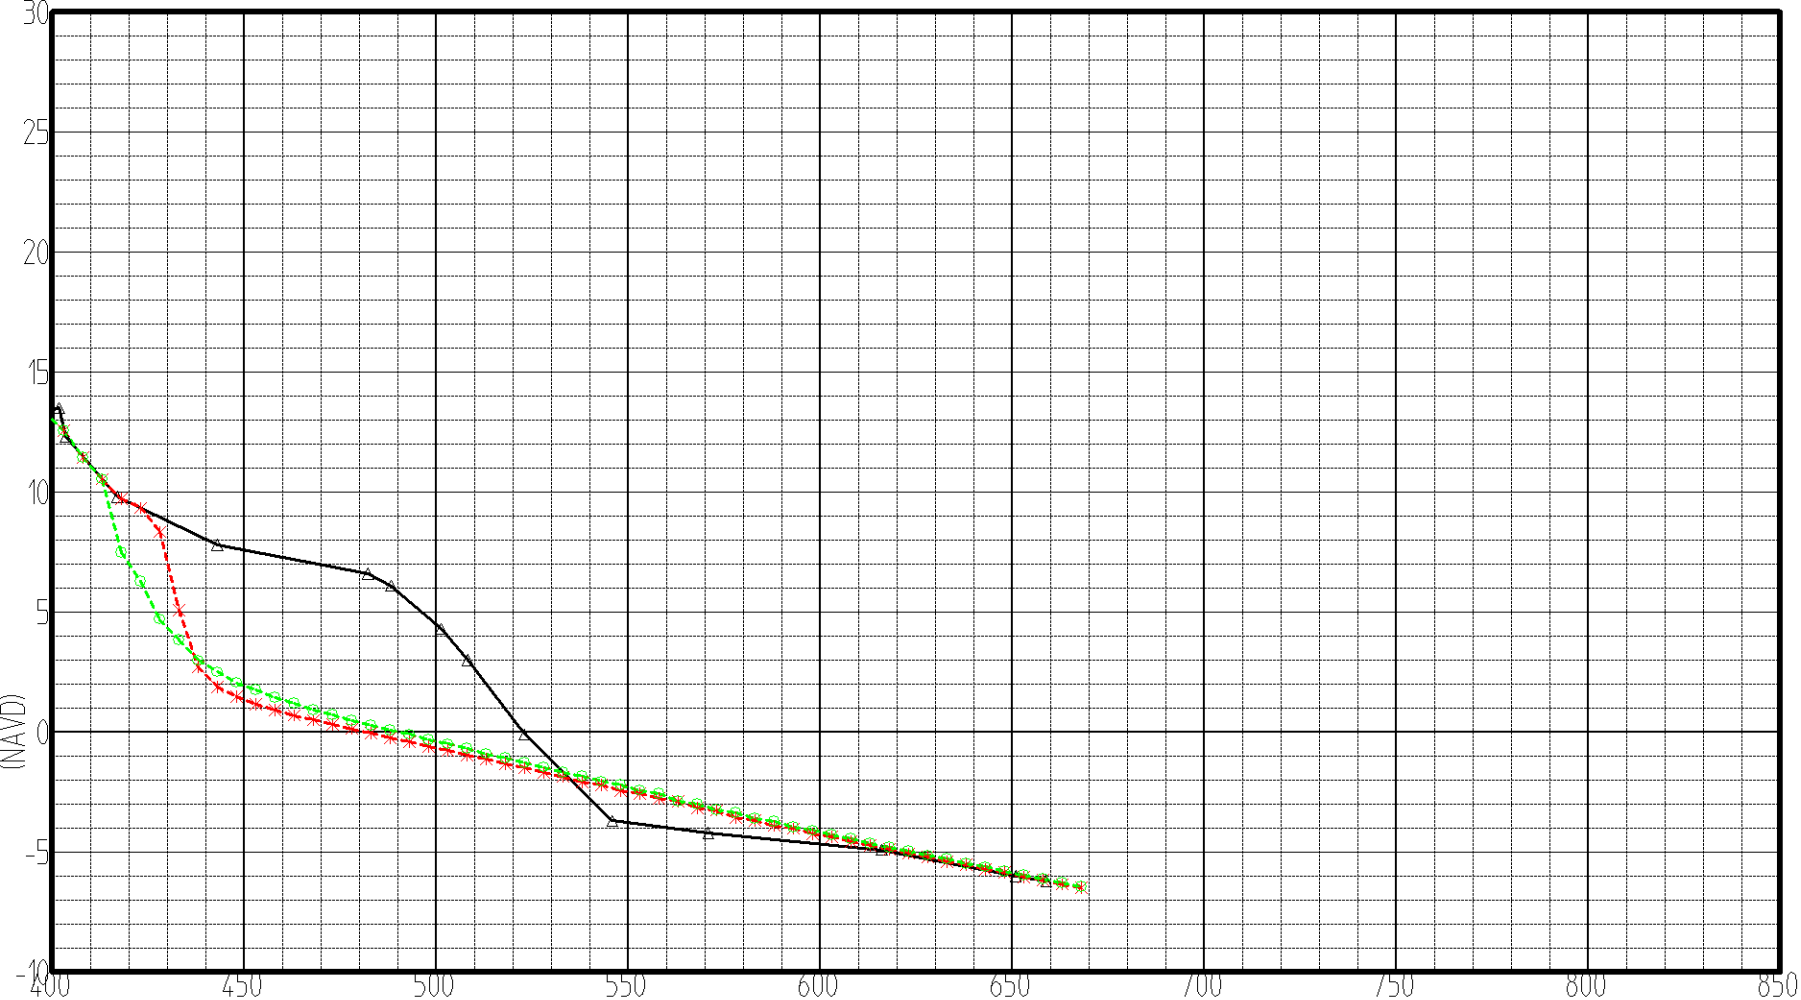
Range: R-216-T

BEACH PROFILE

—△—△— 2005-2008 INPUT PRF

- - - * - - - 15-YR SBEACH ERODED PRF

- - - o - - - 25-YR SBEACH ERODED PRF

BEARING: 70.00

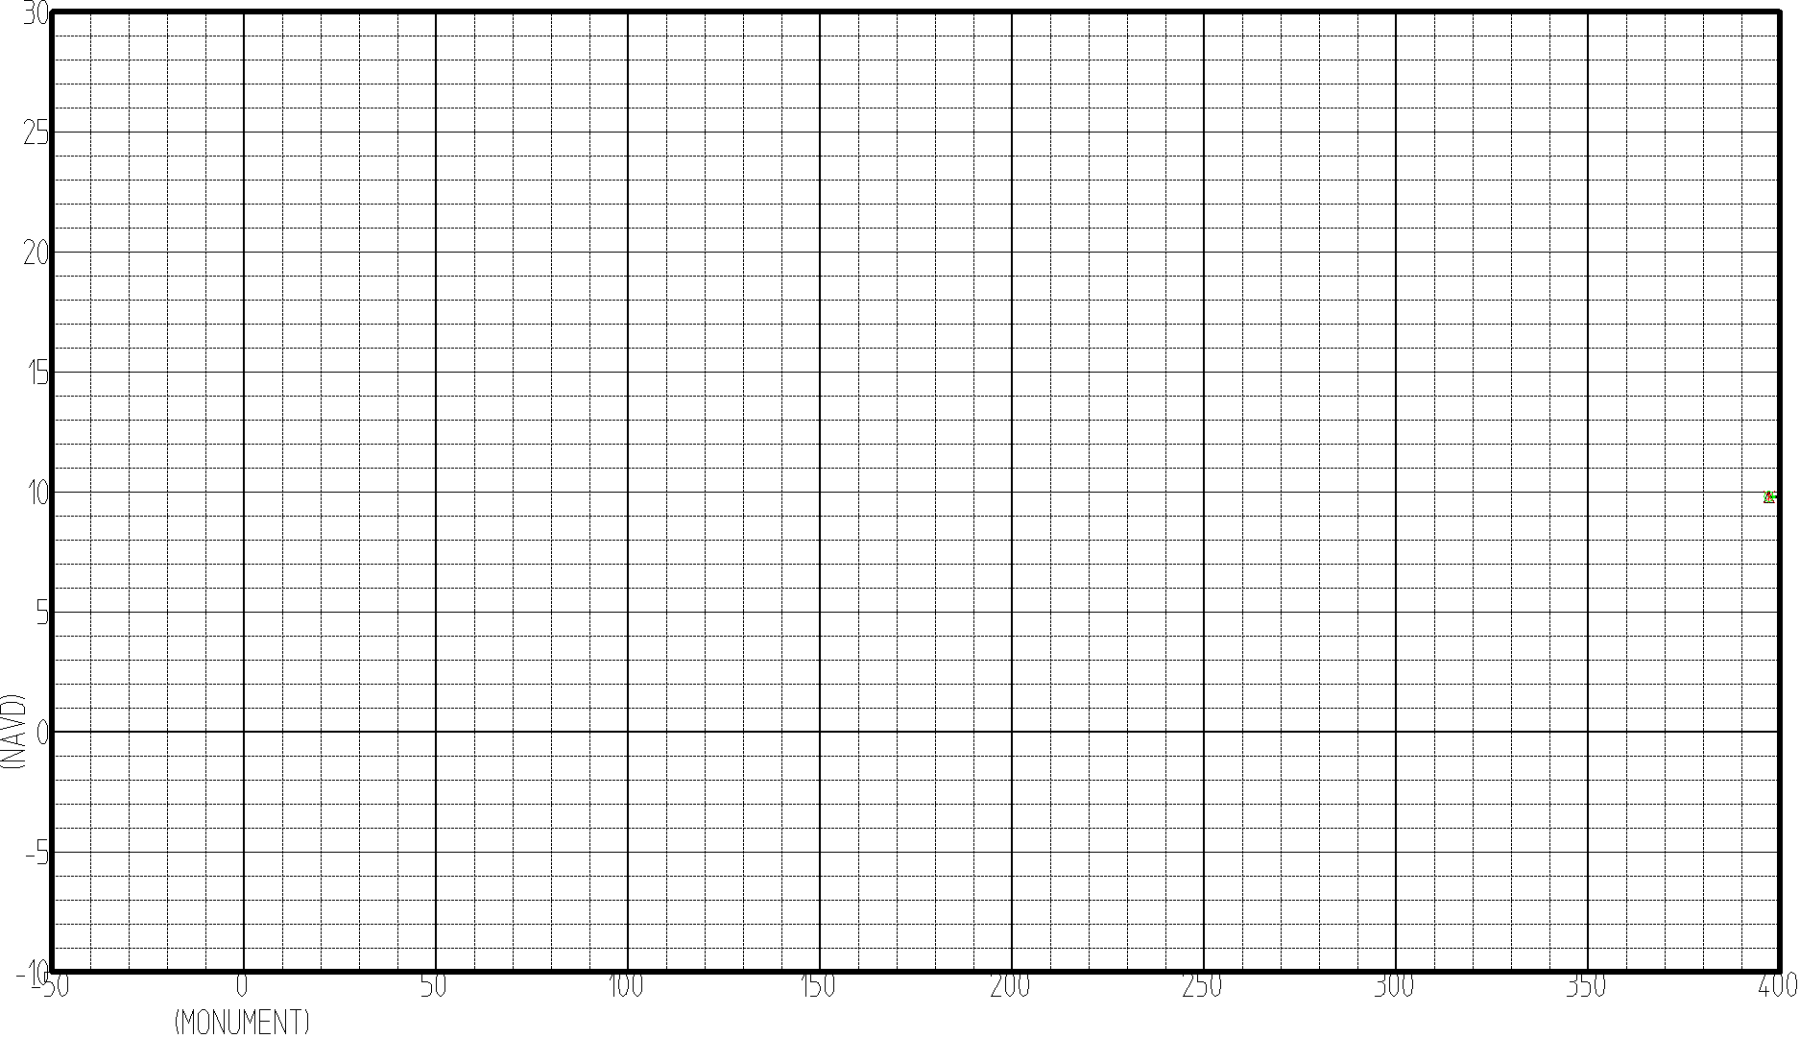
Range: R-219 1/2

BEACH PROFILE

- △—△— 2005-2008 INPUT PRF
- - - * - - - 15-YR SBEACH ERODED PRF
- - - o - - - 25-YR SBEACH ERODED PRF

BEARING: 60.00

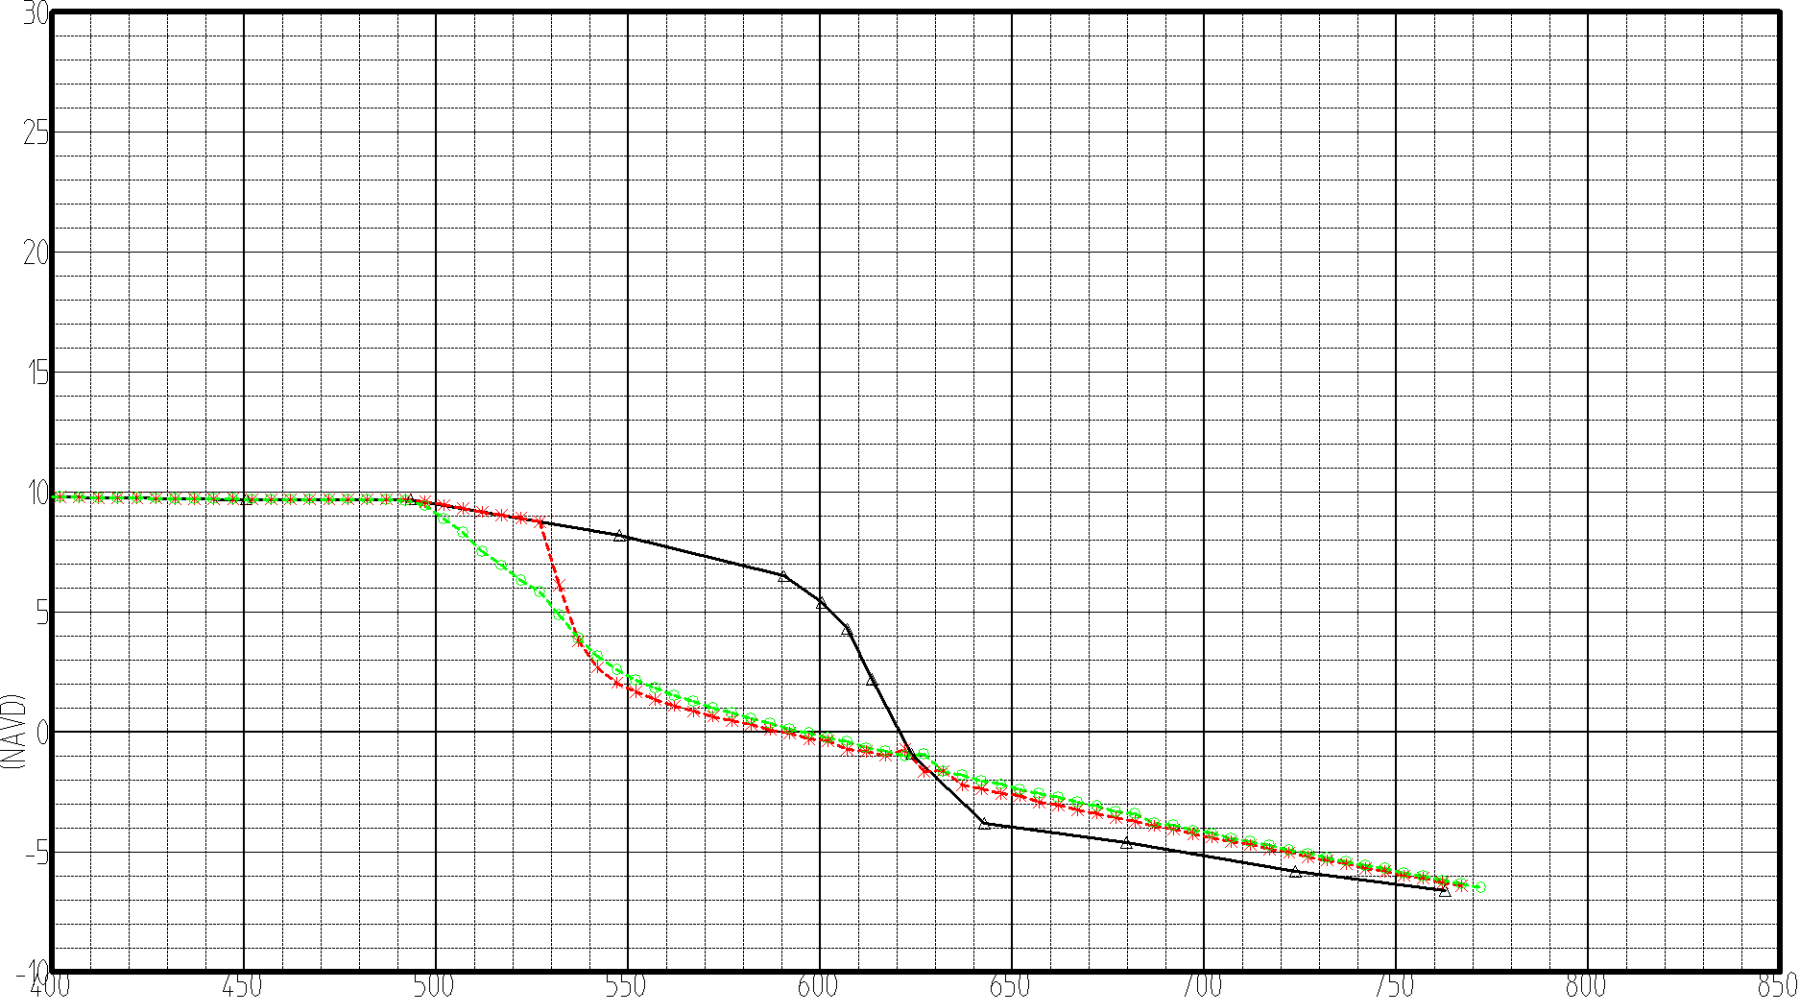
BEACH PROFILE

—△—△— 2005-2008 INPUT PRF
