# THE IMPACT OF HURRICANE ELENA AND TROPICAL STORM JUAN ON COASTAL CONSTRUCTION IN FLORIDA

Beaches and Shores Post-Storm Report No. 85-3

March, 1986

Bureau of Coastal Engineering and Regulation  
Division of Beaches and Shores  
FLORIDA DEPARTMENT OF NATURAL RESOURCES

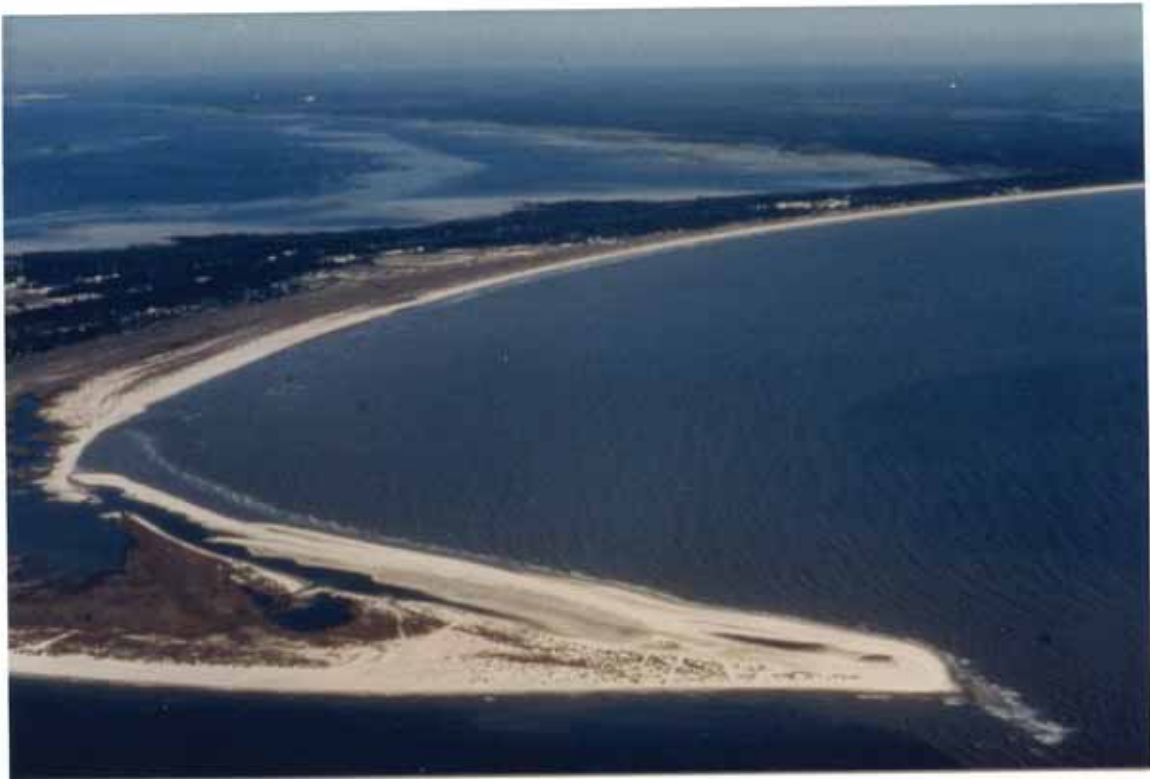
FIGURE 4. Cape San Blas, November, 1984 (K. R. Bodge)

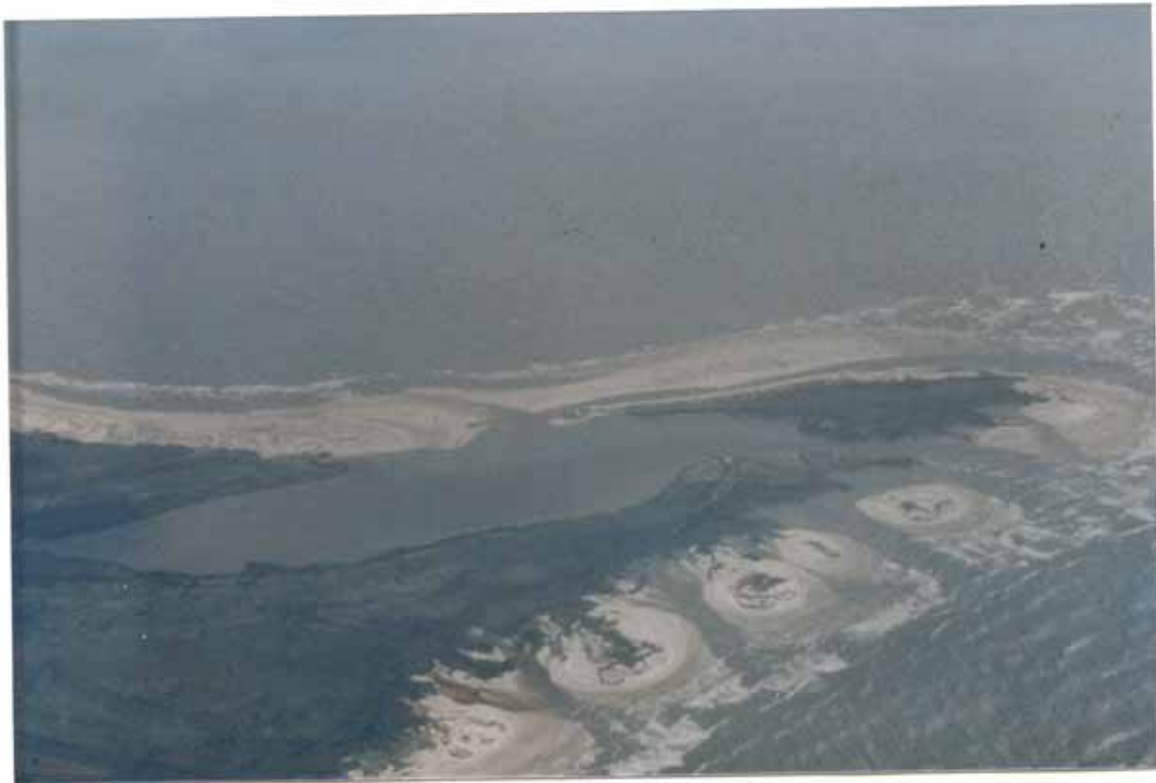
Because of the nearness to hurricane Elena moderate to heavy beach and dune erosion occurred along the St. Joseph Peninsula and eastward from Cape San Blas to Indian Pass. Approximately 1,500 feet off the exposed south tip of Cape San Blas disappeared as the hurricane's center passed by approximately 30 miles offshore (Figures 4 and 5). Several tidal channels were formed across the Cape south of the lighthouse beach access was inundated by coastal flooding. While the storm tide elevation was reported to be approximately +7.0 feet NGVD (Balsillie, 1985) there was undoubtedly a substantial head differential of the storm tide from east to west across the Cape and outer shoals as witnessed by the depth and alignment of the scour channels and the flattening of the dune and wetland vegetation covering the Cape. The fishing pier on Indian Peninsula was damaged by Elena. No other major structures on the Gulf County beaches were damaged

FIGURE 5. Cape San Blas, September 3, 1985 (K. R. Bodge)

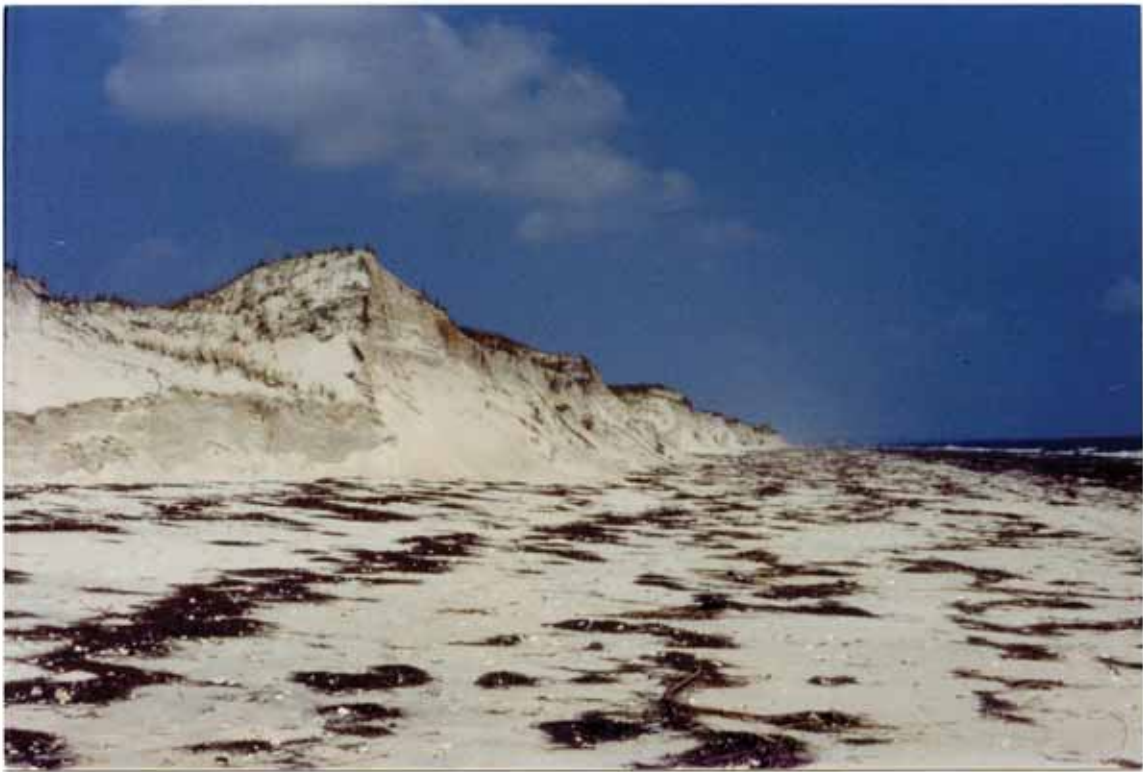
Along the entire lengths of St. Vincent Island, Little St. George Island, and St. George Island heavy dune erosion took place because of Elena (Figures 8 and 9). Nearly all the dune walkover structures were destroyed or damaged along St. George Island. Fallen pines and light roof damage was widespread throughout St. George Island; however, there was no major structural damage to any major structures. A few large decks were destroyed and a number of roofs had to be replaced due to the light wind damage, but generally structures fared well. A discussion will follow reflecting the design adequacy and siting as reasons for the success of the major structures in this storm. Tropical storm Juan had very little impact along the island as the storm tide did not even reach the dune line eroded by Elena.

FIGURE 8. Dunes eroded by Elena, St. George Island  
(G. L. Hill)

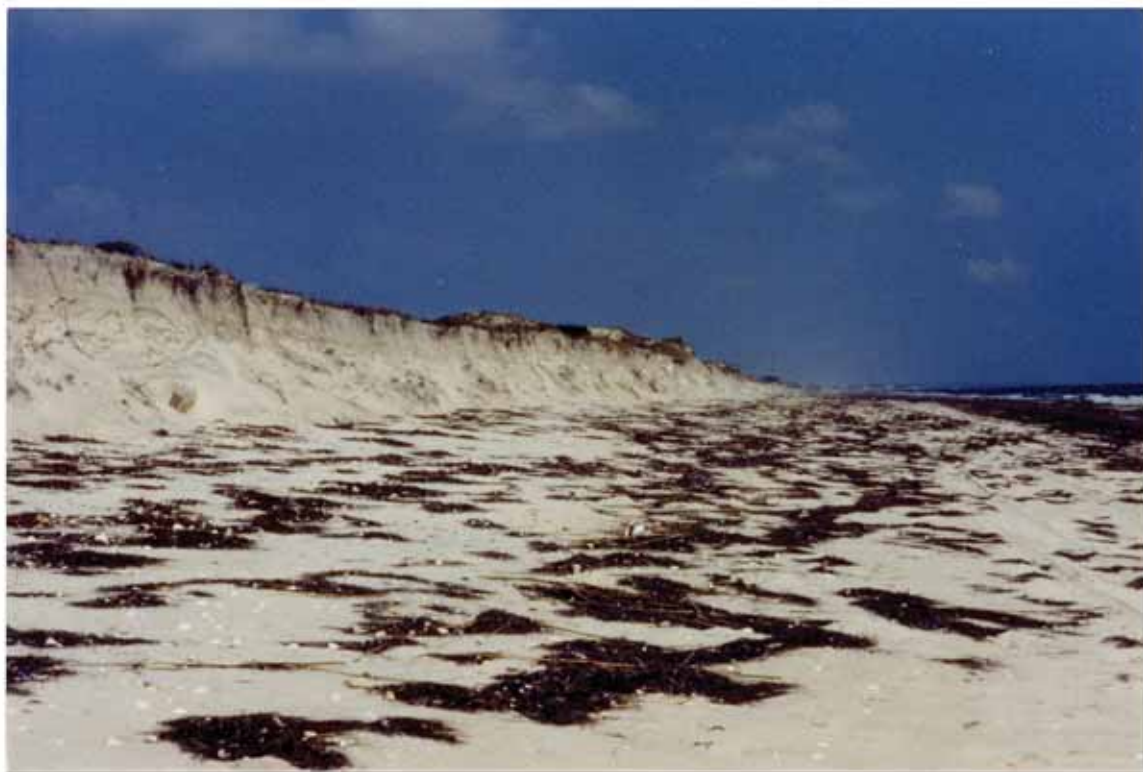
FIGURE 9. Dunes eroded by Elena, St. George Island  
(G. L. Hill)

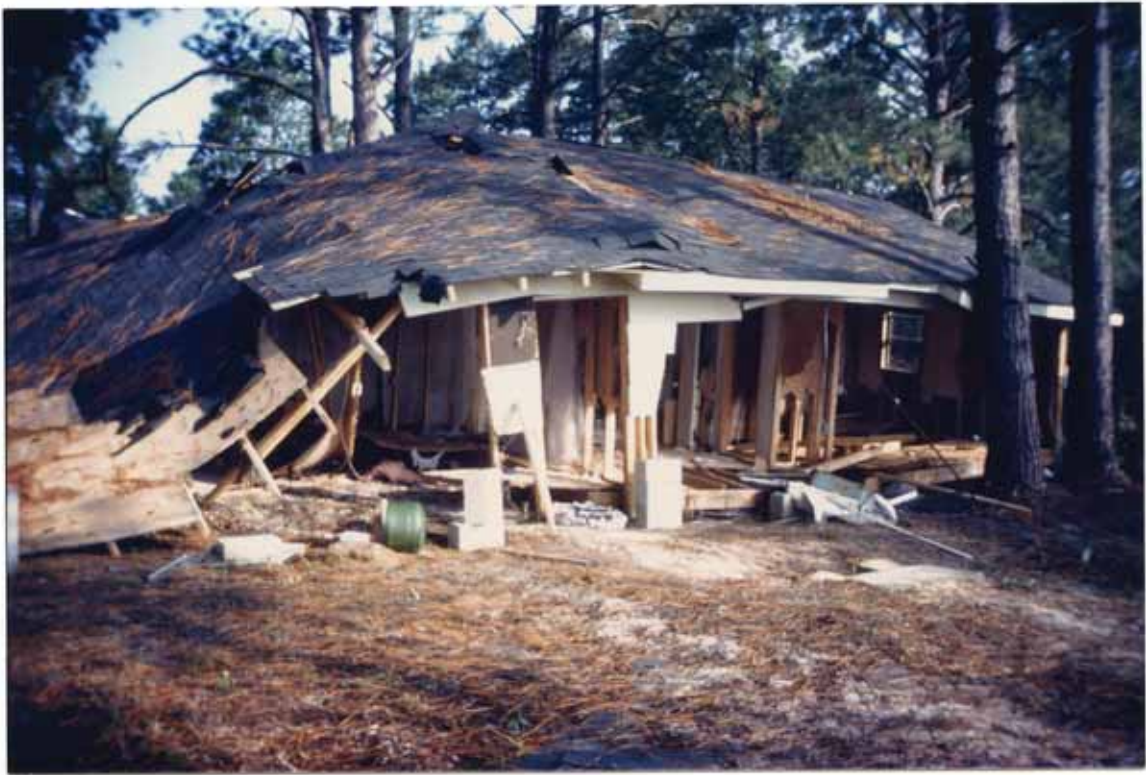
Along the shoreline near Lanark, adjacent the open water expanse between Dog Island and Alligator Point, one wood framed single-family dwelling was destroyed (Figure 22). This structure was not inappropriately sited because its location was a couple hundred feet from the shoreline in an upland stand of pines; however, the structure was not sufficiently elevated and it sustained heavy damage from the storm tide and direct wave activity.

FIGURE 22. Lanark dwelling destroyed by Elena

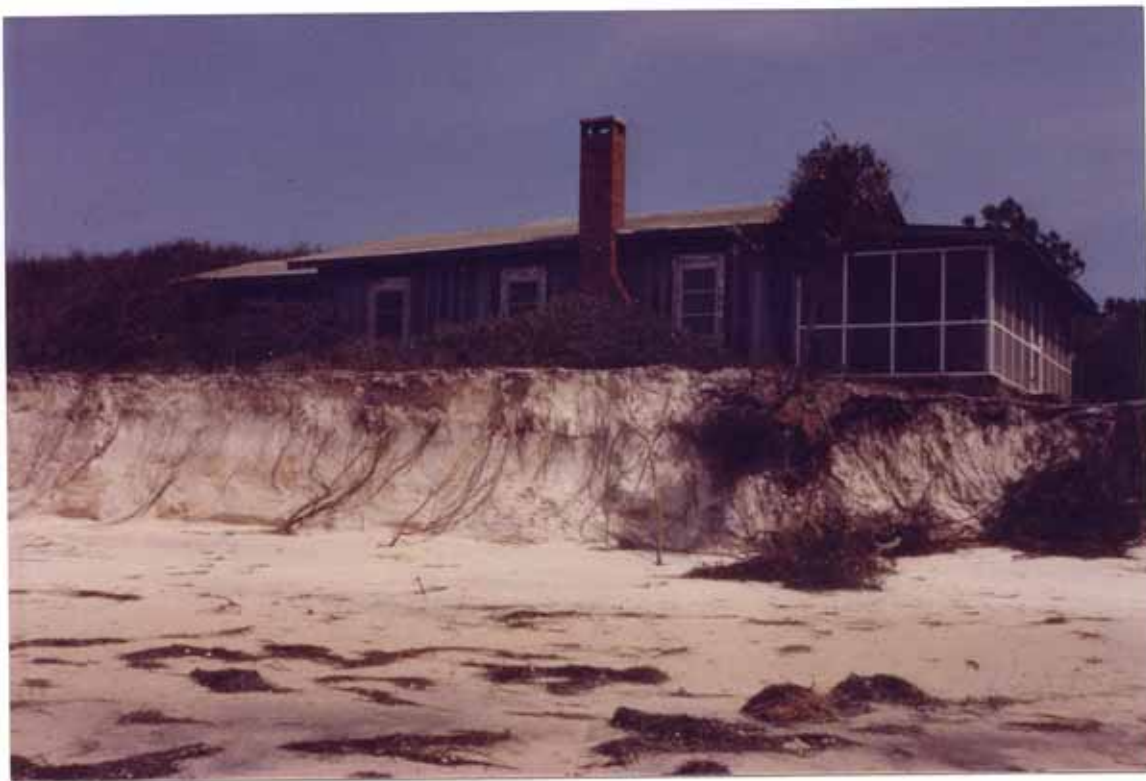
Along Chip Morrison Drive, a few dwellings immediately east of the Southwest Cape were placed in imminent danger and were in need of being relocated inland. Heavy dune erosion from Elena nearly reached these slab-on-grade structures (Figures 25 and 26). Between 500 and 800 feet east of the southwest Cape, a 300 foot long rock revetment was constructed to protect three dwellings after the "El Niño" extratropical storms inflicted heavy dune erosion in the spring of 1983. This stretch of revetment was authorized by the Department of Natural Resources and most of it was constructed to the Department's engineering recommendations. The eastern eighty feet and western eighty feet of this revetment was damaged primarily because of flanking around the ends of the structure which did not have sufficient returns into the upland. It had been anticipated that the revetment would continue both westward to stable shoreline conditions and eastward 200 feet to an existing rock revetment. The western end damage was also due to the low crest elevation and storm wave overtopping which caused substantial erosion losses behind the structure as well as around the end.

FIGURE 26. Southwest Cape dwelling threatened by Elena's erosion

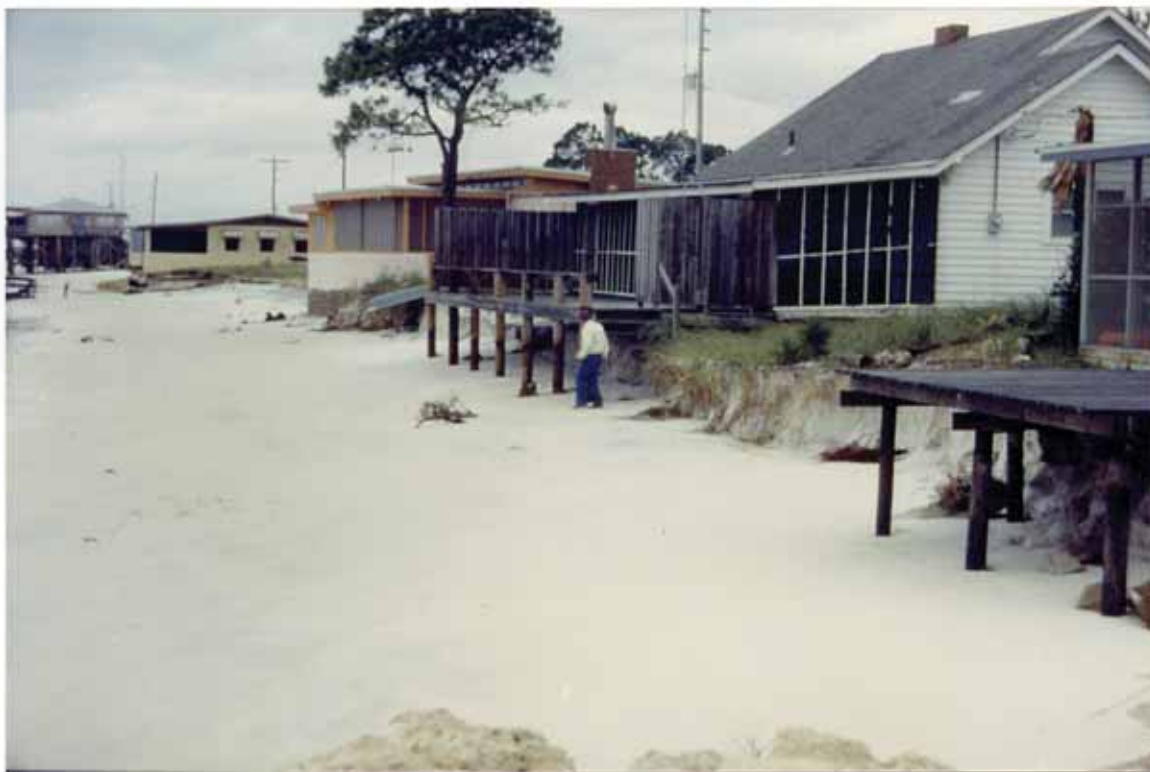
FIGURE 36. Erosion of Elena's first pass on August 30  
(H. N. Bean)

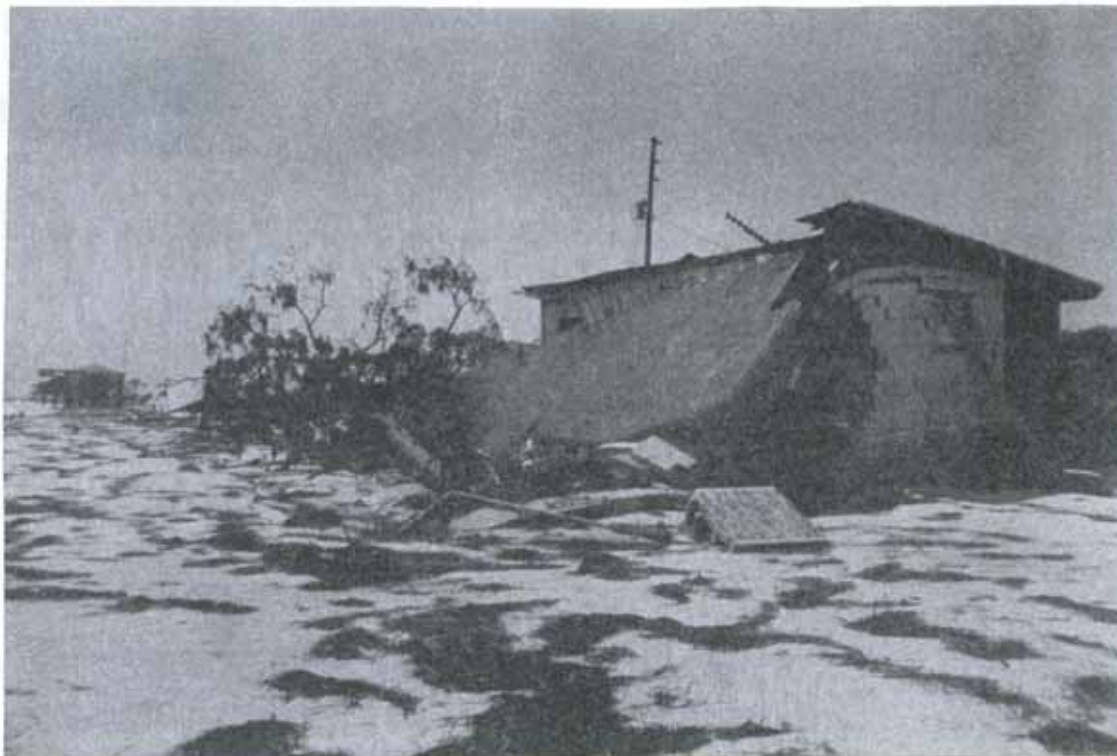
FIGURE 37. Concrete block dwelling destroyed on September 1

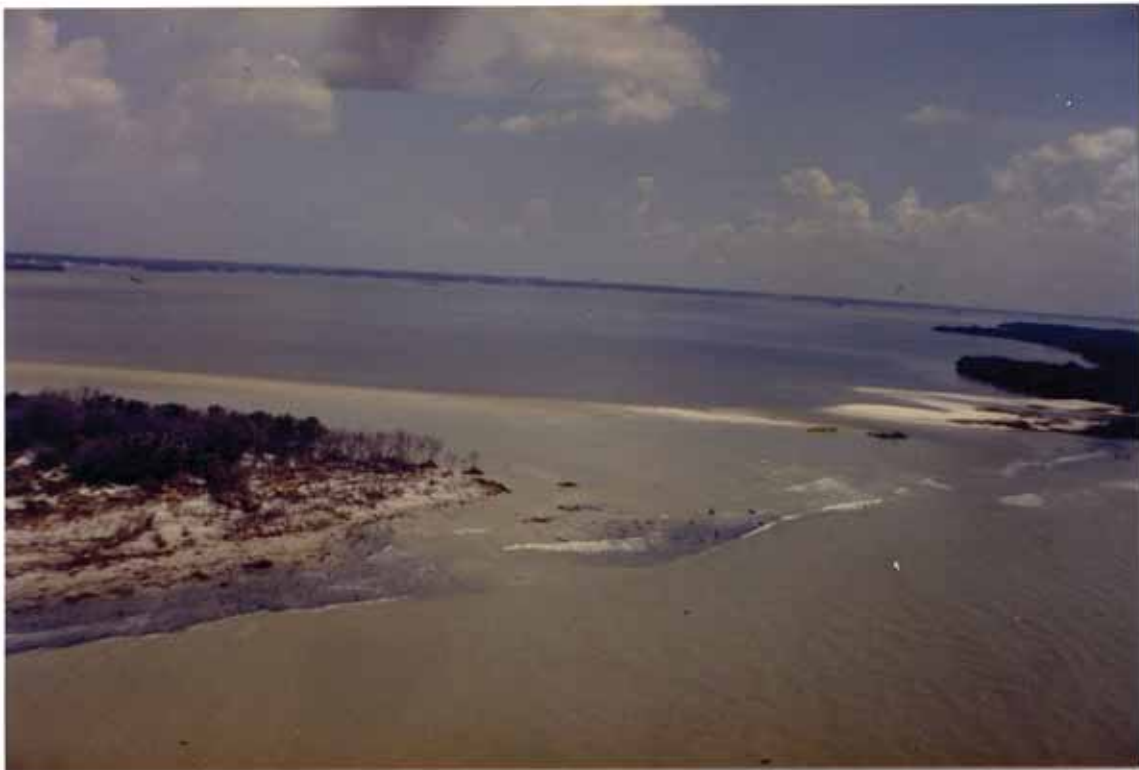
FIGURE 49. Major inlet breakthrough on Caladesi Island

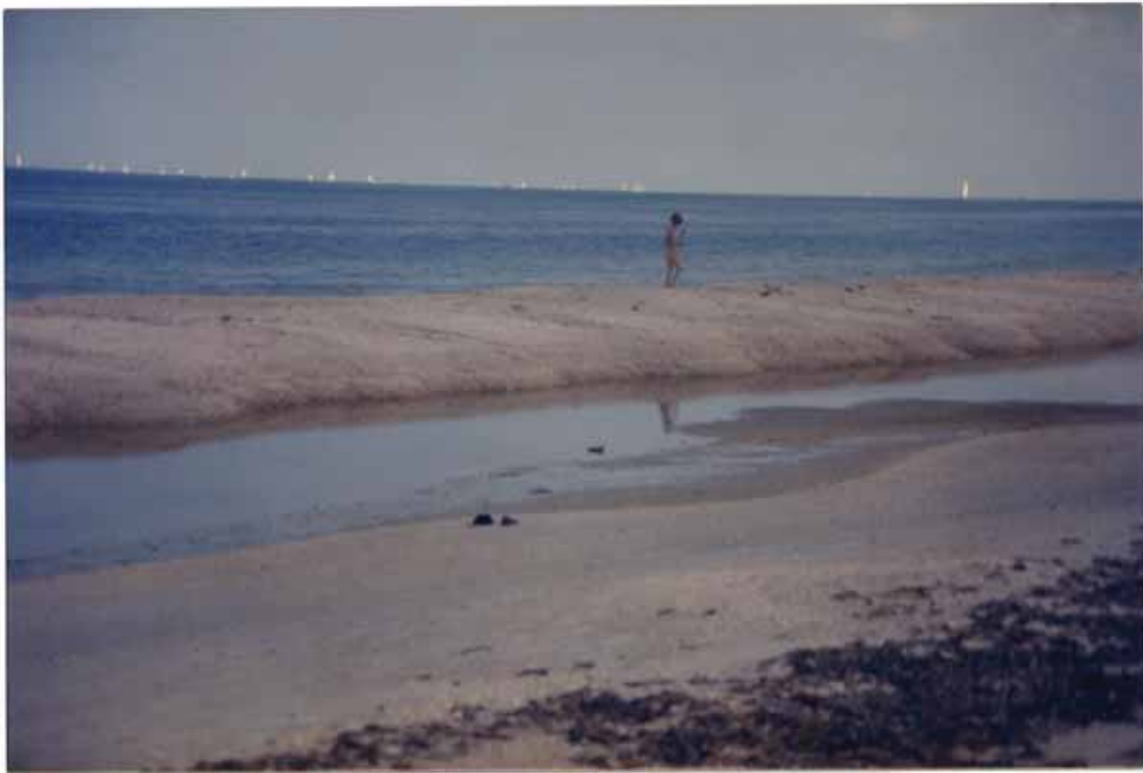
FIGURE 50. Storm beach profile, North Sand Key

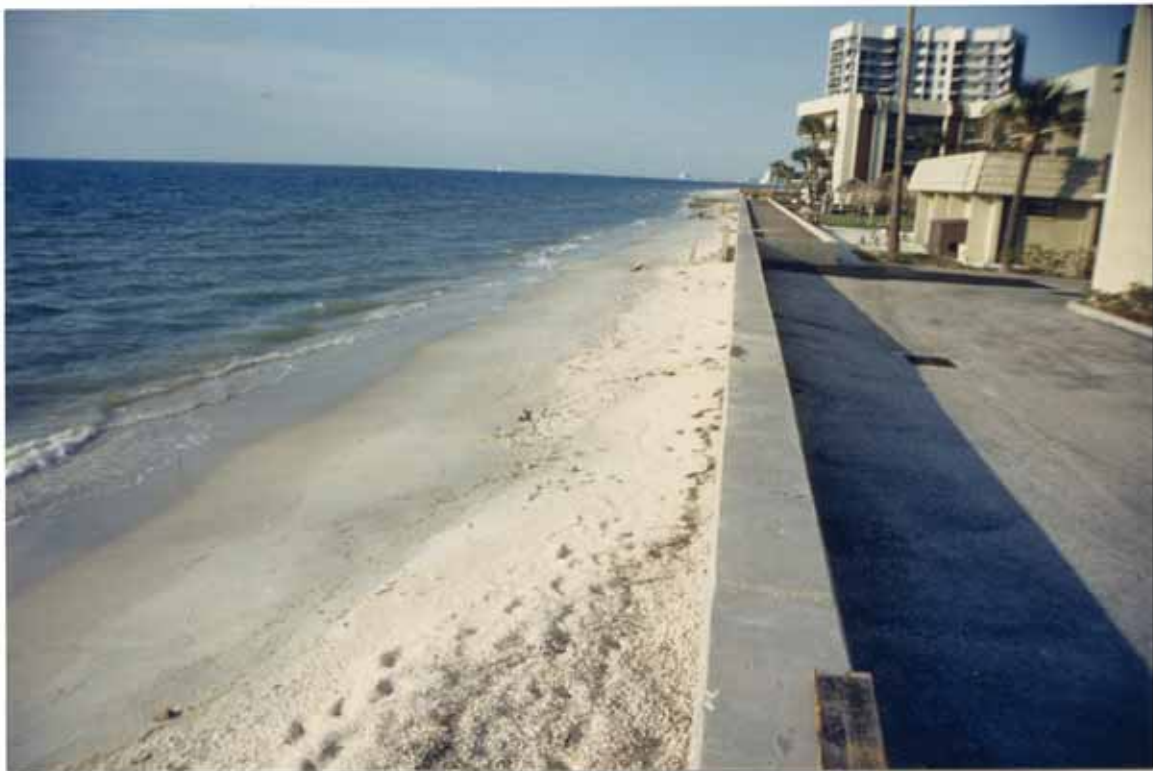
FIGURE 53. Post-Elena beach recovery after one month

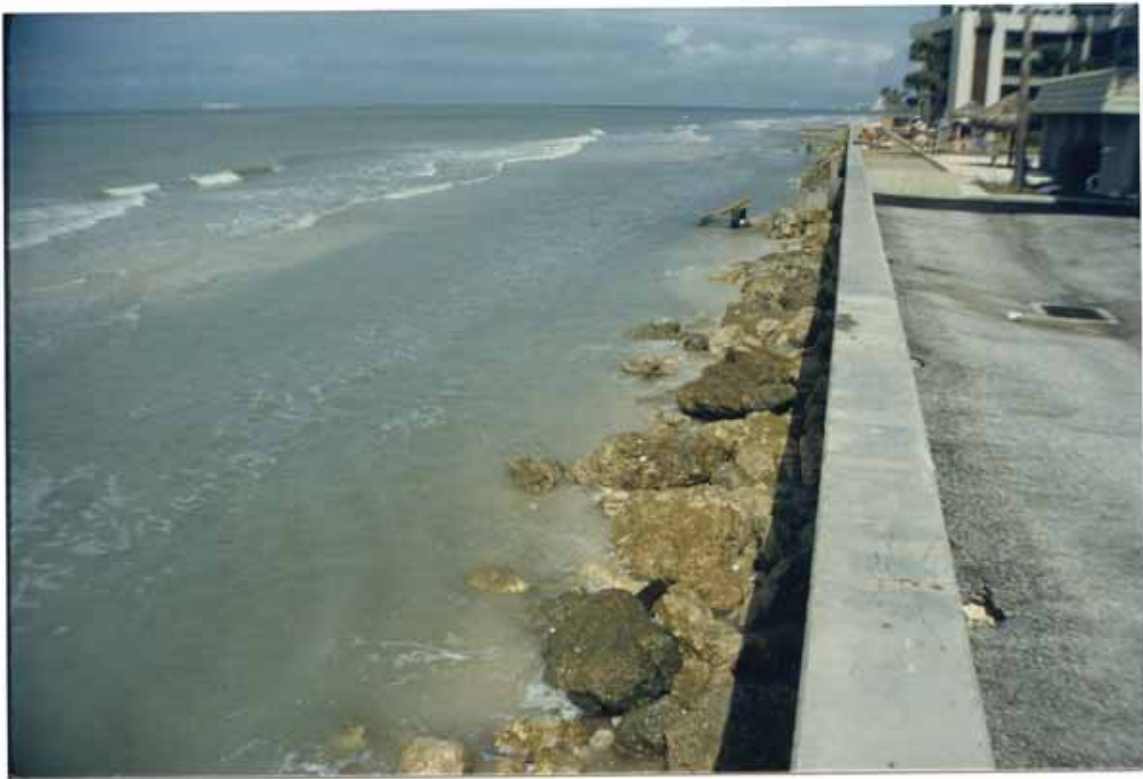
FIGURE 54. Beach erosion due to Juan at Montmarte Apartments

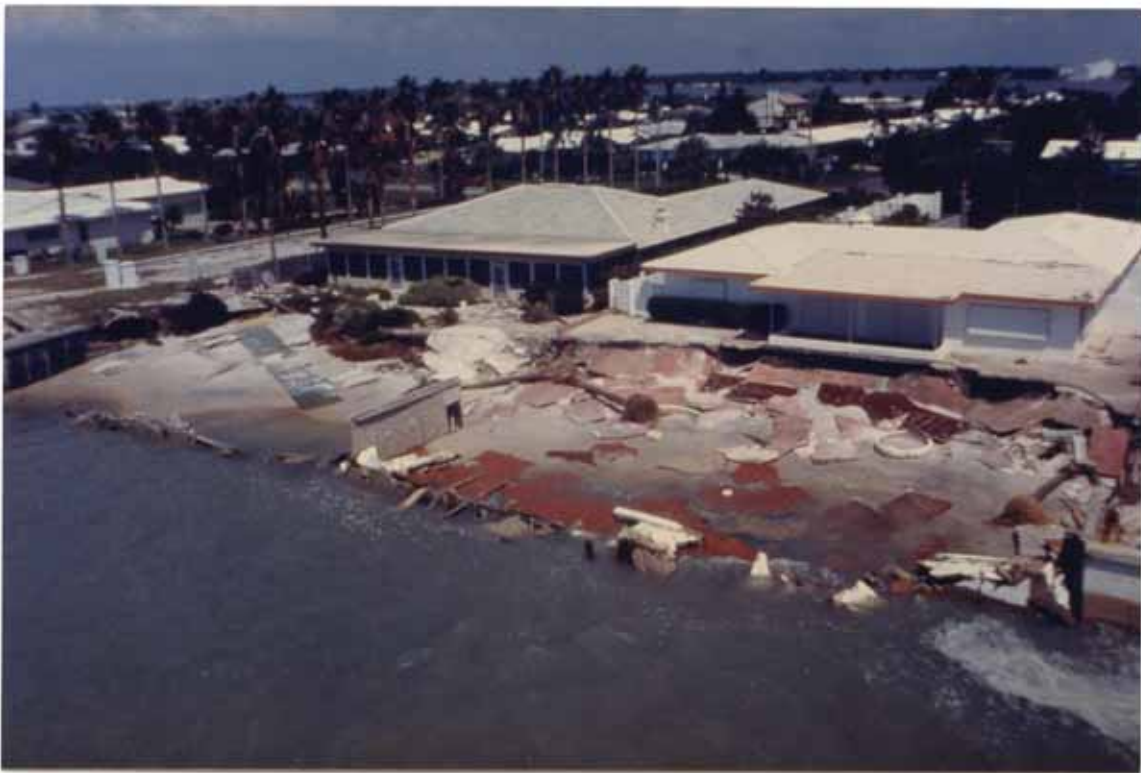
FIGURE 66. Beach, wall, and property destroyed

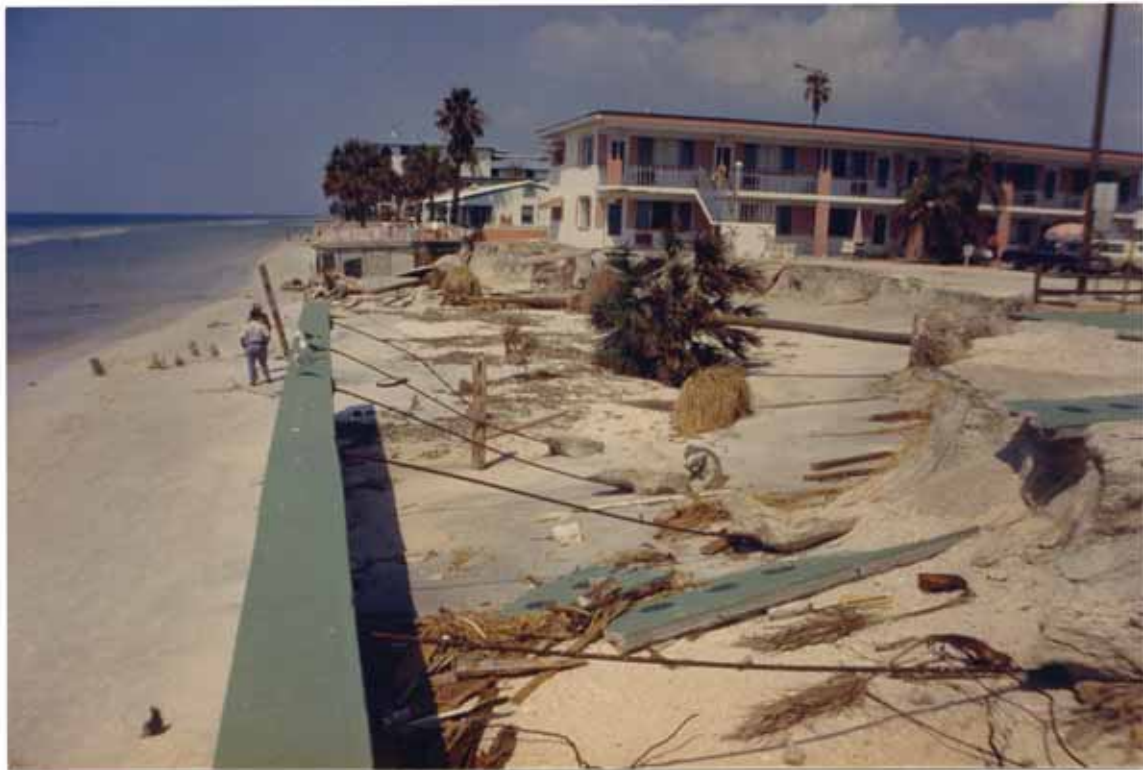
FIGURE 77. Elena destroyed 22nd Avenue

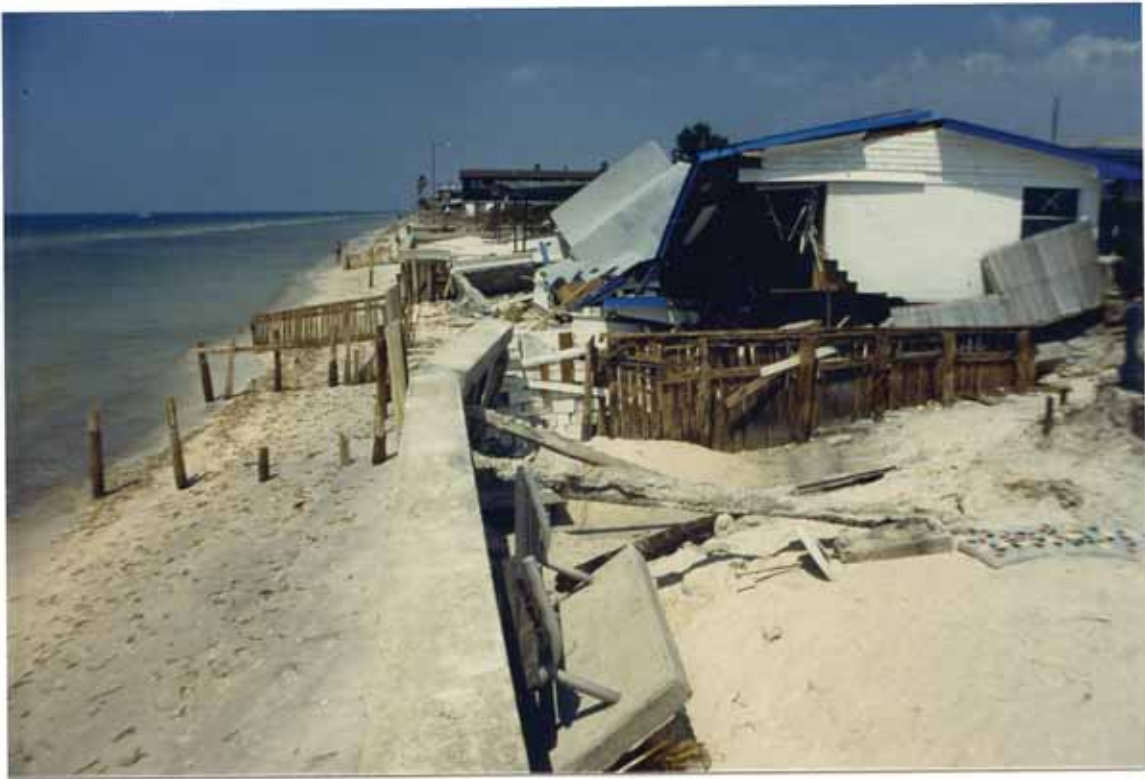
FIGURE 78. Elena destroyed 18th Avenue dwellings

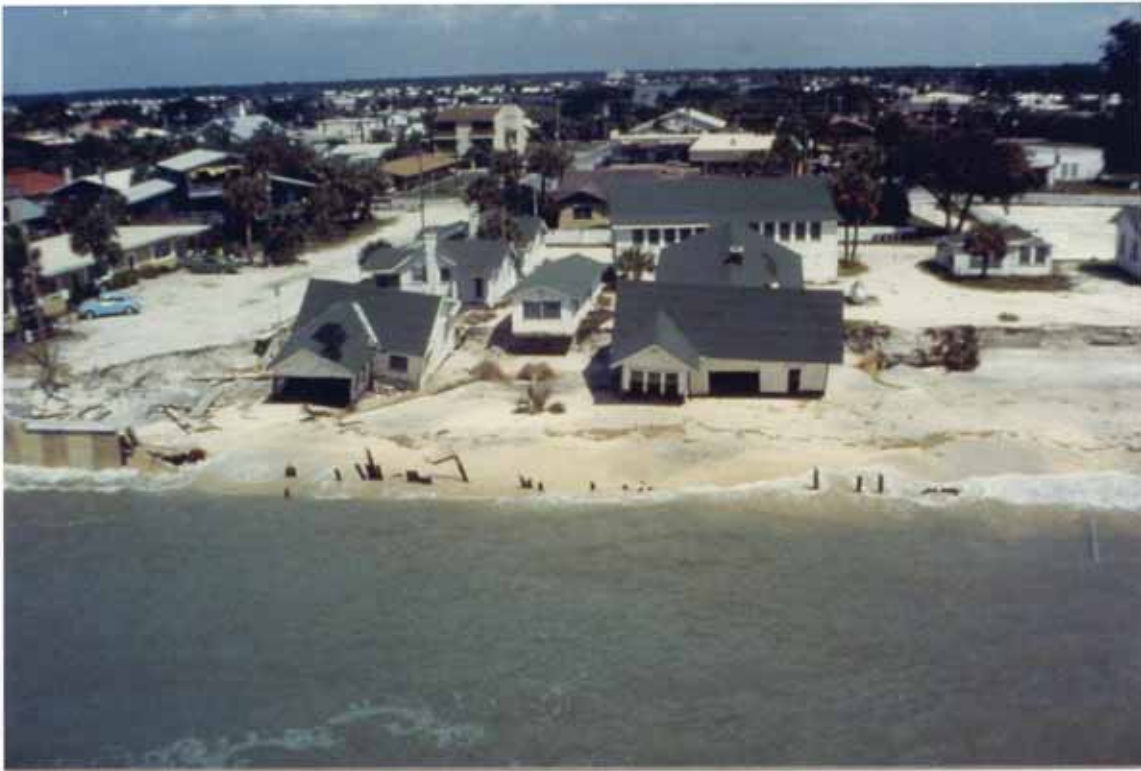
FIGURE 82. Wall, dwellings and property destroyed, 16th Avenue

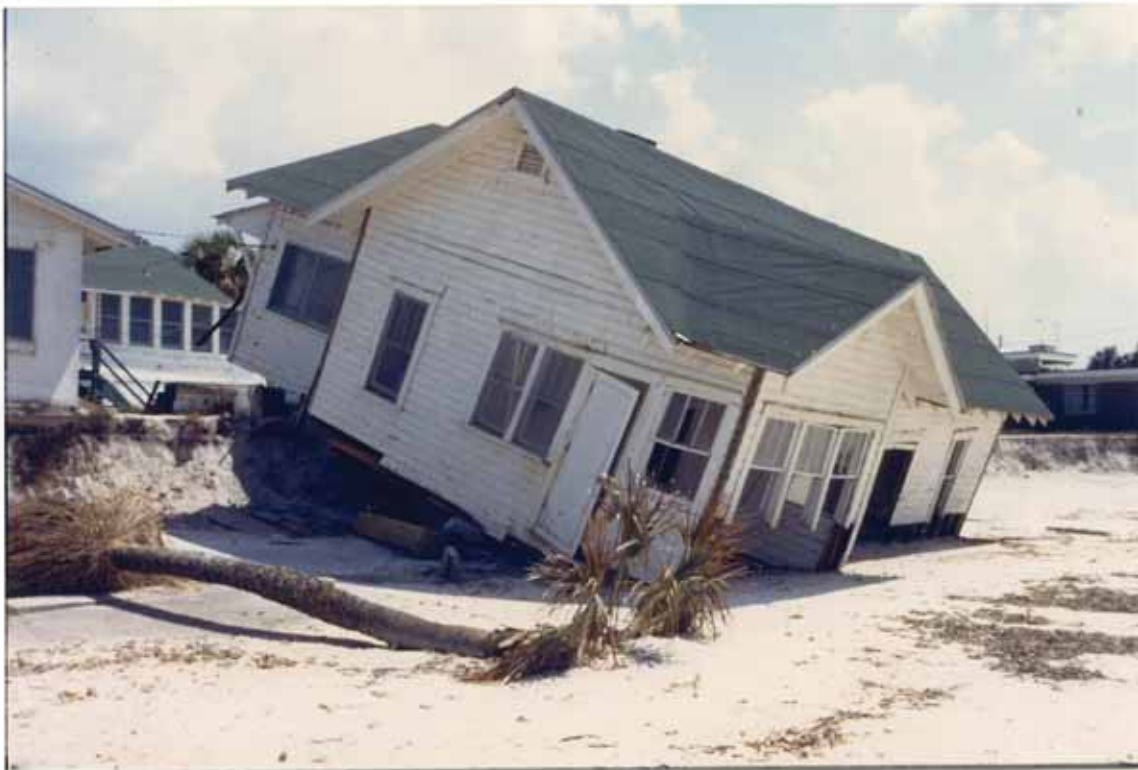
FIGURE 83. Frame dwelling collapsed when undermined

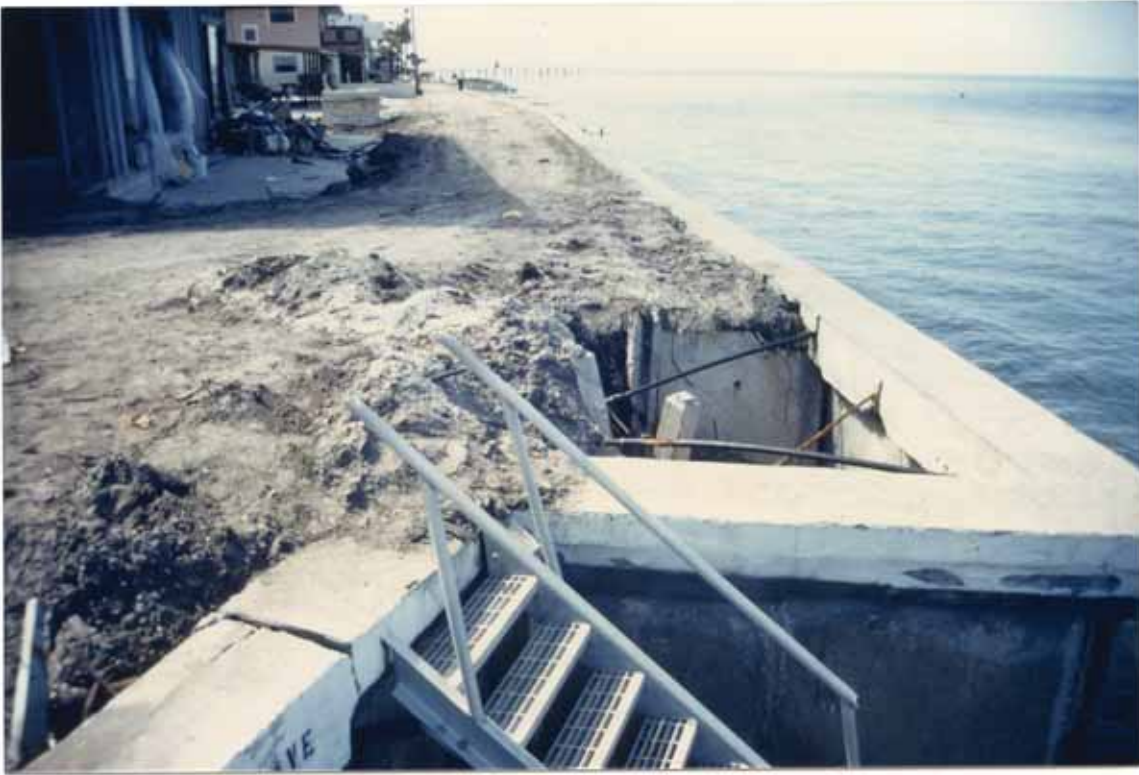
FIGURE 94. Post-Elena fill at 7th Avenue

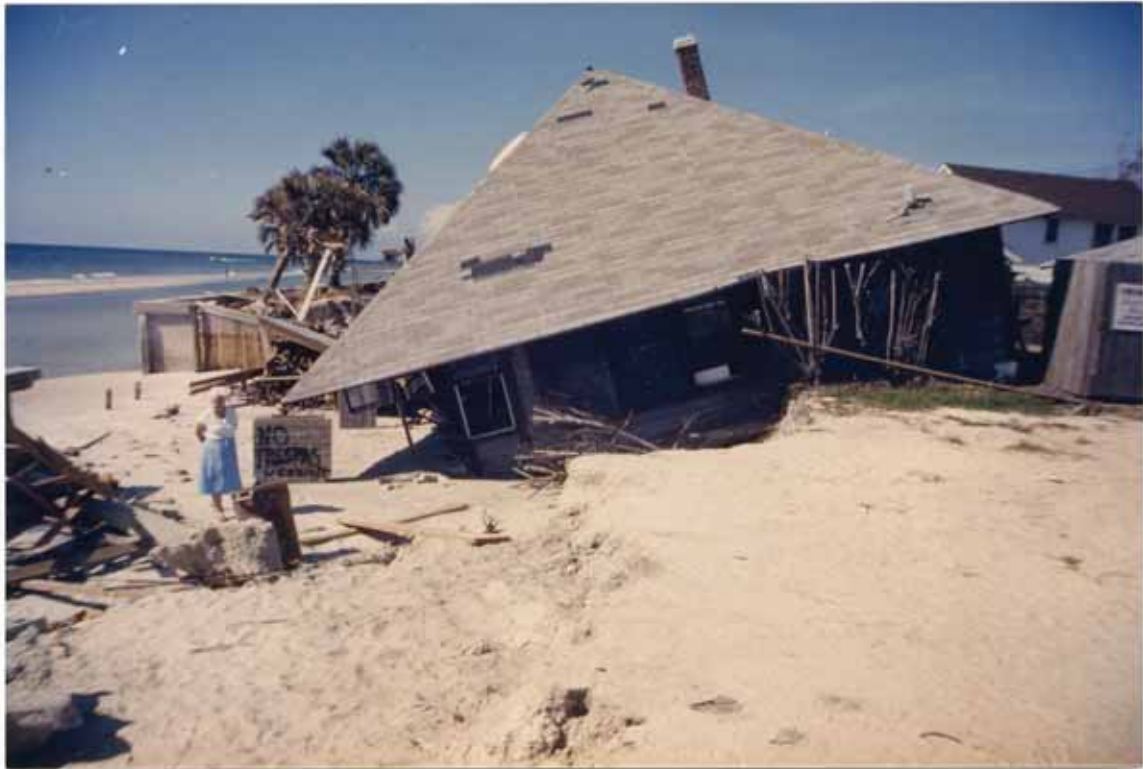
FIGURE 96. Dwelling destroyed by Elena, 2nd Avenue

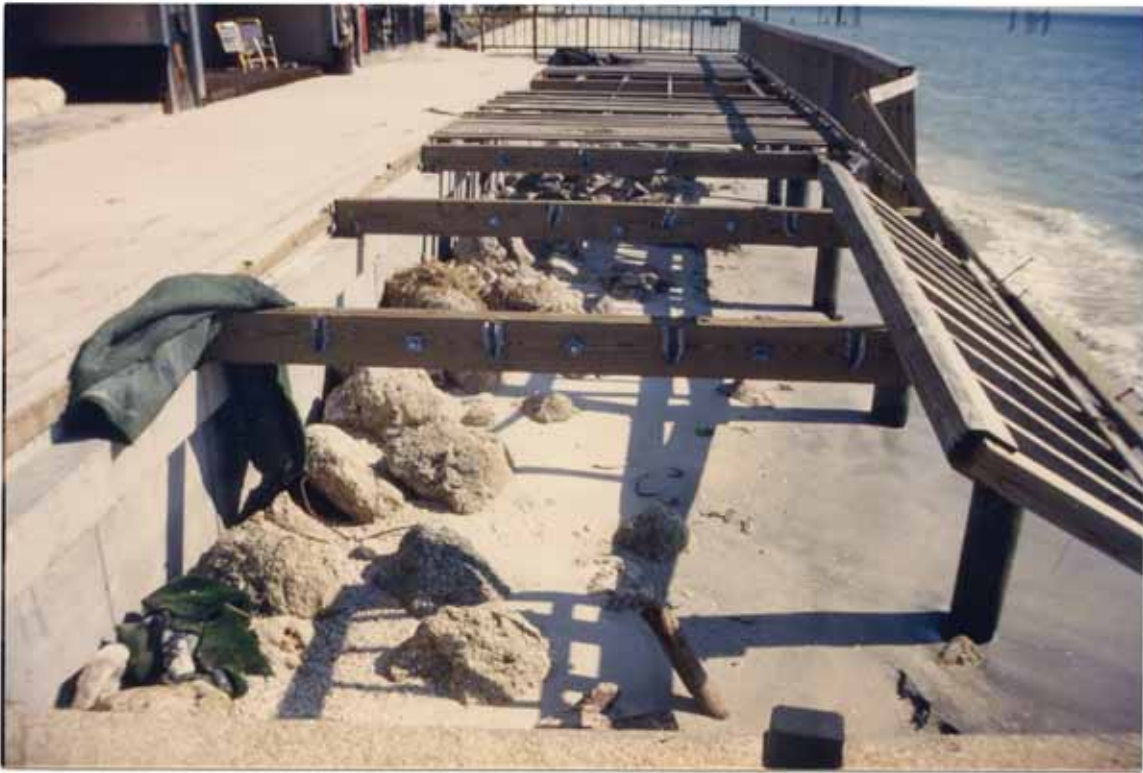
FIGURE 99. Toe-scour protection after Elena, 50 Gulfside Condominium

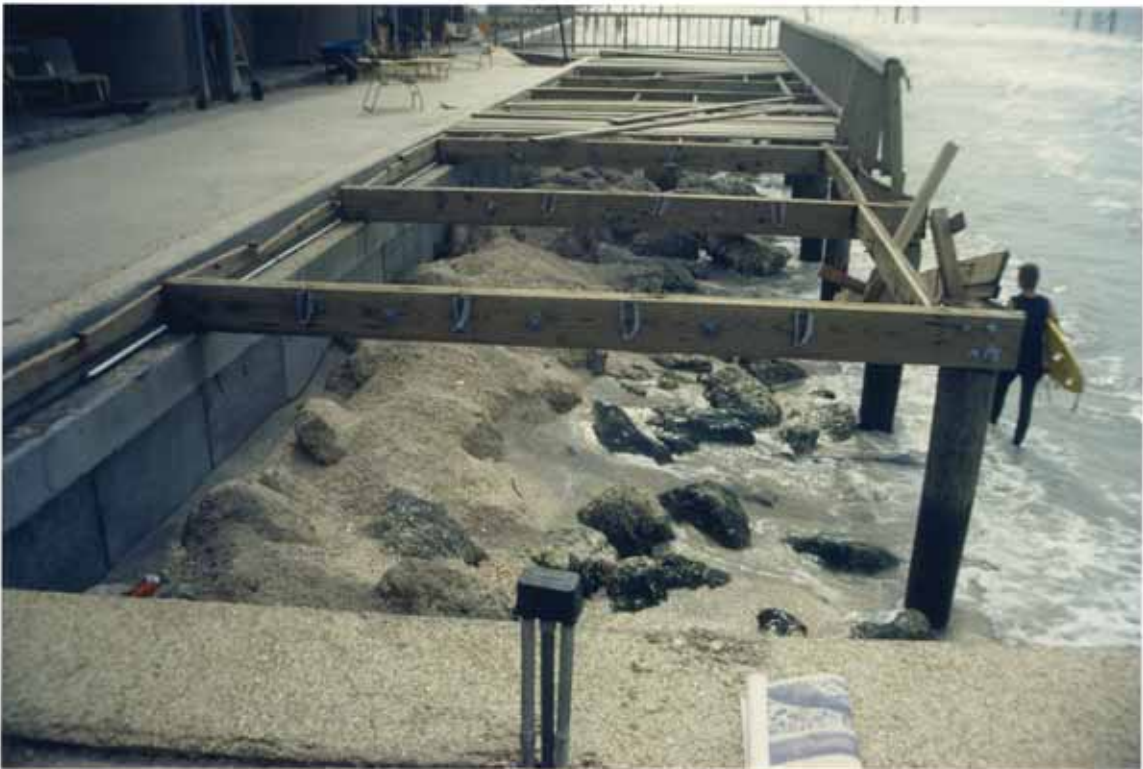
FIGURE 100. Toe-scour protection after Juan

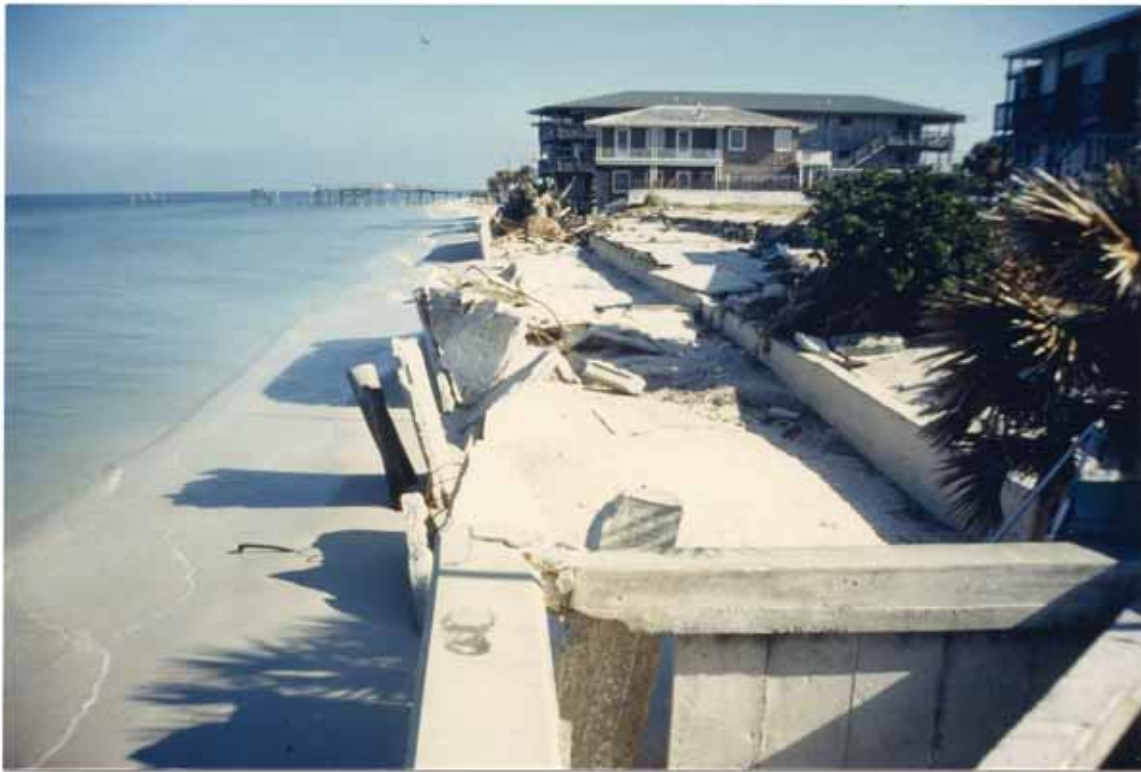
FIGURE 101. South Indian Rocks Beach after Elena

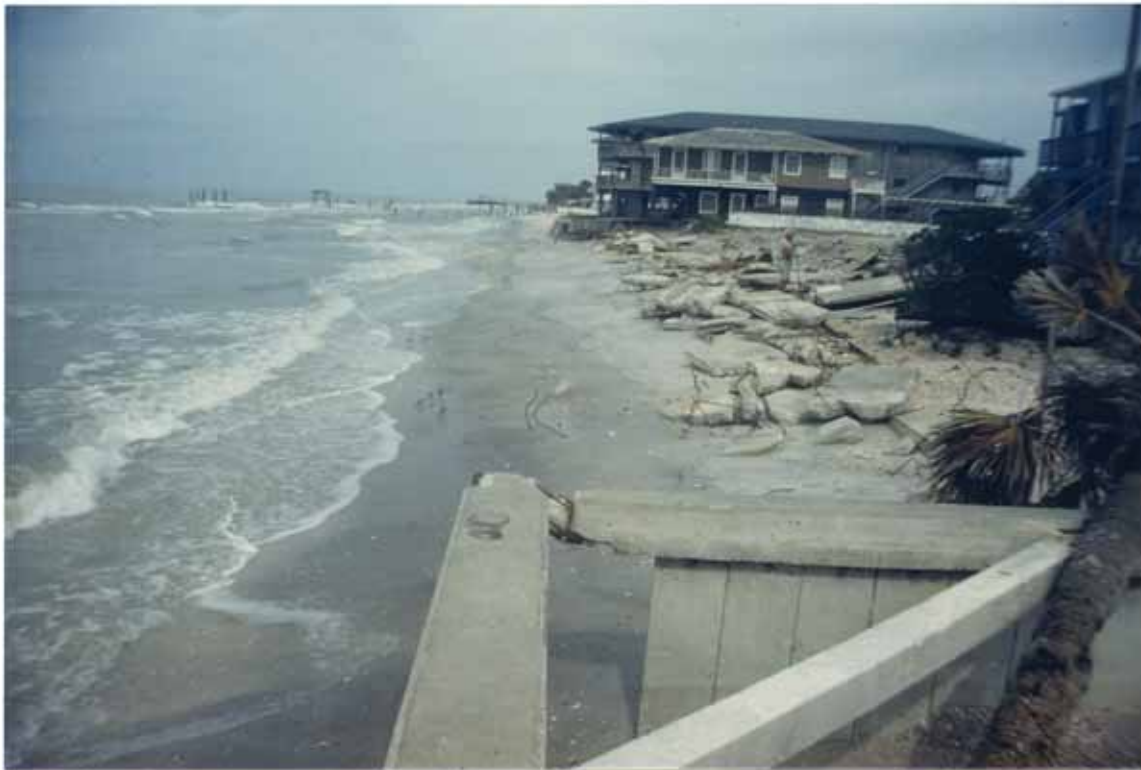
FIGURE 102. South Indian Rocks Beach after Juan

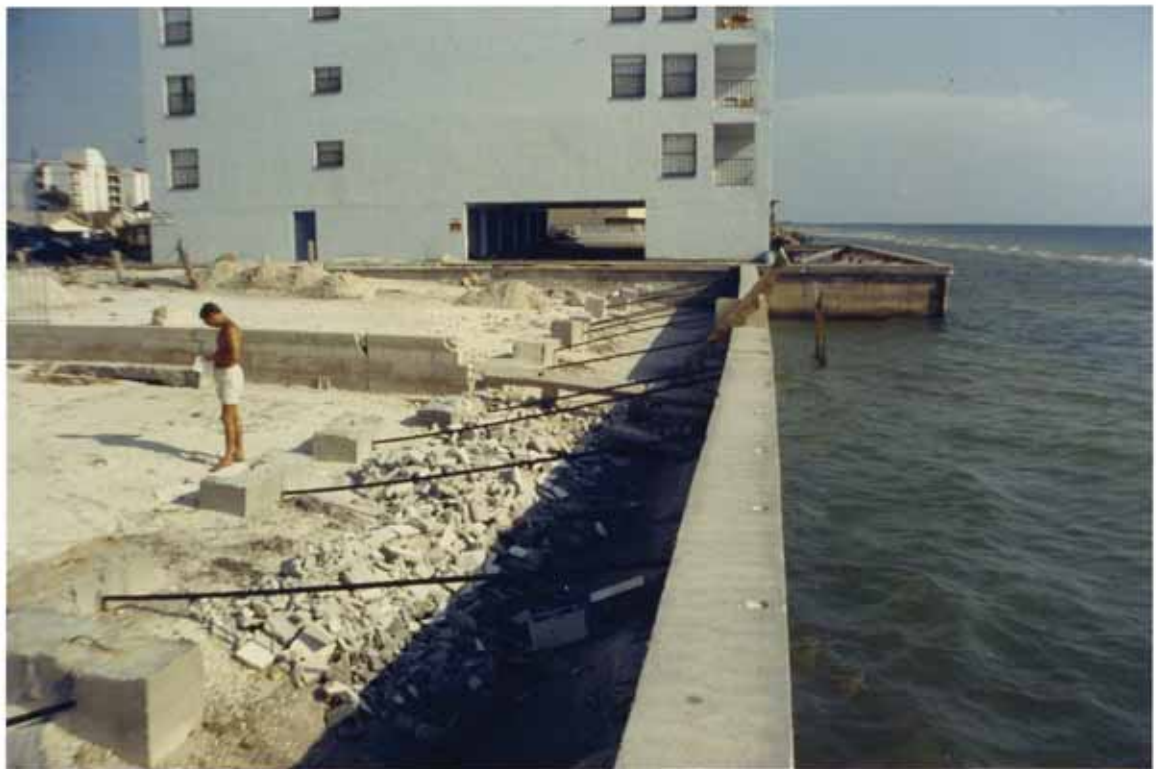
The recent changes of the area may be seen at 193rd Avenue where the gently sloping beach after the subtropical storm in June 1982 (Figure 111) was replaced with the armored shoreline shown after Elena in September 1985 (Figure 112). Upland erosion was reduced, but at the expense of any beach. This wall was damaged by Juan.

FIGURE 112. No beach at 193rd Avenue after Elena
