# THE IMPACT OF HURRICANE ELENA AND TROPICAL STORM JUAN ON COASTAL CONSTRUCTION IN FLORIDA

Beaches and Shores Post-Storm Report No. 85-3

March, 1986

Bureau of Coastal Engineering and Regulation  
Division of Beaches and Shores  
FLORIDA DEPARTMENT OF NATURAL RESOURCES

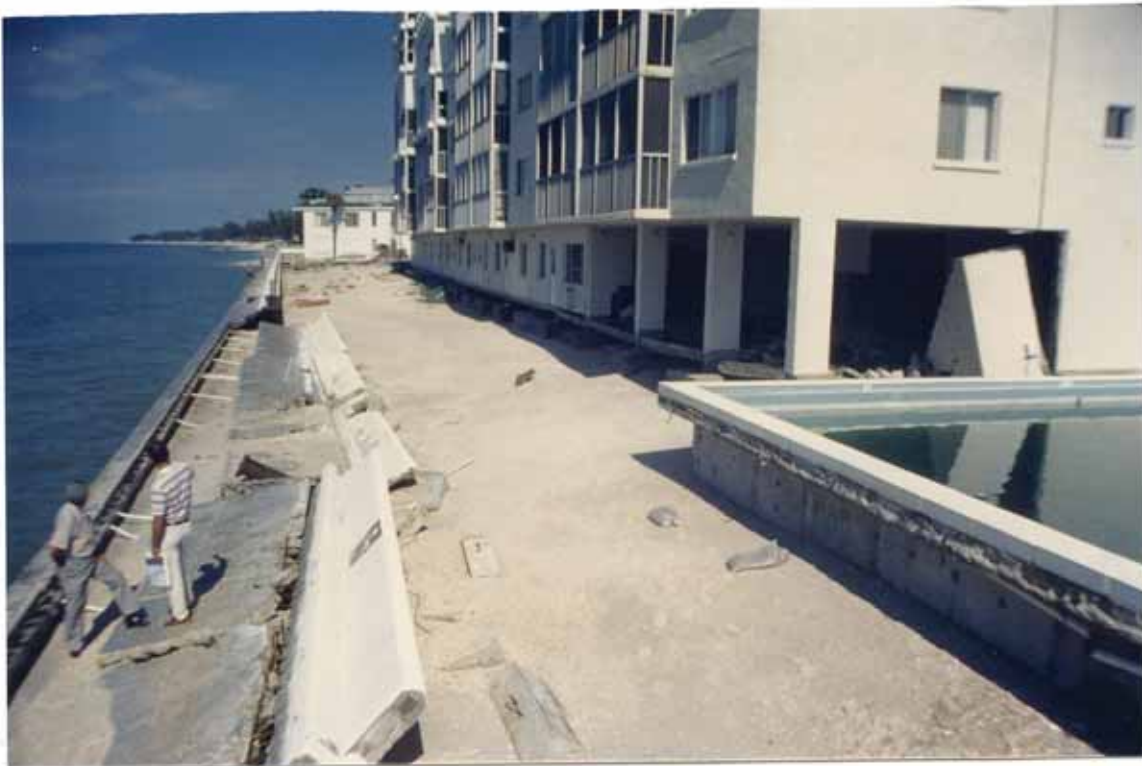
FIGURE 126. Juan destroyed sloping wall at Martinique Condominium

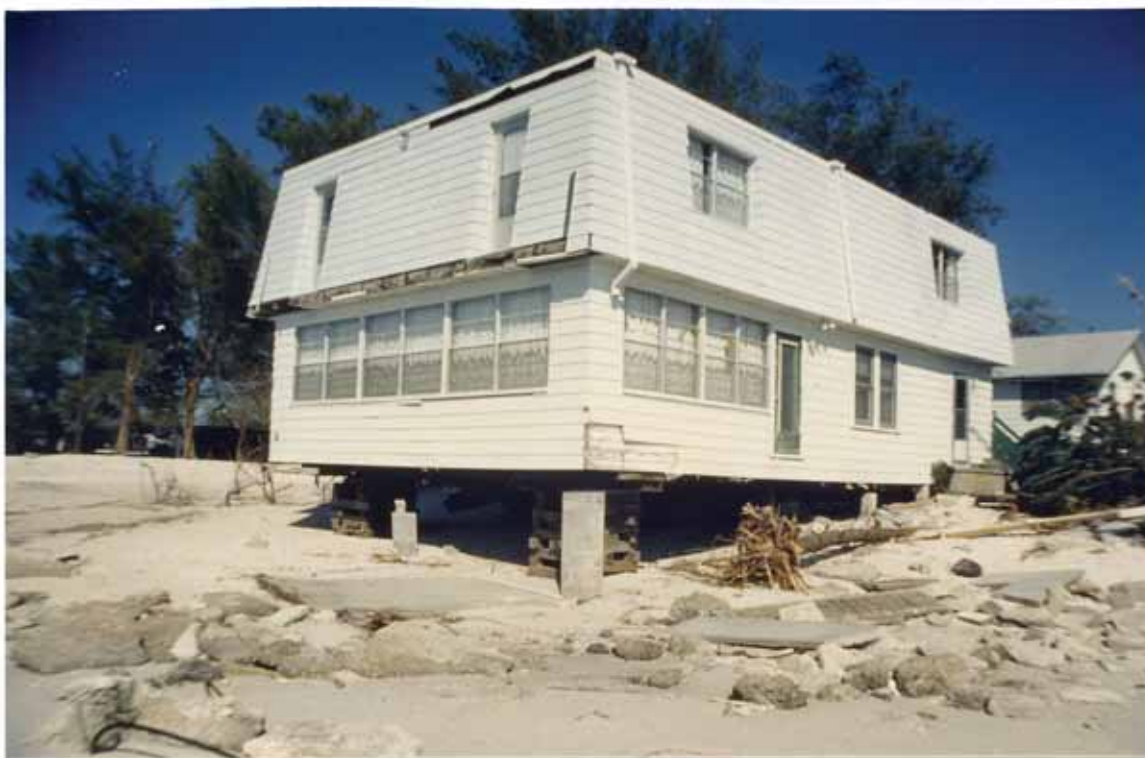
FIGURE 133. Undermined dwelling on temporary supports

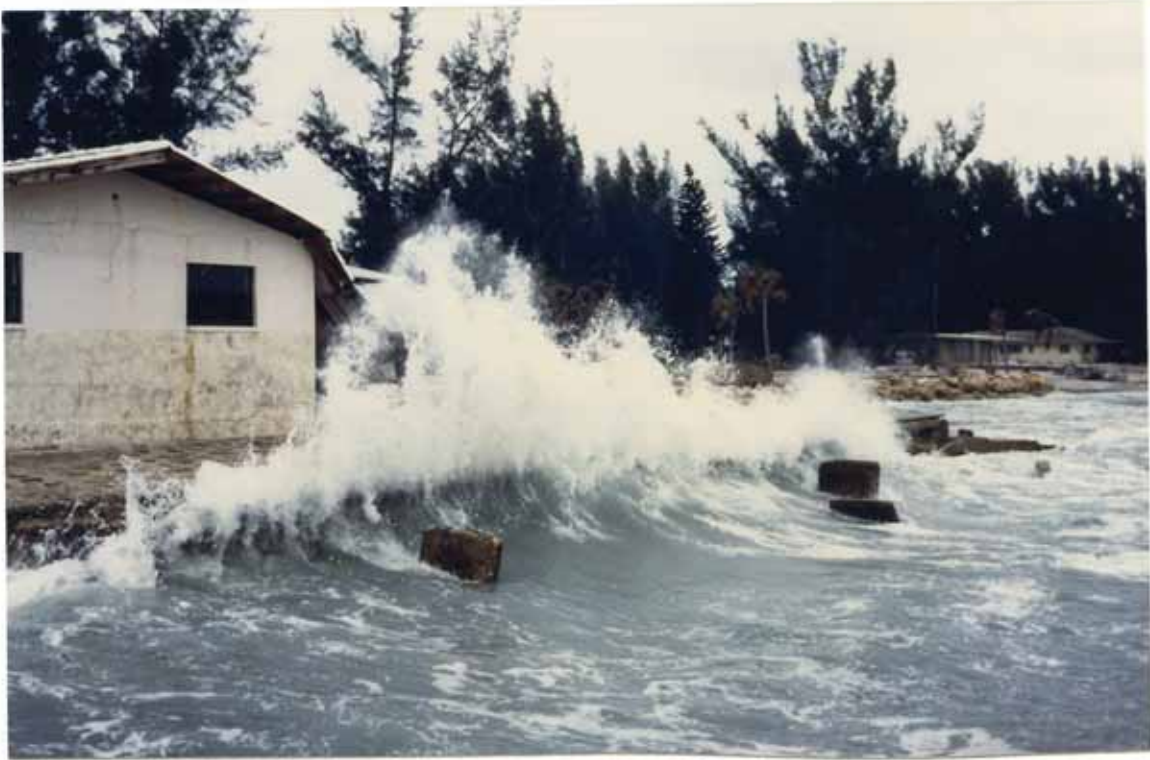
FIGURE 143. Longboat Key dwelling under wave attack  
(S. West)

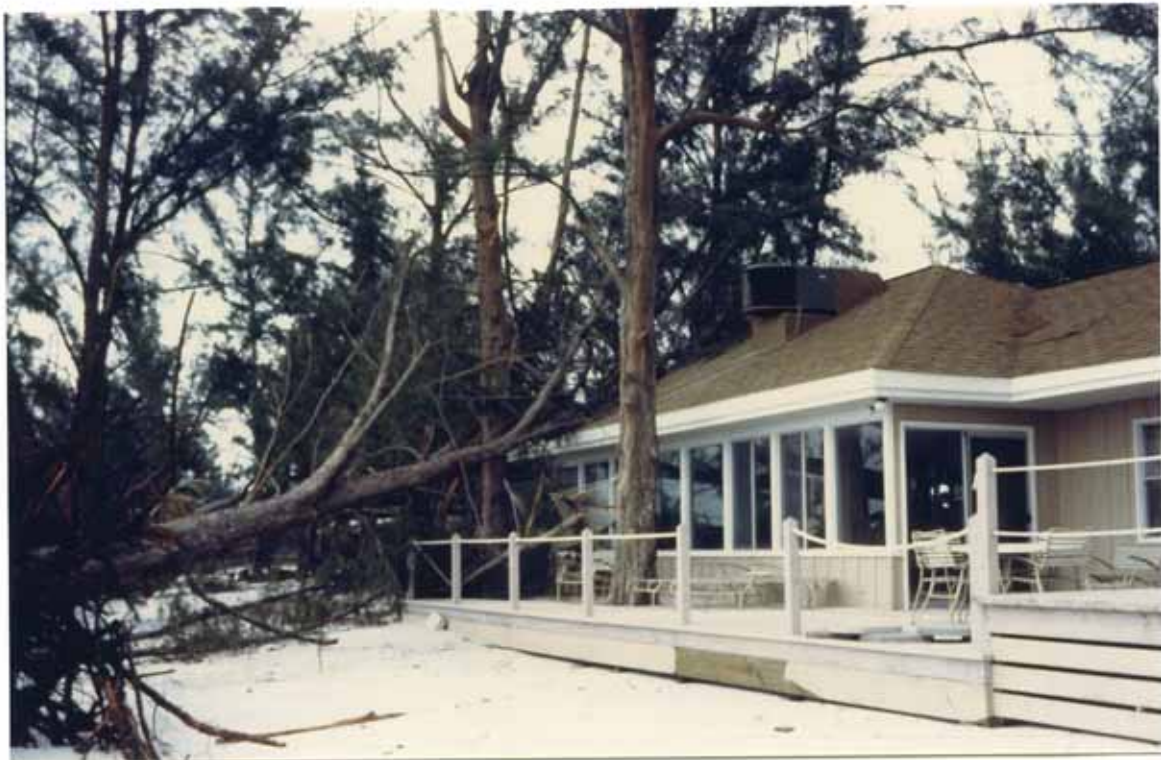
Further south a continuous 700 foot stretch of concrete bulkhead was destroyed by Juan (Figure 142). Considerable erosion took place landward of the bulkhead resulting in a number of large Australian pine trees being toppled (Figures 145 and 146). Notwithstanding the two beach profile computations at DNR reference monument numbers 51 and 54 as reported in Post-Storm Report Number 85-2, moderate to heavy beach erosion took place along the two mile stretch south of this area of heavy structural damage. This area experienced wave overtopping and one swimming pool was damaged by Juan beyond repair.

FIGURE 146. Australian pine toppled by erosion (S. West)

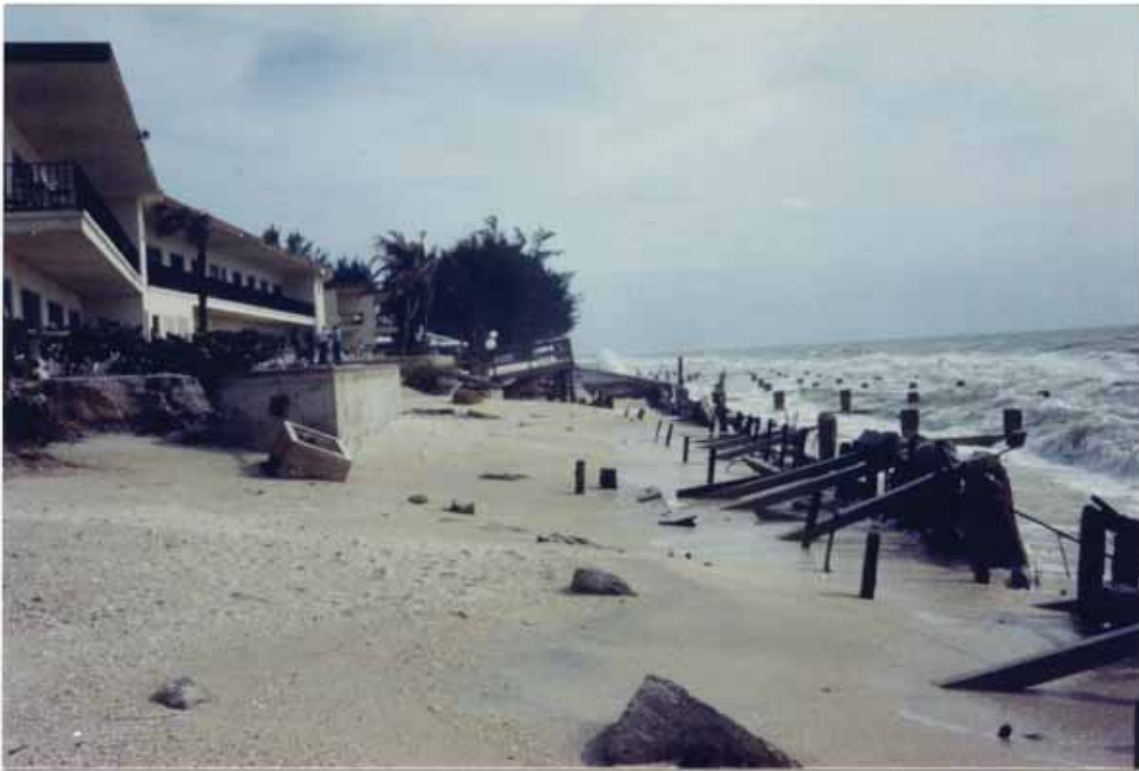
Near the north end of Sarasota County on the middle of Longboat Key, more structural damages were sustained by both storms. At the Seabird Condominium 150 feet of concrete bulkhead was destroyed by Juan. At the Seahorse Condominium 400 feet of concrete bulkhead was destroyed, 150 feet by Elena and 250 feet by Juan (Figure 149). South of the Seahorse, a 30 foot segment of concrete bulkhead was destroyed and south of Buttonview Drive

FIGURE 149. Seahorse Condominium bulkhead destroyed by both storms (S. West)

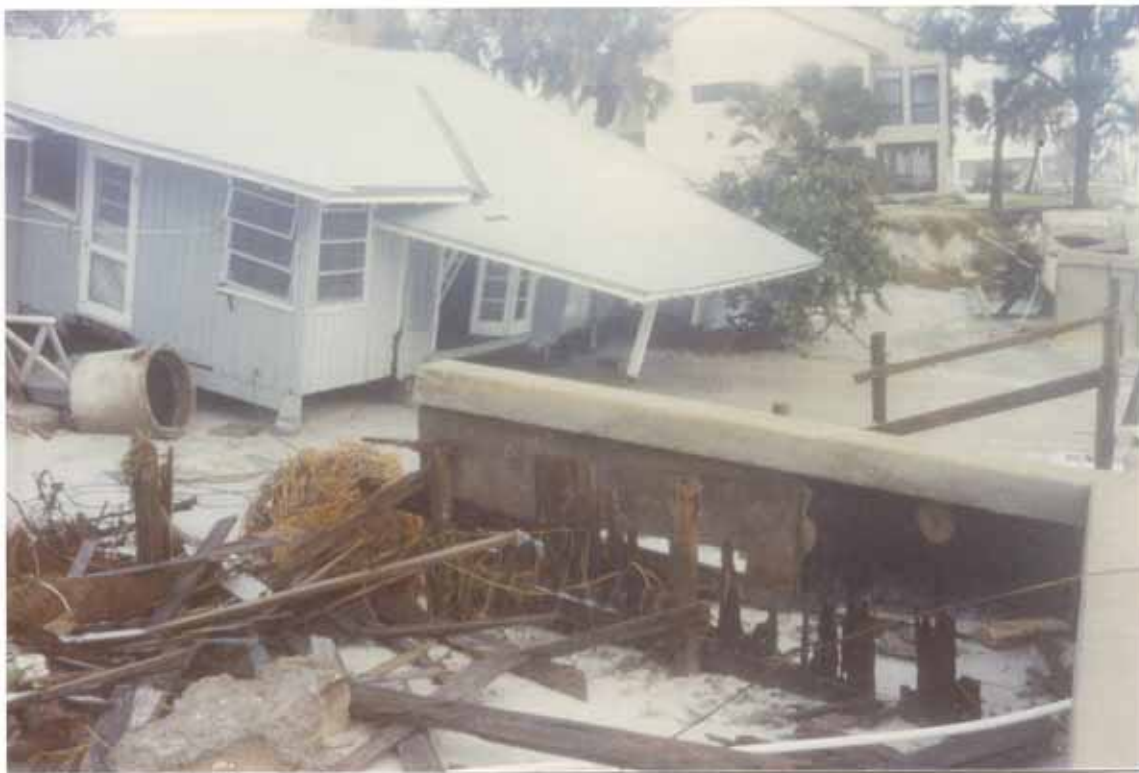
another 35 feet of concrete bulkhead was destroyed by Elena. In the vicinity of Neptune Avenue, 150 feet of concrete bulkhead was destroyed by Elena and another 60 feet was destroyed and 90 feet substantially damaged by Juan. A 75 foot wood bulkhead and a single-family dwelling was destroyed by Elena (Figure 150).

FIGURE 150. Sarasota County dwelling destroyed by Elena (S. West)

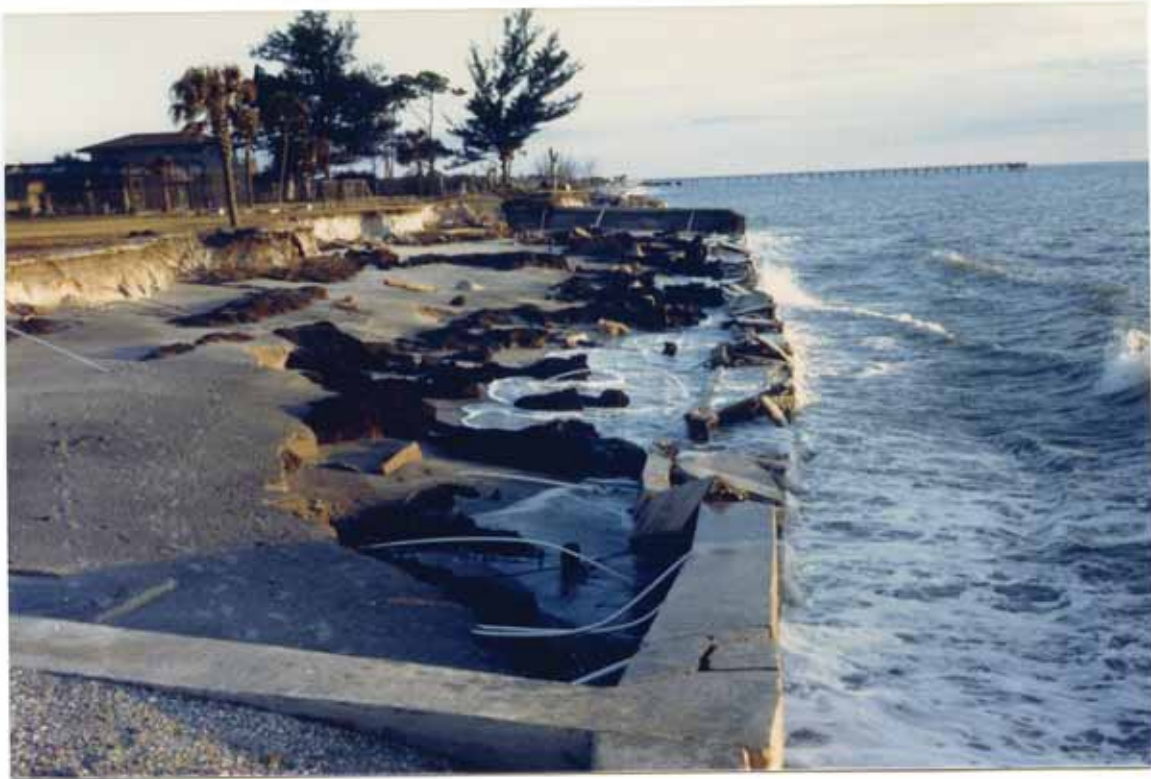
Along Casey Key, three segments of Casey Key Road totaling 2,500 feet were damaged by Elena. New road fill placed after Elena was eroded by Juan. In Venice, south of Rock Creek, 300 feet of concrete wall cap was damaged by Juan. A 100 foot length of concrete bulkhead located 400 feet south of Rock Creek was destroyed by Juan (Figure 153) and a 200 foot length of concrete bulkhead located 500 feet south of Rock Creek was destroyed by Elena (Figure 154). Further south along Manasota Key, a 150 foot wooden bulkhead was destroyed and 1,000 feet of the Manasota Key Road was destroyed by Elena.

FIGURE 153. Juan destroyed Venice bulkhead (S. West)
